Technical Assignment 3

[Arena Stage]

Washington, DC

Joni Richelle Anderson
Construction Management
Dr. John I. Messner
Friday, November 21, 2008

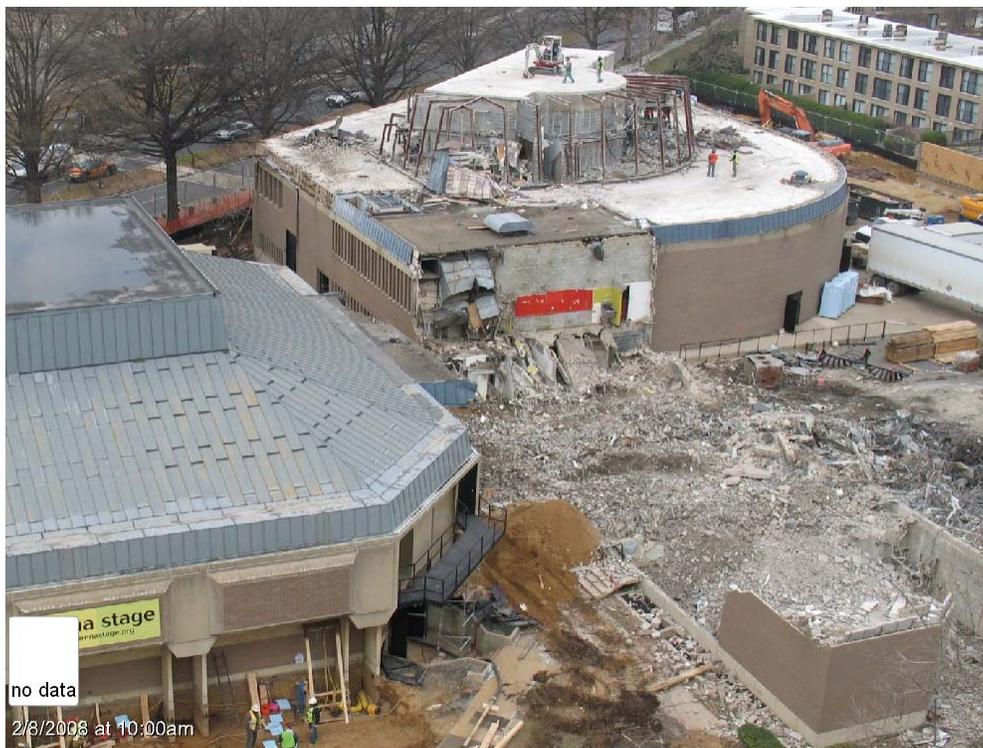
Figure 1: Arena Stage during selective demolition in February 2008
(Provided by Clark Construction WebCam)

According to Mr. Galbraith, there are several constructability issues on the project. The first is the selective demolition. From the beginning, knowing that the Fichandler and the Kreeger were going to be preserved as historical structures, the project team knew that the demolition phase of the project was going to be a challenge. To make matters more interesting, the initial site survey performed by the architect proved to be incorrect. The recorded locations of the existing buildings were recorded two inches off of their actual position.

Although two inches may seem minor to the average person, in the world of construction, two inches is a major dimension error that can cause compounding problems. Specifically, many issues arose when it came to making cuts to separate the Fichandler and the Kreeger from the existing administration building that was demolished. Luckily, the discrepancy was recognized and the project team addressed it immediately. Since the drawings had already been released for construction, the only way to resolve the issue was to write RFI's to the architect. Matt Galbraith stated that Bing Thom Architects (BTA) has been working hard to keep their responses timely to avoid any hold up on the project. Although this process is somewhat of an inconvenience and requires much more coordination, it keeps the personnel on their toes and makes them aware of the consequences of even the smallest mistakes.

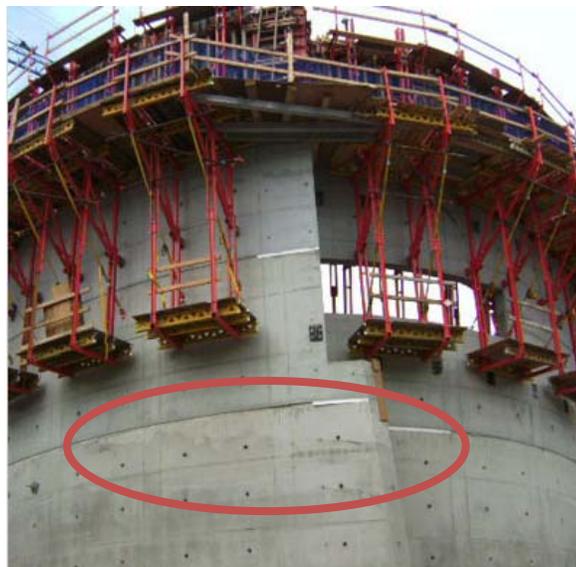
Figure 2: Architectural concrete finish at the Cradle Theatre.
Some pigment discrepancies not tolerated.

As with most theatre complexes, a lot of the areas are large, open spaces with very few columns present to provide support. Due to their large size, the concrete walls require a lot of time and man power to form and pour. In addition, the majority of the concrete walls are required to have an architectural finish. Of course, the Cradle Theatre is the epitome of these challenges. With 8 different wall radiuses that tilt on a 4 degree slope, getting the construction joints to match perfectly around the ellipse has been a great challenge.

Even more difficult is the problem that Clark Concrete has been facing. Despite the fact that all of the concrete batches are made using the exact same formula with the same material, each batch has noticeable variations. Although slight variations are common, a few batches have resulted in extreme color differences which BTA has had to refuse on several occasions since they do not meet their specified standards. Clark Concrete has not been able to pinpoint the exact reason for this problem, but they believe it may be due to variable pigment in the aggregate. Similarly, some of the larger walls have caused issues. Because they require the use of large, continuous formwork, they cannot always support the pressure of the concrete. This results in walls that have settling at the base, or “fat-bottomed.” Unfortunately, several walls have been ripped down and replaced because of their unfavorable appearances.

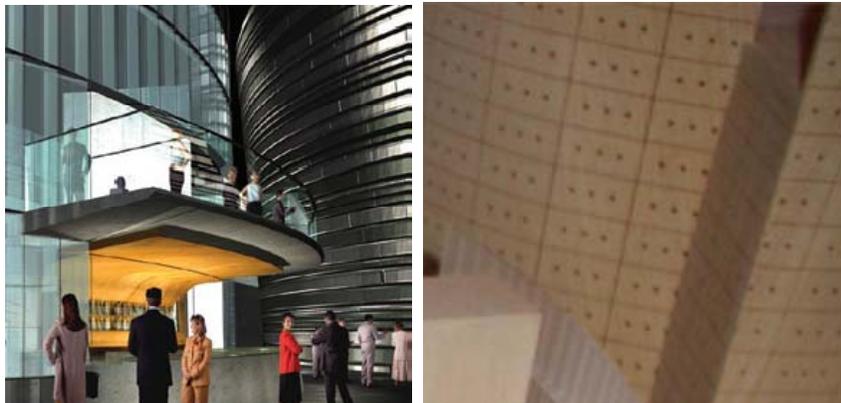
Figure 6: (Left) Original zinc-clad Cradle exterior finish (Original Rendering from BTA)
(Right) PERI-formwork finish being implemented (Most current model)

Also, the Cradle was originally designed to be clad in zinc panels. This expensive feature was quickly VE’d and changed to board-formed finish concrete. This method, however, is also very expensive and would require an enormous amount of man power, so it was also VE’d. The Cradle finish that was agreed upon is the current PERI-RUNDFLEX finish which has circular voids from where the formwork ties together.
