University of Maryland, Baltimore New Administration Building Baltimore, MD

Keith Meacham Construction Management Technical Assignment 3 Dr. John Messner

University of Maryland, Baltimore New Administrations Building Baltimore, MD

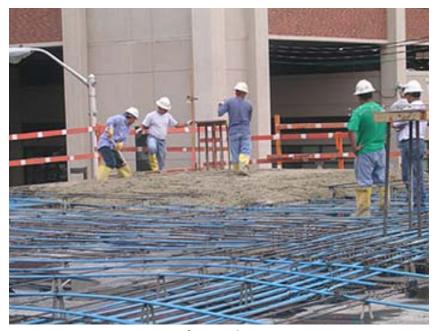
Figure 3
Reinforcing at interior column.

Figure 3 was taken on a North end pour and notice the congestion of PT strands laid East to West and North to South.

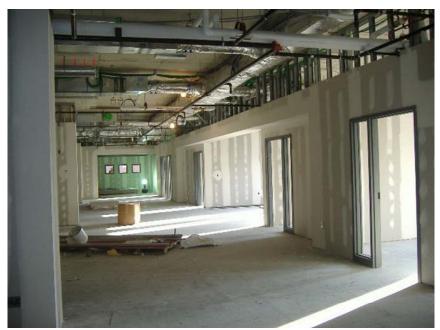
Figure 4
Drywall and mechanical installation.

Another area on the schedule with potential acceleration was R/I and finishes. This was a viable option due to the large and somewhat typical interior areas. Extra men could be brought in without interfering with trades already in progress. Considerable cost implications of extra men at this phase would apply. Because of the large spaces, it was possible to have ceiling mechanical R/I and vertical drywall go up at the same area and time. Significant time is saved anytime two trades can occupy the same space and work as if there is only one. Below demonstrates work occurring simultaneously.

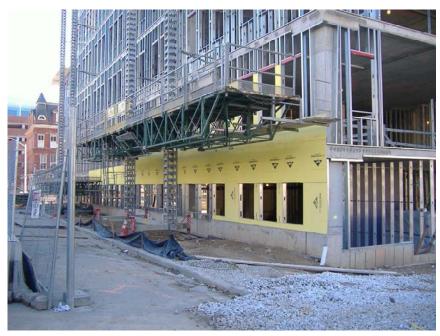
Figure 5a
Façade scaffolding.

Having enclosures and masonry go smooth is key to façade construction. There is a lot of material and contractors must reach the entire length of the building, while moving vertically up. Achieving the second point with few breakdowns and set-ups can be difficult. To remedy this BMC made it mandatory for the masonry sub to have full length hydraulic scaffolds on 3 sides of the building, during the enclosure phase. The owner incurs a greater expense than hanging scaffolding from the roof but the facade is installed much faster and so construction can progress faster. This leads to a water tight building which allows interior finishes to begin much sooner. Figure 5a shows the scaffolding that was present during façade construction.

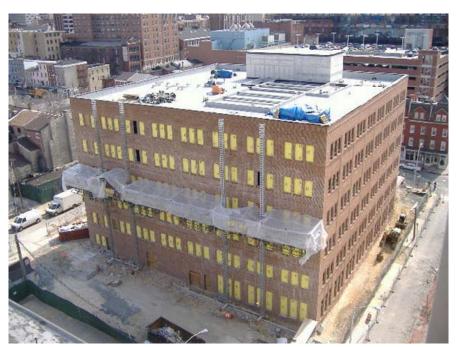
Figure 5b
Façade Scaffolding.

To further moisture protection, temporary and dense window panels were installed in lieu of thin plastic that is commonly used in construction. These can be seen in figure 5b. BMC experienced far fewer moisture problems after the building was enclosed compared most projects. Moisture problems, many times, call for replacement of damaged or moldy finishes and can delay work.

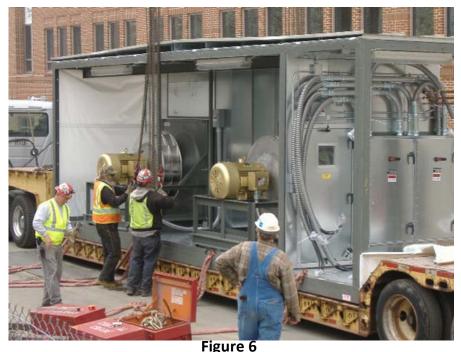
3 different air handling units were called out by the mechanical engineer to be placed on the roof. Also a penthouse was supposed to be constructed onsite. BMC estimators came up with two different options to improve this design. Option 1 was to have an AHU on every other floor inside the building, each servicing 2 floors. Option 2 was to combine all 3 AHU's into 1 and install it on the roof. Option 2 was chosen. This AHU was delivered in 8 components and assembled onsite. Once assembled the AHU has a self contained penthouse which will make future maintenance easier. Also, having only 1 AHU reduces the penetrations through the roof. There was only 1 supply and return riser each. Figure 6 is one of the 8 preassembled components that were delivered and assembled on site.

1 of 8 AHU Components delivered on site.
