Technical Assignment 3: Alternative Methods Analysis

Natalie Bryner

Constitution Center

400 7th Street SE, Washington, DC 20024

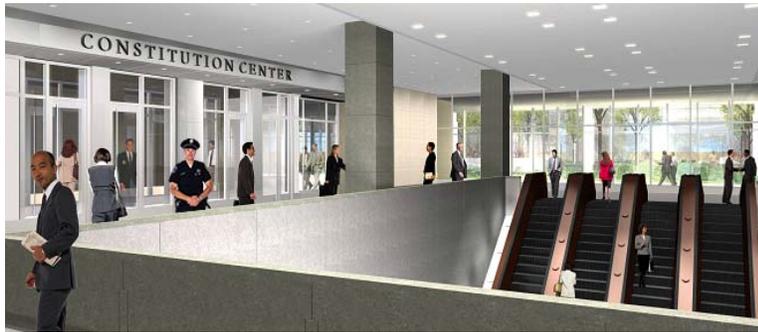
Figure 1: Rendering of the L'Enfant Metro Station Entrance.

because the Washington Metropolitan Area Transit Authority (WMATA) would not permit the entrance, show in Figure 1, to be closed during the entire construction. The final constructability challenge that was studied was the density of the MEP installation and how DAVIS redesigned the largest chilled beam system being installed in the United States.

The second constructability issue that occurred on the site of Constitution Center was that the L'Enfant Plaza metro station entrance is directly beneath the building. One issue was that the metro did not permit the entrance to be closed for the full duration of the project. The only time frame they allowed it to be closed was during the overhead curtainwall work along D Street. One stipulation for the closure was that it had to be fully reopened by the July 4th holiday since the National Mall is two blocks away. Therefore, from October 2007 till

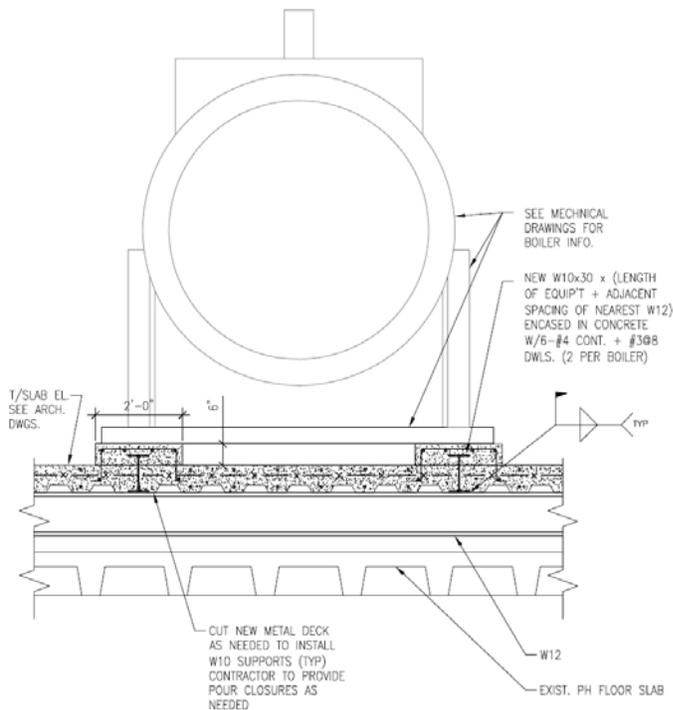
Figure 2: Structural Engineers' sketch of the boiler supports.

The weight of the three new boilers was a challenging constructability issue because the two 350hp boilers weights 27,500lbs (138 tons) and the 800hp boiler weights about 49,750lbs (250 tons) . With this weight, steel beams had to be added perpendicular to the support steel below the boiler spring isolators. Theses steel beams transfer the weight out of the columns. Figure 2 is a sketch provided by the structural engineers to show the W10x30 that were installed and encased in concrete in order to support the boiler weight. Figure 3 documents the actual installation and provides a visual of the spring isolators. One limiting factor of the steel beam installation was that the roof could not be raised so the additional steel had to be low profile so the top of the boilers did not hit the roof but are strong enough to handle the weight. Additionally, since the boiler weight was so large, a separate crane had to be brought onto site in order to set the boilers into place. The crane is a Manitowoc GMK7550 mobile hydraulic crane with a capacity of 450 metric tons on a seven-axle carrier. This crane was set up parallel to the north façade on D Street, which meant that coordination with the District of Columbia had to occur in order to temporarily shut the street down. This closure took place from 6:00pm on Friday to 7:00am Monday. Figure 4 shows the installation of the boilers. The photo on the left exhibits the closure of D Street in order for the crane to be set up. The middle and right photos illustrate the actual installation process, which took about 4 hours to rig, lift, and set all three boilers. Although the installation only took 4 hours, it took a total of 16 hours to set, assemble, and take down the crane. Overall this issue took coordination with DAVIS, SmithGroup, SK&A, and Pierce in order for the boilers to be properly installed.

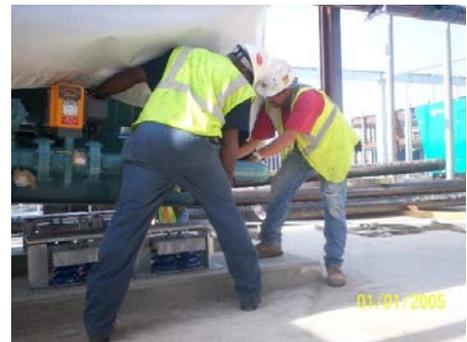
Figure 3: Installation of a boiler, please note the spring isolators, which sit upon the steel beams encased in concrete.

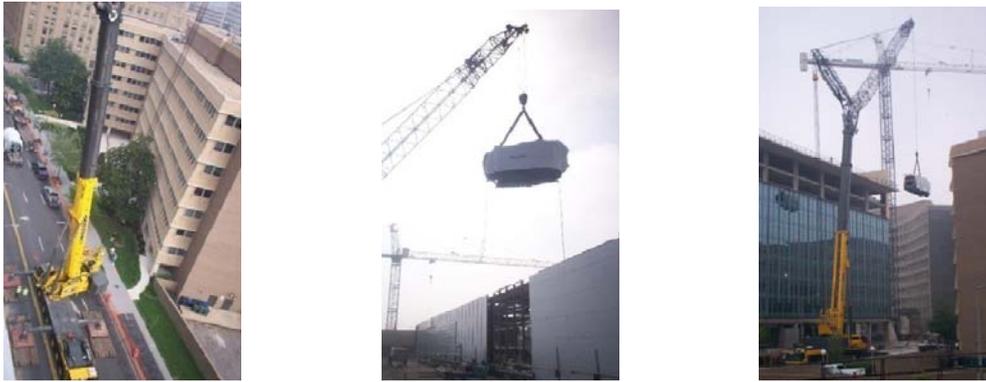
Figure 4: The photos show the installation of the boilers along D Street.

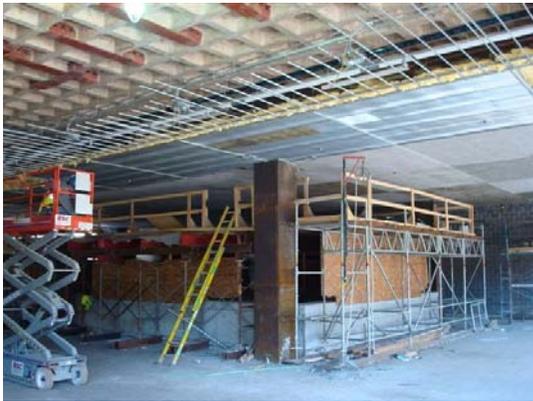
Figure 5: Photo showing the escalator ceiling work.

June 2008, the metro escalator was shut down and the curtainwall installation took place along D Street and the ceiling work directly above the escalators was completed. Figure 5 shows the ceiling work taking place over the metro escalator. From the start of the project, overhead protection was in place in order to protect pedestrians while demolition was taking place. Finally, the metro entrance was reopened on July 1, 2008 and overhead protection was eliminated since all overhead work was complete. Additionally, special measures were implemented to protect pedestrians while the remaining work along the streetscape and lobby are being completed. Some of the special measures were:¹

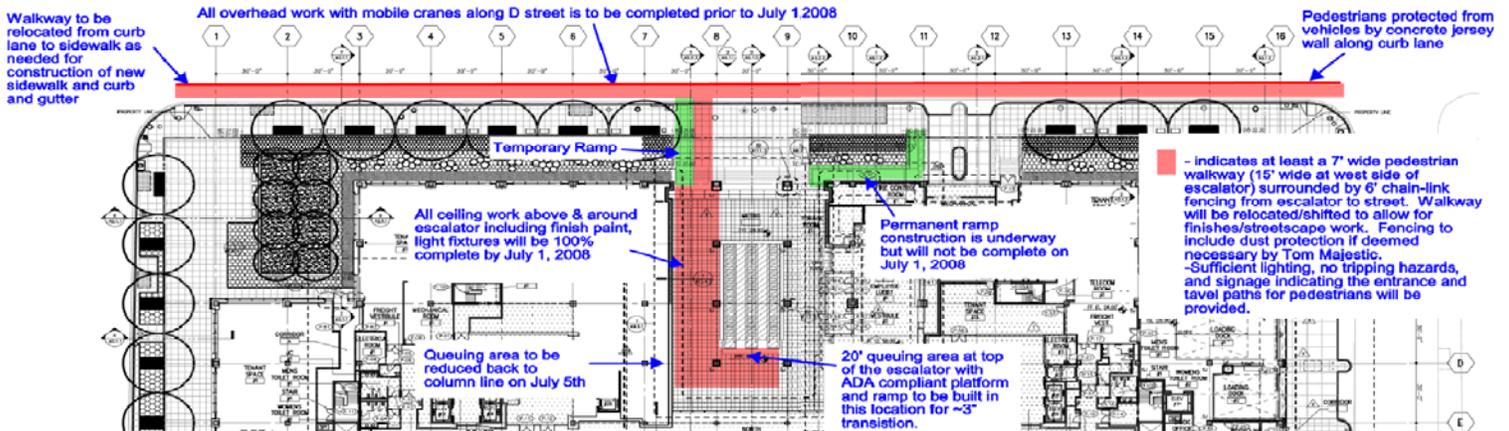
Figure 6: Metro entrance protection plan.

- All ceiling work above and around the escalator is in the finishing stages – finish paint, final light fixtures, etc. will be completed by July 1, 2008.
- All overhead work involving mobile cranes along D Street will be completed by July 1, 2008.
- Construction of an ADA compliant platform and ramp at the escalator entrance to accommodate for the ~3" transition until the finish stone can be installed
- 6' high chain link fence surrounding the perimeter of the pedestrian pathway – dust protection will be provided if deemed necessary by site conditions and WMATA.
- Although the original metro easement did not include a ramp from the sidewalk to the escalator entrance, DAVIS constructed the new final ramp. While this construction was underway, it was not be completed by July 1, 2008.

Figure 6 is the plan that was executed in order to have the L'Enfant Metro entrance reopened by July 1, 2008.

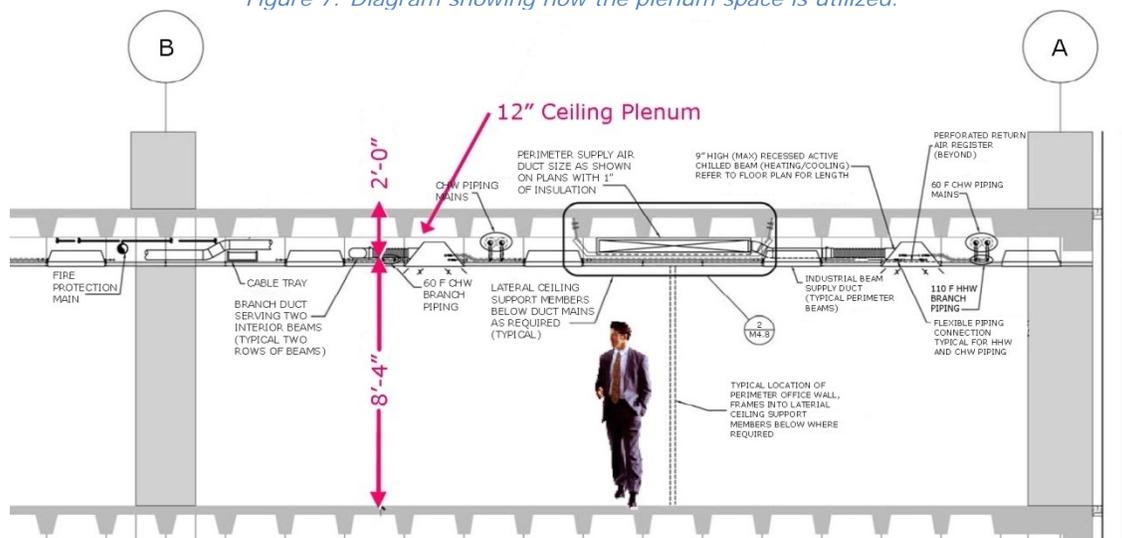
Finally, the density of the MEP installation at both the typical floors and the Penthouse was a constructability challenge. This challenge required tremendous amount of time to study the shop drawings. One recommendation that DAVIS provided to the ownership was to complete BIM studies with the shop drawings. However, they did not feel it was necessary, and "took a less costly study by using the contract design drawings by SmithGroup."² The way that DAVIS overcame one of the density issues was to customize the typical floor chilled beams. The original design was to have the system be made up of a beam that is 8' in length and 11" deep. "Through coordination with Trox (Chilled Beam Manufacture), SmithGroup Engineering and DAVIS, they were able to develop a beam that is typically 6' in length, about 7" in depth with pipe and duct connections that do not have be predetermined."³ Figure 7 shows how the plenum space is utilized and how it was necessary to reduce the chilled beams depth. This coordination was about 8 months long, which included a visit to both Trox in Germany and Trox in the United Kingdom to visit with the various engineers and testing facilities. Overall, since the plenum space is only 12" in depth, the customization of the chilled beams were critical since there are over 6,600 units. Finally, this constructability challenge will be beneficial to the United States market because the units will start to be utilized in construction and become the standard size.

Figure 7: Diagram showing how the plenum space is utilized.

A problematic feature of Constitution Center is the density of the MEP installation needed to be placed into the 12" plenum space. This space needs to be utilized by numerous subcontractors for items including fire protection, cable tray, branch duct, branch piping, duct mains, supply air ducts, chilled beams, returned air register, and hot/cold water piping.

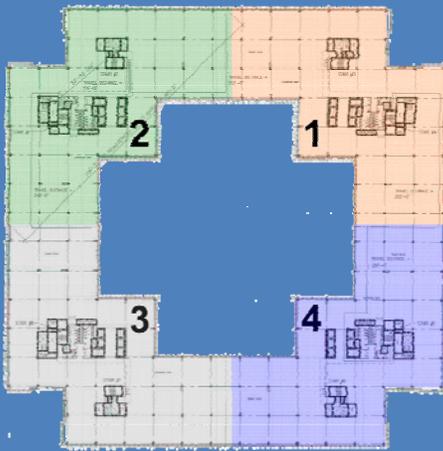
Start Construction	07/02/07
Curtainwall Release Dates	
Bid Curtainwall	11/03/06
Release Curtainwall	01/01/07
Initial Installations	02/19/08
Weatherright Ready for Davis to Start Tenant Construction	
NE Quadrant 1	07/25/08
NW Quadrant 2	10/15/08
SW Quadrant 3	12/05/08
SE Quadrant 4	12/05/08
Tenant Buildout Availability for Other Interior	
NE Quadrant 1	01/01/09
NW Quadrant 2	04/01/09
SW Quadrant 3	06/01/09
SE Quadrant 4	07/15/09
Substantial Completion	
NE Quadrant 1	05/01/09
NW Quadrant 2	07/01/09
SW Quadrant 3	09/01/09
SE Quadrant 4	11/01/09

At the current time, DAVIS is not pursuing many acceleration options since there is not a tenant for the building. One way DAVIS considers schedule acceleration is to focus on specific trades and/or isolate specific tasks that have the largest impact on the overall project. DAVIS has chosen to do this for the permanent power sequences. One option was to have "half the gear be replaced while using the old gear for construction, then use half the new gear for construction and replace the old 2nd half, eventually turning both sections on as permanent. The other option was to take advantage of utilizing generators for construction power while installing the

permanent power gear in one sequence.”⁵ The reason why DAVIS has chosen to accelerate the permanent power is because coordinating with the local utility company PEPCO is the longest path to energize the permanent gear. There is a projected cost of about \$400,000 to work off of generators and it is expected to stay on schedule overall. There are several benefits to accelerating the permanent power. Initially, during a “phased de-energizing and energizing sequence they expected the work to take 5-6 months, however utilizing a single de-energize/energize sequence, they can complete this work in about 3 months.”⁶ Overall, DAVIS will be expending about \$400,000, but will avoid a 3-4 month late start with the commissioning process, which is an activity on the critical path/highest risk radar.

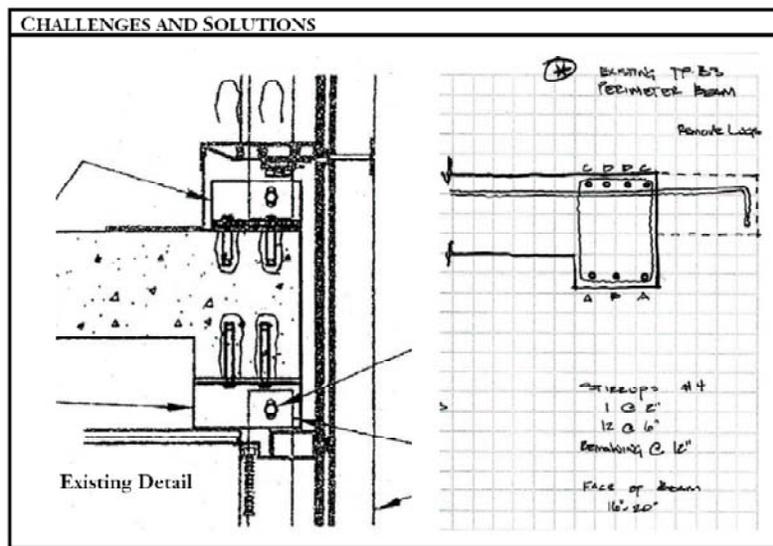
Another value engineering topic that DAVIS chose to pursue was the anchor system used for the curtainwall. They determined that this again was both value engineering and a constructability issue. It was established that the anchorage was to be changed to the face of the beam instead of the top/bottom of the beam installation. One main reason this occurred was because it is nearly impossible to have the top/bottom of the beam installation. The underslab mounting location increases the difficulty in erecting the panels, especially because they exceed 800 pounds. Another reason is because the “embed anchors are likely to conflict with existing rebar and stirrups, along with the installation being difficult which would result in low labor production and potentially dangerous edge conditions.”⁷ Figures 9 and 10 are visual representation on how the anchorage detail changed. This value engineering idea correlated with the owner because it was less expensive, faster, and easier to install.

Figure 9: Details of the existing curtainwall anchorage.

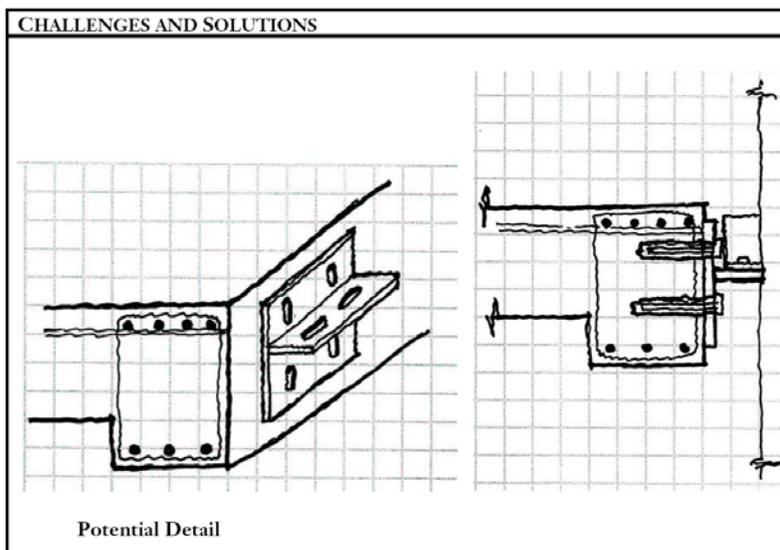
Figure 10: Details of the potential curtainwall anchorage.

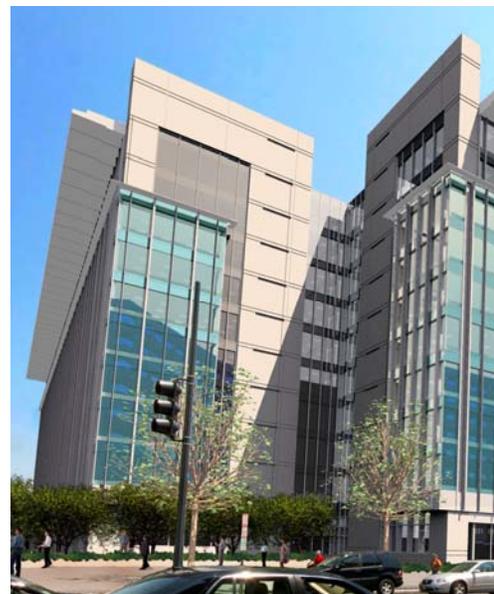
Figure 12: Rendering that shows the location of the precast panels.

There were several ideas of value engineering that were considered but not implemented on the project. First was to apply traffic coating to all three levels of the parking garage instead of just levels one and two. The reason why this was deleted is because they did not feel it was necessary to execute since level three only has parking, unlike levels one and two that have electrical rooms located on them. Another idea was to implement the Davis Bacon Law instead of an Open Shop. The reason this was not used was because it would limit the number of subcontractors that were able to bid the job. The suggestion of deleting the precast panels at the Penthouse corners was also a value engineering idea. Figure 12 shows the location of the precast panels. The reason why this topic was cancelled was because they felt it would take away from the aesthetics of the building's design if the panels were removed. One final value engineering idea that was not used was to delete the ladder and platform for the 400hp boiler. The reason why this was not put into action was because they felt it would be easier to access the boiler if the ladder and platform were a part of the system.
