KIMBERTON ELEMENTARY SCHOOL

EAST PIKELAND TOWNSHIP, CHESTER COUNTY, PENNSYLVANIA

TECHNICAL REPORT 1 CONSTRUCTION PROJECT MANAGEMENT

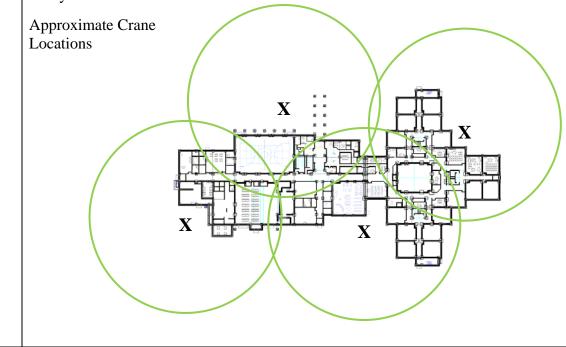
The erection of the steel would be done by a standard crawler crane. The steel would be erected starting near the mechanical room. Based on logic of crane placement total of four picks will be used. The first pick will be in the southwest corner outside the mechanical room and kitchen. The second pick will be next to the gym and main entrance. The third pick will be in the southwest corner of the classroom wing, located outside the media center. The final pick will be in the northeast corner of the building to erect the remaining section of the classroom wing.

Based on my calculation of the largest lift on this job being the steel trusses for the gym, a Manitowoc model 8000 crawler crane would easily be able to lift all of the steel lifts for this job. The Gym truss weighs 6750lb and with a 20% safety factor that weight is 8100lbs. The furthest lift for the building is approximately 100 ft. (the lift for the gym truss will be only about 75 feet). For extra safety, the critical pick was calculated at 105 feet. The height of the building should not be a factor because it only raises 30 feet at the highest point but for added safety a boom angel of 40 degrees was assumed. The crane boom will be far above the 30 feet. At the critical lift the Model 8000 is able to pick 8.5 tons at 105 feet and a boom length of 160 feet. The Manitowoc Model 8000 is rated at 80 ton lift capacity and has a 200' foot heavy lift boom.

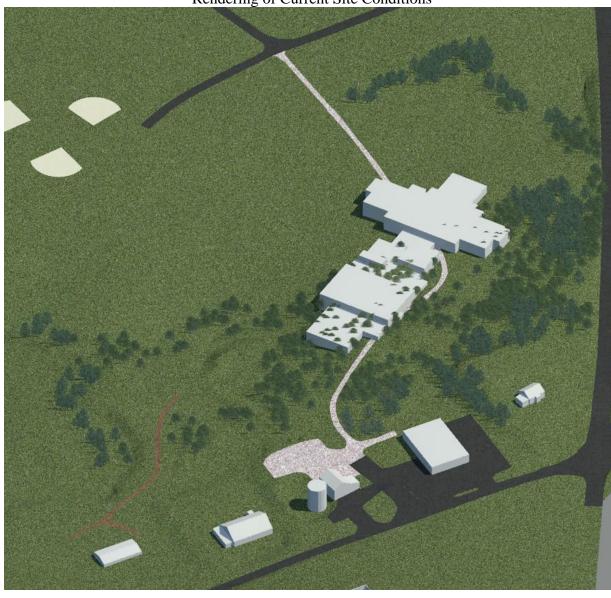
Rendering of Current Site Conditions

roads surrounding the site are two way roads and the site will be accessed for construction

directly from route 113.

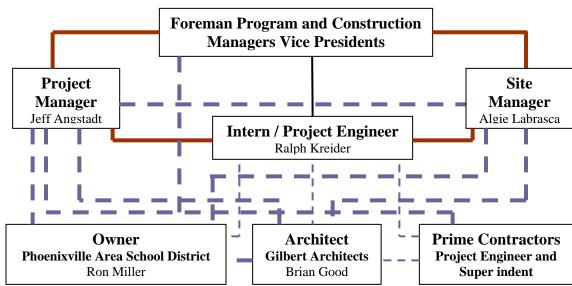
Organization Chart

Note: The heavy solid lines indicate direct boss. The light solid line indicates secondary boss. The dashed lines are lines of communication.

The main project management staff for the construction of Kimberton Elementary consists of a FPCM project manager and FPCM site manager. The two positions are overseen by the vice presidents of the company. FPCM will also have a project engineer/intern assigned to the job, who is supervised by both the project manager and the site manager. Both the site manager and the project manager are in constant communication with the owner, architect, and prime contractors. The project engineer is also in contact with the owner architect and prime contractors but on a less formal manner. The architect and prime contractors have basically the same management setup as FPCM with a project manager and superintendent. The owner has a facilities manager, Ron Miller, a superintendent, and a school board that makes its decisions. The prime contracts have communication with the owner and architect; however the CM usually facilitates it.
