Section 6: Analysis #1 – Concrete Columns with Steel Trusses Vs. Glulam Structural System (Structural – Breadth Topic #1)

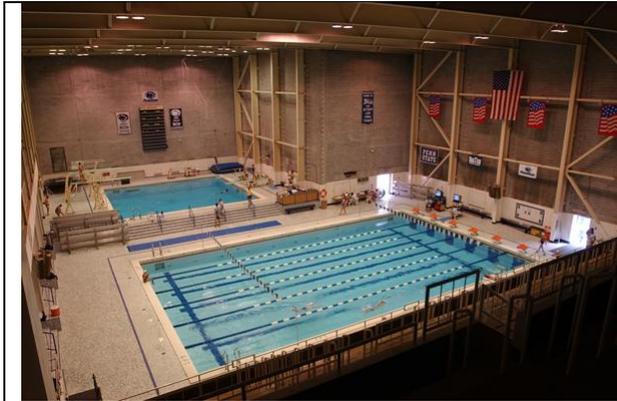
Figure 6-1.1 - Natatorium with steel structural system. Courtesy of Penn State

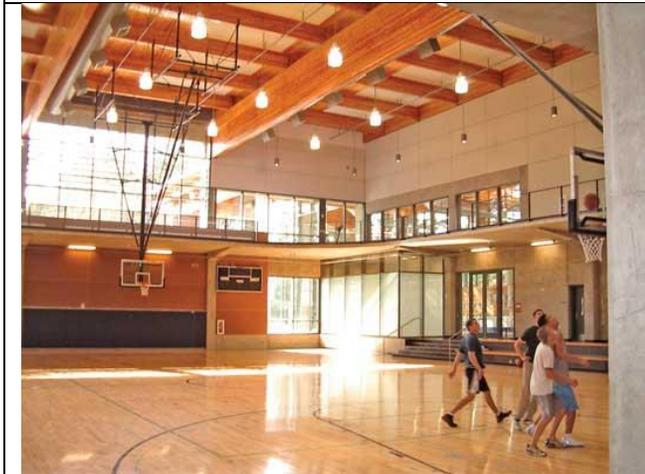
Figure 6-1.2 - Gymnasium with glulam structural system. Courtesy of Structure Mag
