# Technical Assignment 3: Alternative Methods Analysis

The Salamander Resort and Spa

Paul Roberts

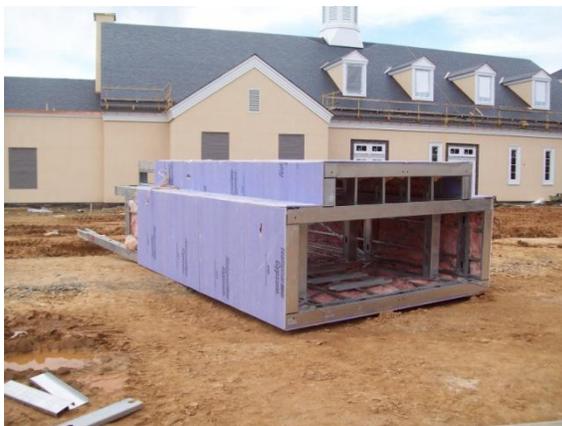
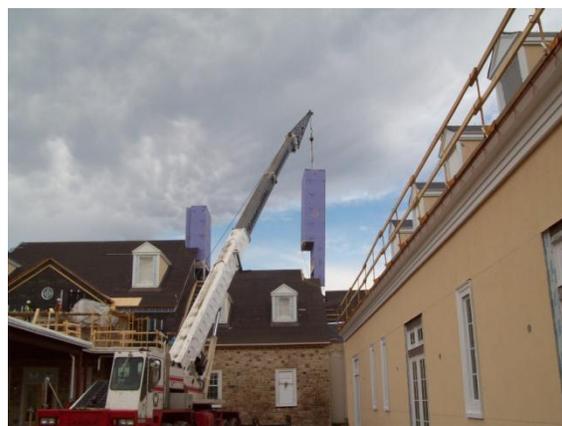
This indecision from the owner caused the project team to just continue with concrete pouring and truss installation and deal with the chimney once the design was finalized. Once the final design came in, the chimneys were constructed on the ground and then hoisted up into place. In order to drop them into the correct location, the steel roof trusses that were in the way needed to be cut out. Also, because the location on the chimneys was unknown at the time of concrete pouring, the concrete subcontractor did not include any steel plates for structural support. Instead, the project team was forced to do extensive plate modifications right before the chimneys were placed. The following pictures show the construction of the chimneys on the ground and the placement of them on the lodge.

Just as in the main building, the architect only determined the approximate plan location of the chimneys, none of the connections or construction drawings were produced. The biggest problem was the chimney to roof connection and maintaining a waterproof seal. The other problem was the structural support of the mass of the chimney. All while this was going on, the owner was continuously value engineering so one design never received approval before a new one was coming out.

The chimneys found in both the main building and the guest lodge was never fully designed by the architect. This created many problems with trade coordination because space was not left for the extension of the chimney from the floor through the roof in the main building. In the guest lodge, the location of the chimneys was not known until after the roof trusses had been installed. In order to place them, holes needed to be cut in the trusses and additional reinforcing had to be installed to support the mass.
