The Pennsylvania State University
5th Year thesis

Technical Assignment One

Construction Project Management

Timothy Conroy
Construction Management
Professor Chris Magent
2175 K Street NW
Washington DC
10/5/2009

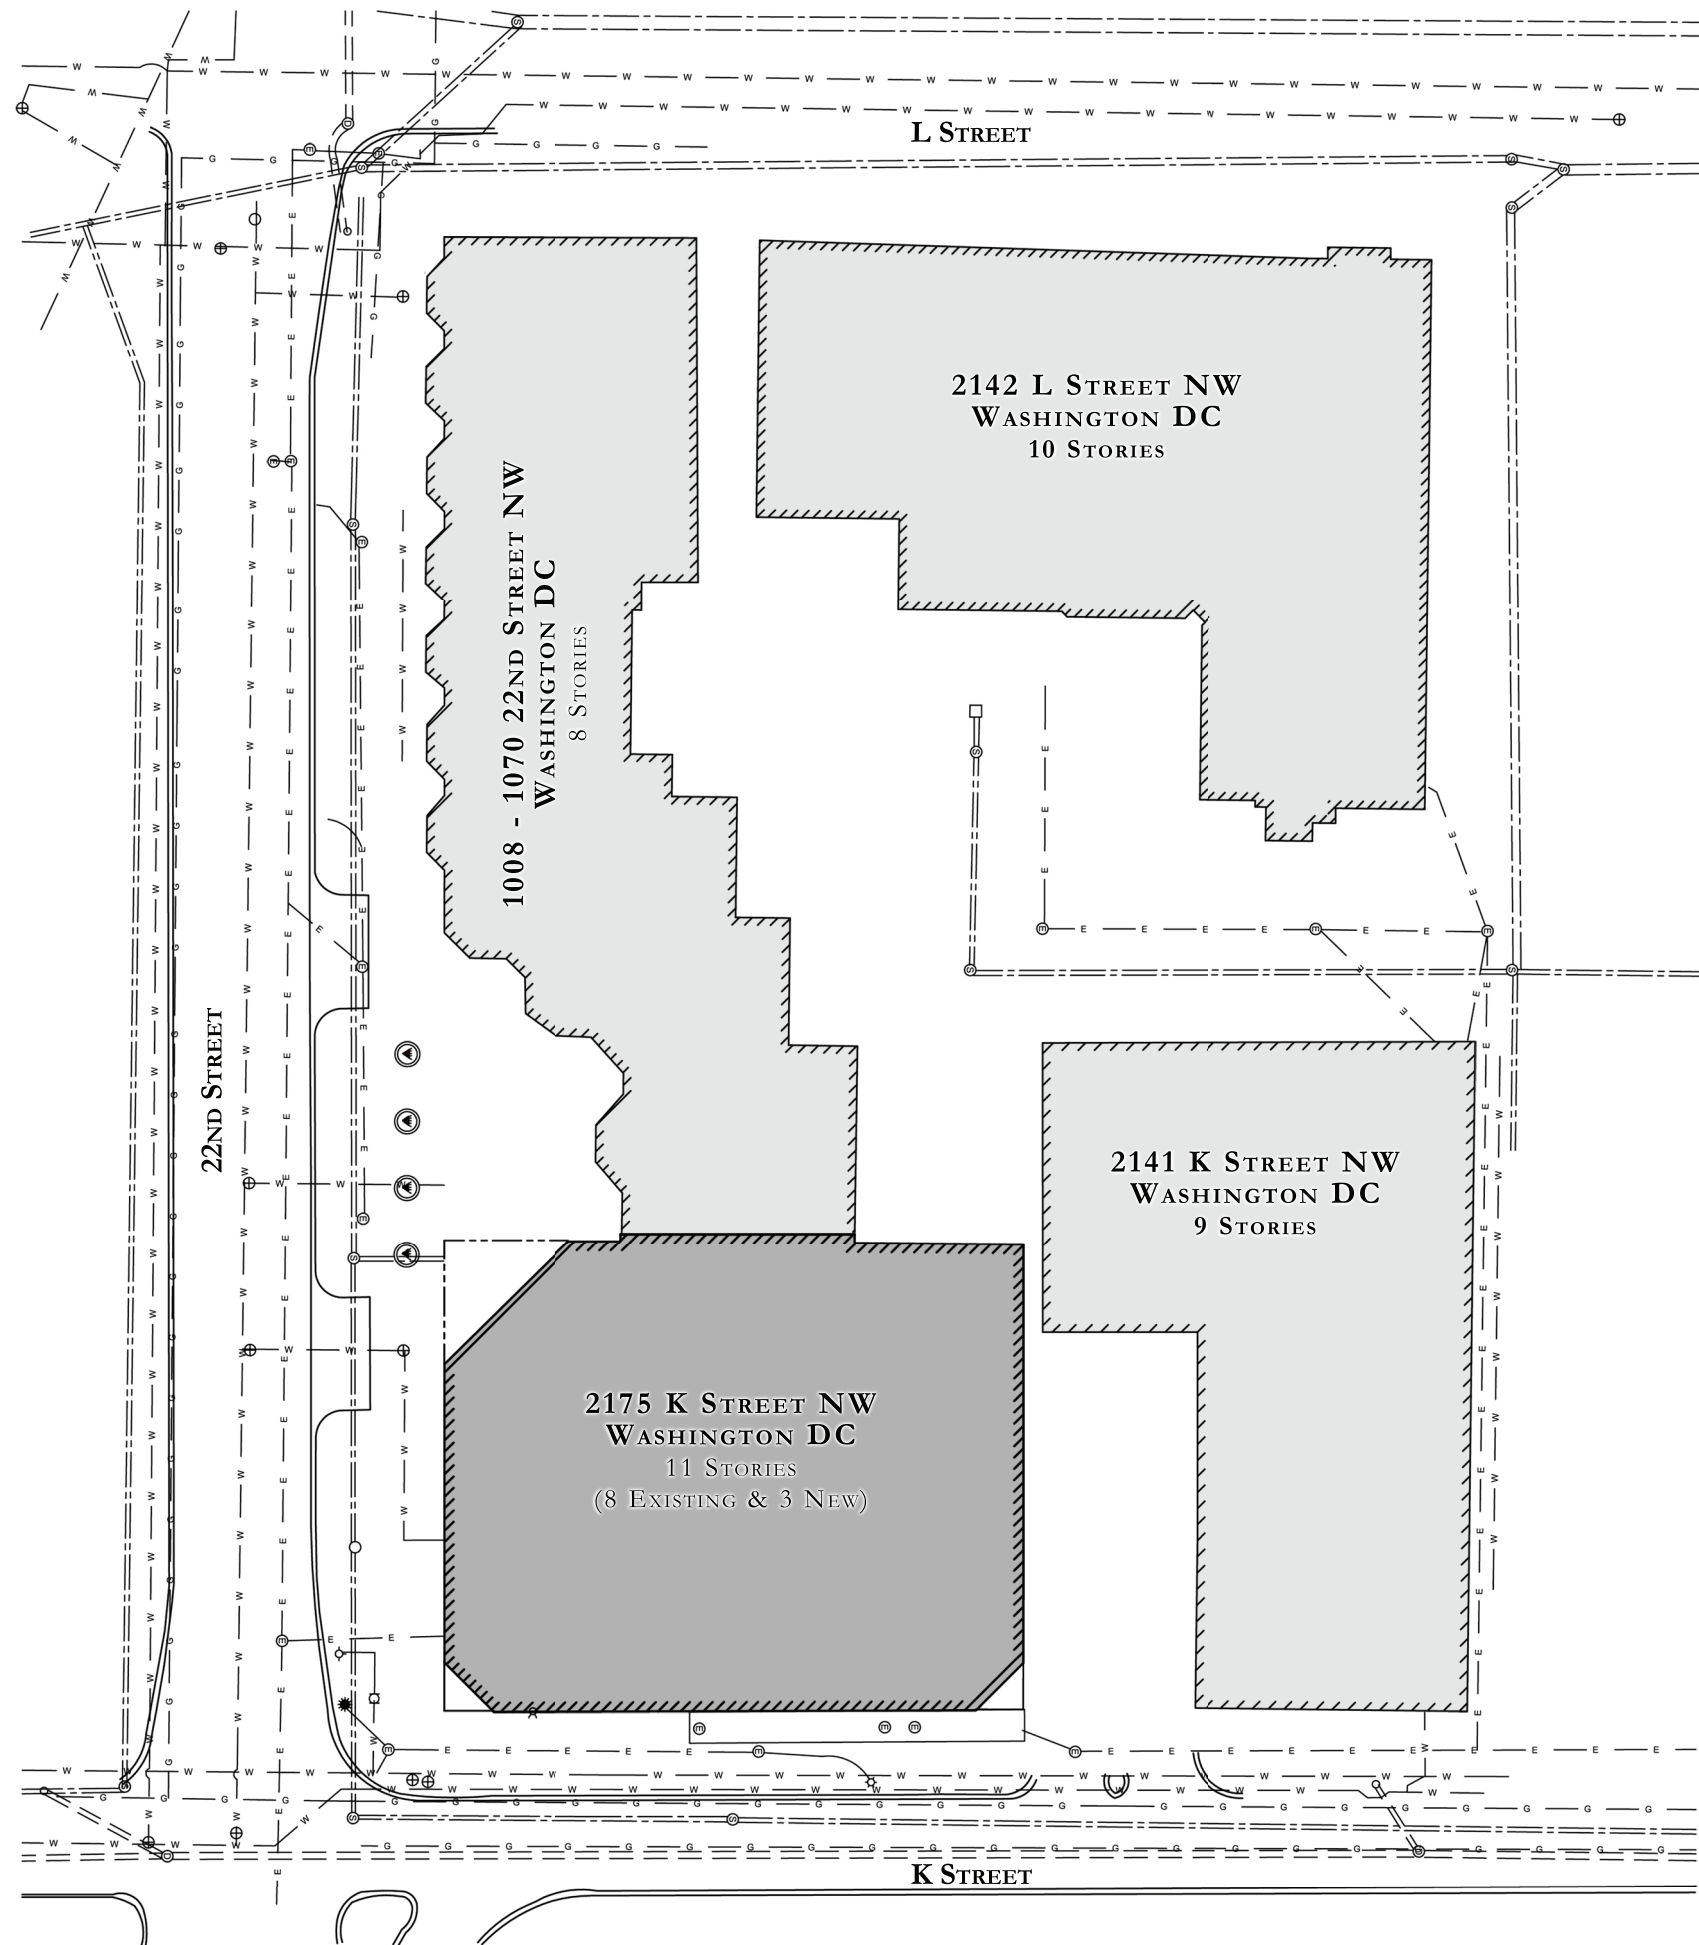
C-01

- SHEET NOTES:**
1. ALL EXISTING UTILITIES ARE TO REMAIN
 2. PROJECT CONTAINS NO NEW UTILITIES
 3. CONSTRUCTION ACTIVITIES ARE TO USE EXISTING SERVICE
 4. TELECOMMUNICATION WAS NOT SHOWN ON UTILITIES PLAN
 5. NO TEMPORARY LIGHTING

SITE EXISTING CONDITIONS PLAN
SCALE: NTS

Due to the nature of this project, the use of temporary utilities was limited to temporary electric which was feed by the existing building electric until the new switchgear and supporting equipment were in place.

For more information, please reference Appendix D. Located in Appendix D.1 is a set of maps to help locate the project site in Washington, DC. Additionally, in Appendix D.2 and D.3 are graphical representations of what was stated above as well as much more information.
