Technical Assignment 3

Project 2012

Susquehanna Patient Tower Expansion
Williamsport, PA

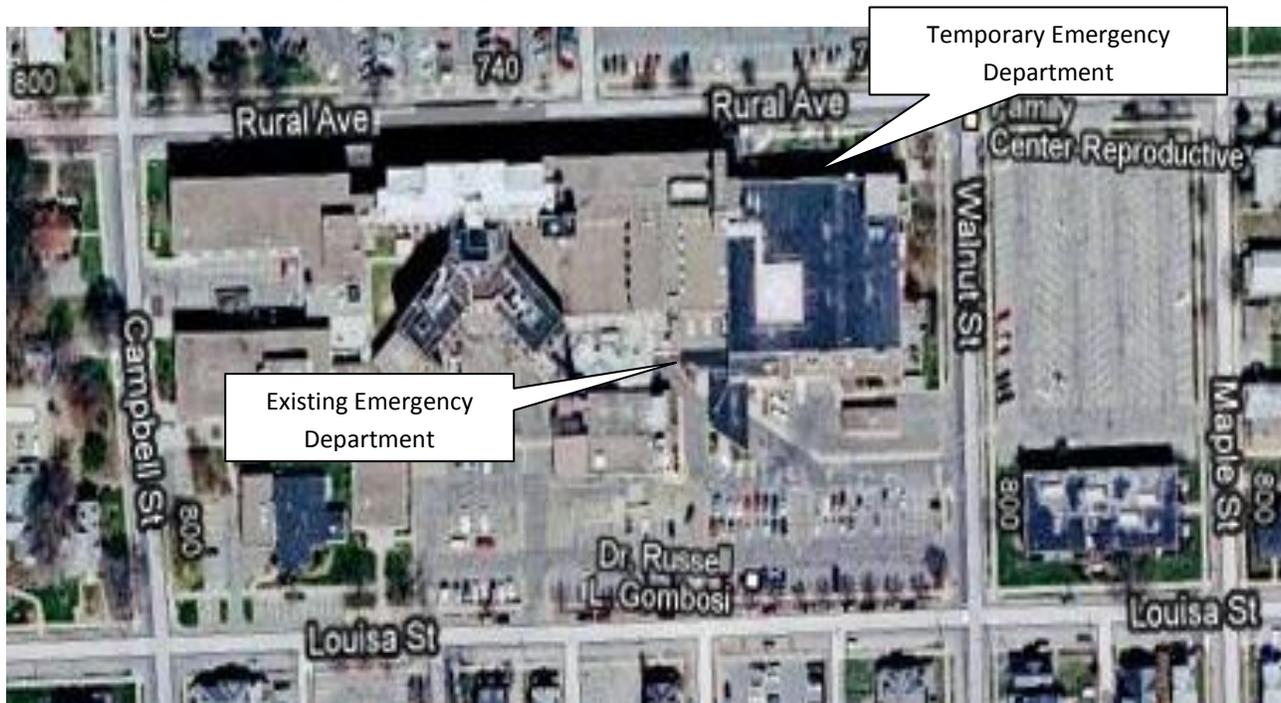
Figure 3: Existing and New Temporary Emergency Department
Figure Provided by Google Earth

Before any construction or site work could begin, the emergency department located on the south façade of the existing hospital had to be temporarily relocated. Emergency departments for hospitals must be operational 24 hrs a day 365 days a year. It is critical that absolutely no construction has any impact on this function of the hospital under any circumstances. In order to solve this problem a new emergency department had to be constructed far away from the major construction. The new emergency department

is a small addition in the northwest corner of the existing hospital. This small project was particularly challenging due to the fact that it connects to a large area of the hospital. Similar to the demolition of the façade for the walkways and the routing of the plumbing/electrical lines, the temporary emergency department produced dust, chemicals from fireproofing, and other airborne contaminants. ICRA plans for this addition were more in-depth and more complicated than those previously mentioned. Because the temporary emergency department was located next to surgery and patient rooms it had to be absolutely sterile. This small addition fell under Class IV ICRA category. To solve this constructability issue, L.F. Driscoll required all personnel to adhere to the strictest ICRA regulations. These requirements included building ICRA barriers with plastic lining, shoe and clothing covers, constructing anterooms, isolating HVAC ducts, negatively pressured work area, and the use of HEPA vacuums.
