Technical Assignment Three

Penn State AE Senior Thesis

UMBC
Performing Arts &
Humanities Facility
Baltimore, MD

Courtney L Glaub
Construction Management
Dr. Chimay Anumba

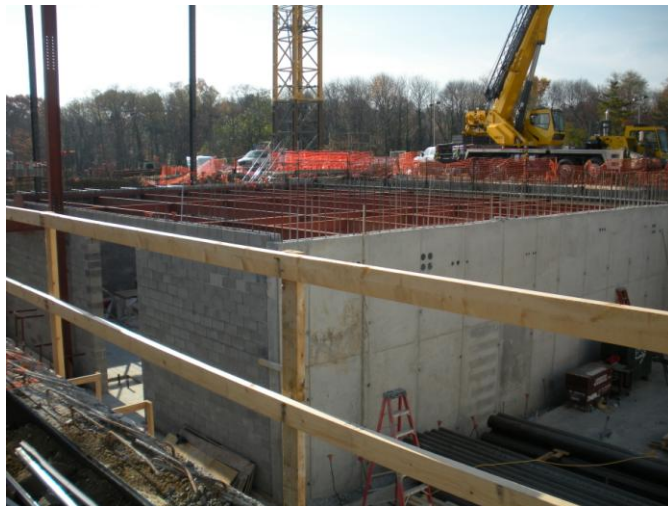
There is a complicated relationship between the site excavations, structural excavation, foundations and structural elements. There are multiple structural systems being used on this project. The different systems incorporated into this building are concrete structures, masonry bearing structures, structural steel, and some areas have a combination of all three as shown in Figure 1. Certain areas are isolated

Figure 1: View of all 3 Structural Elements in Basement

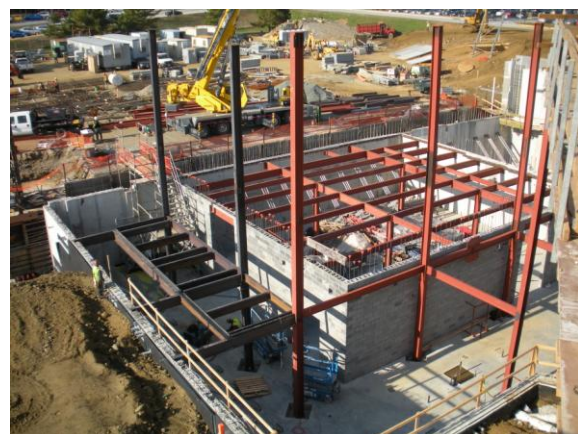
Figure 2: View of Structural Steel in Humanities Section

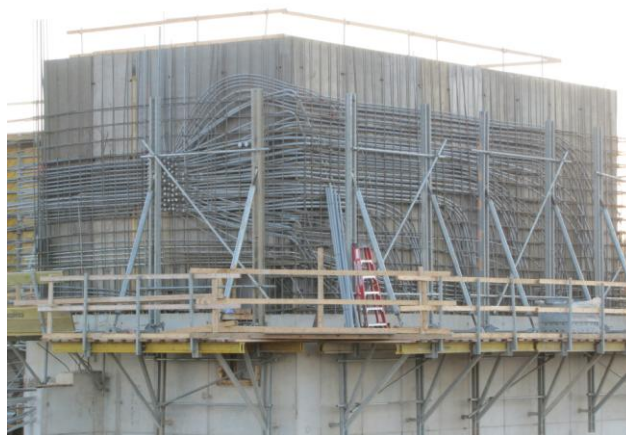
When it comes to the proscenium theatre, there is a big challenge that the project team had to overcome – fitting a lot of conduit into the theatre walls in the cast in place concrete without weakening the strength of the structure. There is a large quantity of conduits required in the theatre for power, lighting, dimming controls, audio/visual, telecommunication data, theatre controls, etc. There are nearly three hundred conduits for lighting/dimming controls alone. The conduits are only allowed to penetrate the walls of the stage and theatre in a few very confined locations due to acoustical concerns. The conduits are also not allowed to be surface mounted because the concrete is left exposed in the stage area and only a single layer of drywall is laminated to the concrete in the theatre seating area. Therefore, surface mounted conduits would be exposed to the view of the audience which would not be very pleasing to them or the university. This forces all of the conduits to be embedded in the concrete walls as shown in Figure 3. The challenge is how to route hundreds of conduits within the concrete walls to only a few points where they would be allowed to penetrate to the other side of the wall and maintain the spacing and density limitations required of the structural engineer. The solution that the project team came up with was to route the conduits to a few oversized junction boxes located at two locations where the walls were allowed to be penetrated. The oversized junction boxes (3'x12'x6') allowed the conduit spacing to be controlled, allowed the conduits to come from multiple sides, eliminated the concern of conduit bends, and allowed the conduits to then be combined to larger conduits back to the electrical panels, control panels, and AV racks. See Appendix A for a sample of a few of the drawings submitted showing the routing of the conduit in the theatre.

Figure 3: View of the Conduit in the Theatre Walls

In the Proscenium Theatre, as discussed above in the constructability challenges, there is a lot of conduit going into the walls to provide lighting controls, power, audio/visual, etc. which poses a problem to the structural strength. Not only is that an issue, but since there is all that power in this theatre with all the different lights, that also means that there is a good amount of load coming from that equipment. This is a problem because that is making the mechanical system run harder to compete with all the lighting loads. A possible solution would be to change out the type of lights to make fewer loads which in turn does not make the mechanical system work as hard.

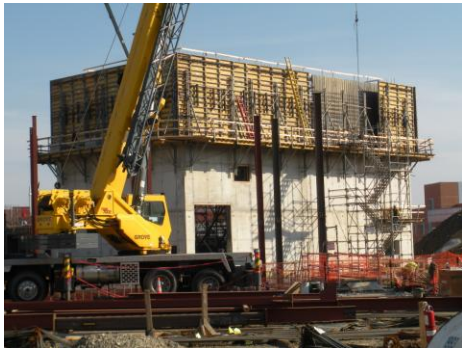
Currently, as stated above, the critical path of the project runs through the proscenium theatre. Every item in the theatre is critical from the start of the foundations through the finishes, the rigging, the specialties, tension grids, etc. The most important task on the project is getting the structure up in a timely fashion. The biggest risk to the project completion date is if there are any delays with the construction of the proscenium theatre structure. A major impact that would cause delays is the weather, which is outside of the control of the project team. More so than rain, the wind is the primary concern according to the weather effects because of the tower crane on site. The tower crane is used to swing the forms into place for the concrete structure on the theatre. In Figure 4, the tower crane is used to place the forms on the Proscenium Theatre foundation and structure. The workers must also be

Figure 4: Tower Crane Placing Forms on PT
