# Project X NYC, NY

Luke Gray

Technical Report 3

October 29, 2010

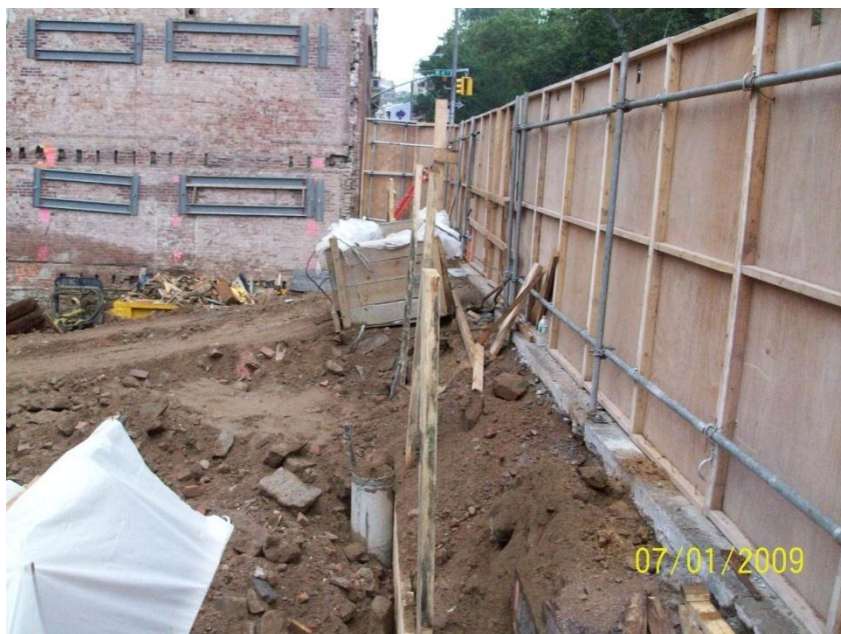
Figure 1: Shows the C-Channel used to reinforce north side of adjacent structure

Restoration would have to be completed to the conditions, which existed prior to the start of work. This put a great deal on the contractor. Fortunately, there were no lateral movements to the adjacent building. The adjacent buildings were extensively braced on the south side due to the preservation of the existing playhouse's walls. The existing adjacent structure required additional c-channel to reinforce the north neighboring structure by tying into the floor wood trusses of the neighboring structure; because the wall was not load bearing wall it was only two courses thick. Also a great deal of underpinning concrete was used to uphold the adjacent structures.

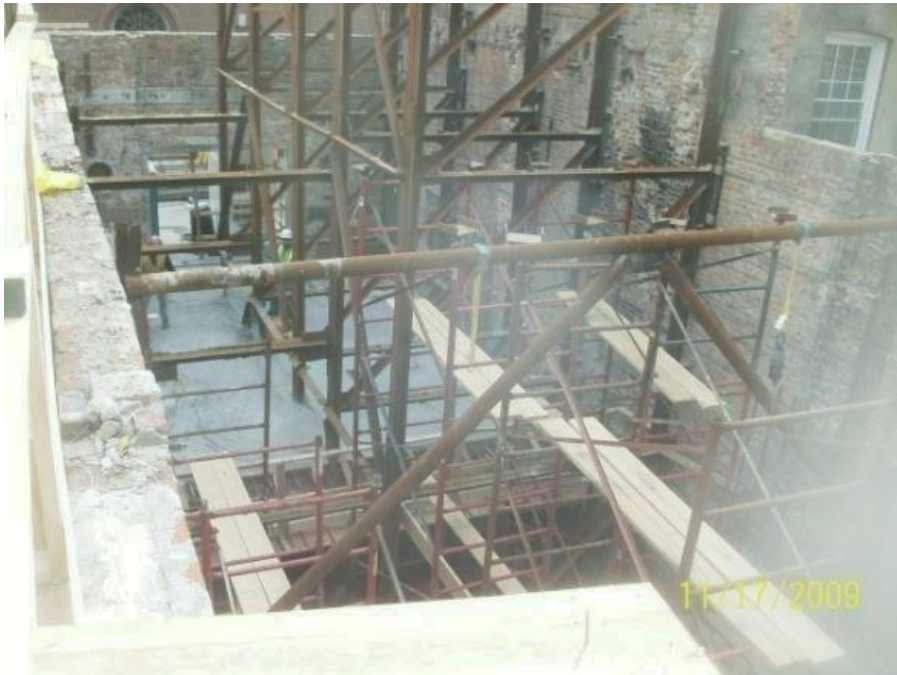
Figure 3: Shows an Up-close View of the Structural Steel Bracing

A temporary steel frame was used to preserve the existing theatre walls and the adjacent building. This made construction activity very difficult due to the structural bracing. The steel bracing was anchored to the adjacent building's masonry wall. Double l-angle steel welded together was used for vertical members and round hollow structural sections (hss) steel tubing was used for the lateral members shown in Figures 2 and Figure 3. One lane of traffic was closed during construction to allow for a crawler crane to be used.

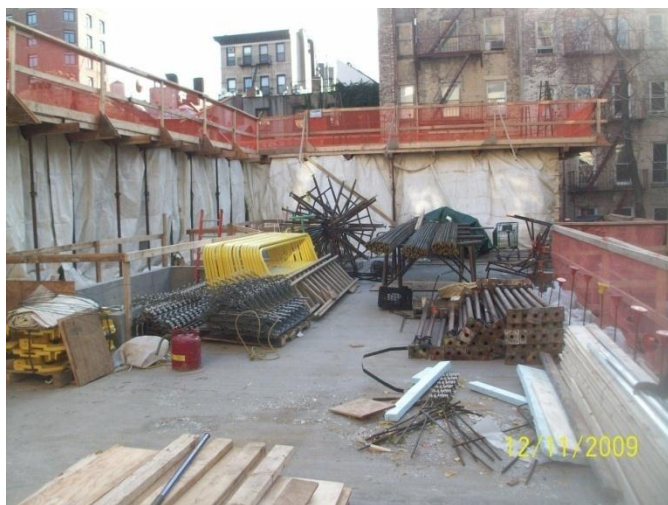
Figure 4: Illustrates the Very Limited Storage Area

The third constructability challenge was that there was no material layout area. All of the material deliveries had to be just in time deliveries. There was no room on the site for material storage. All of the long lead items had to be ordered prematurely to ensure a timely delivery when needed. The cast-in-place concrete system congested the site with formwork and shoring. In order to allow space for the delivery trucks and crane one of the lanes traffic to be closed for a two week period. Also the entire road had to be closed in order to install new service off the existing water main, which runs approximately center and parallel to MacDougal Street. MacDougal Street (from West 4th to West 3rd Street) was closed beginning no earlier than October 26, 2009, 8:00 AM to 4:00 PM, Monday to Saturday. Sidewalk access on the east side of street will be maintained at all times. No impact to the water service to the adjacent neighbors is anticipated. Neighbors directly south of 133-139 MacDougal Street will be able to back up their cars to the front of their property. At the end of each work day - after 4:00 PM - steel plates will be placed over the pit to allow street access.

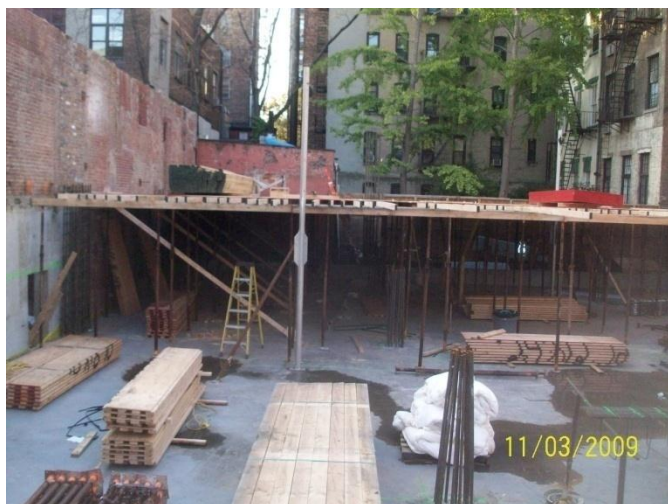
Figure 5: Shows limited material handling due to the space required for shoring and formwork

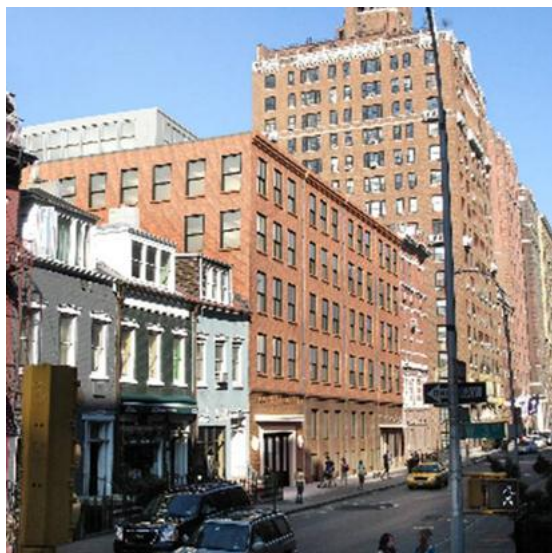
Figure 7: Shows the Adjacent Height Restrictions and the Metal façade Used on the Roof Level.

The owner went with a metal panel system instead of brick on the 6<sup>th</sup> floor. The cost of the metal paneling system \$131,360, while the brick would have cost \$287,350 a total cost saving of \$155,990.

The client decided to have an extra floor but do the sunken first floor, because they had a height restriction of aligning with the existing surrounding building. This cost the owner less by not having to construct façade and windows on the 1<sup>st</sup> floor. Also, this allowed the owner to meet the goal of adding square footage while maintaining the buildings low profile. The cost of heating and cooling the underground portion will also be less for the owner. The owner originally wanted a taller building to add 3 floors to the original building and renovate the existing building. Though the existing structure could not support additional floors and the existing pressure on the bearing wall footings was not adequate for additional load required. Therefore the owner decided to sink two of the floors into the ground in order to satisfy the square footage requirements.

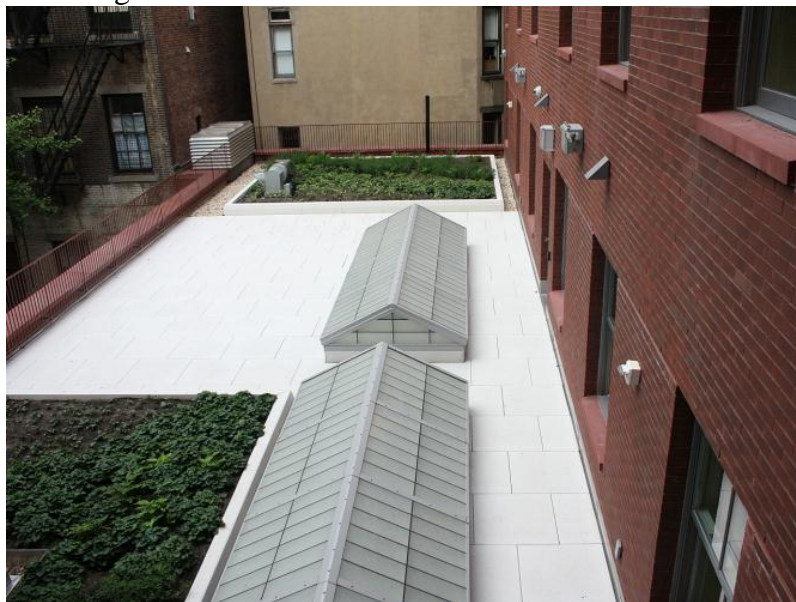
Figure 8: Shows Green Roof and Aluminum Railing

Traditional roofing methods were suggested by Skanska however a green roof was still used despite cost implications. Adding green roofing cost the owner approximately \$300,000 more than traditional methods. The green roof was a part of the owner's requirements to implement practices and procedures to meet the project's environmental performance goals, which include achieving LEED Platinum Certification.

Skanska suggested not using aluminum roofing. Since, the aluminum roof railing did not require maintenance the owner decided to use the aluminum roof railing. Aluminum roof railings were added in lieu of painted steel railings, even though this would cost approximately \$50,000 more. The owner's goal for the aluminum roof railing was to allow for occupants on the green roof terraces.

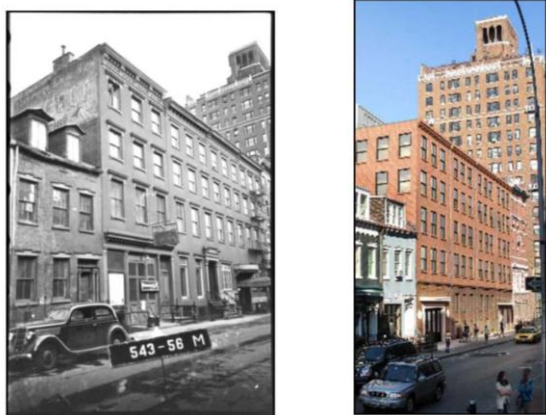
Figure 9: Shows the Pre-1940's Renovation on the Left and the New Project X Building on the Right.

NYU has recently discussed with local community groups about a construction project on the site that would provide space for legal research centers for the NYU School of Law. Before construction an office and apartment building which houses the Playhouse, occupies an important cultural spot in the history of the American theatre. However, the actual building that previously existed on the site today looks nothing like the building occupied by the playhouse theater, most famous for launching the career of Eugene O'Neill among many others of his contemporary writers, actors and artists. The existing building is the result of a major renovation in the 1940s when four separate houses were converted into one apartment building. This conversion included the complete renovation of the interiors of the buildings and the construction of a single façade that you see today. Figure 9 shows the Pre-1940s renovation on the left and the new building on the right.
