Government Office Center

Penn State AE Senior Thesis Project
Alexander Ward | Construction Management
James Faust | CM Advisor

- \$42 Million Renovation
- 14 Story Federal Office & Courthouse
- 316,000 SF
- August 1, 2011 – January 31, 2014
- Major upgrades to Envelope and HVAC systems
- LEED Gold (LEED 2009 EBO&M)
- Occupied throughout construction

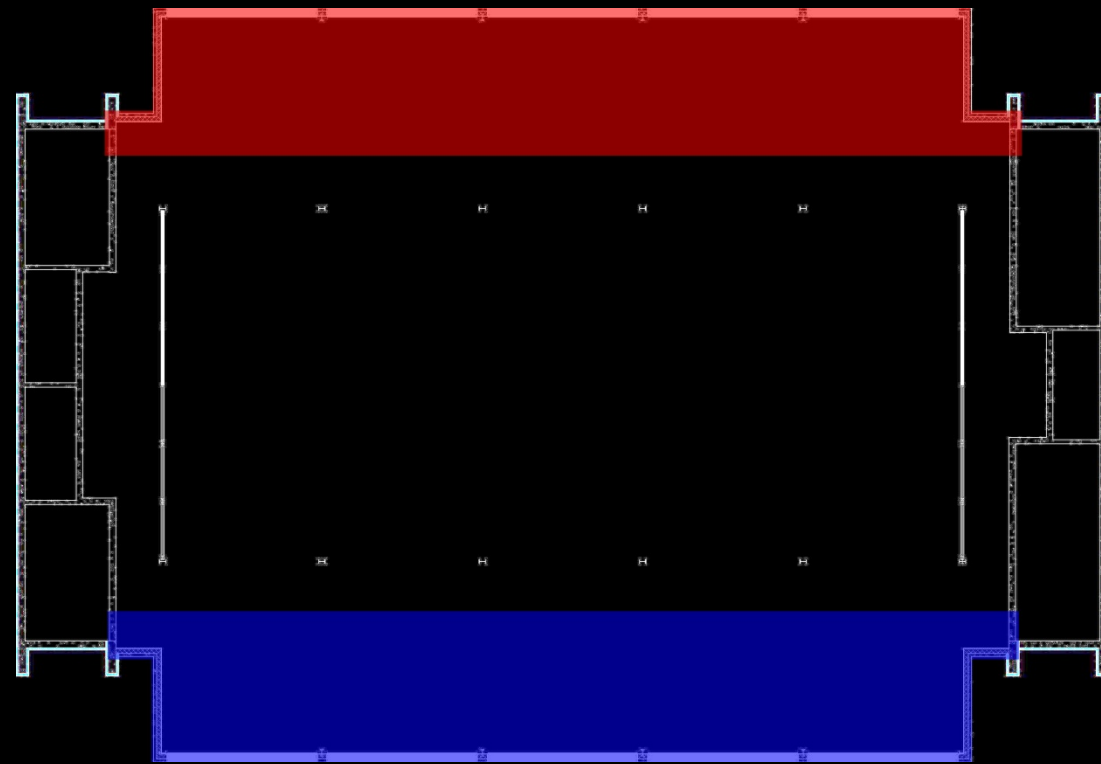
North Area in Red – South Area in Blue

Activities:

- Installation of weather wall
- Demolition of existing curtain wall
- Installation of new structural steel
- Installation of new curtain wall
- Demolition of weather wall
- Frame and rough-in
- Restoration of finishes

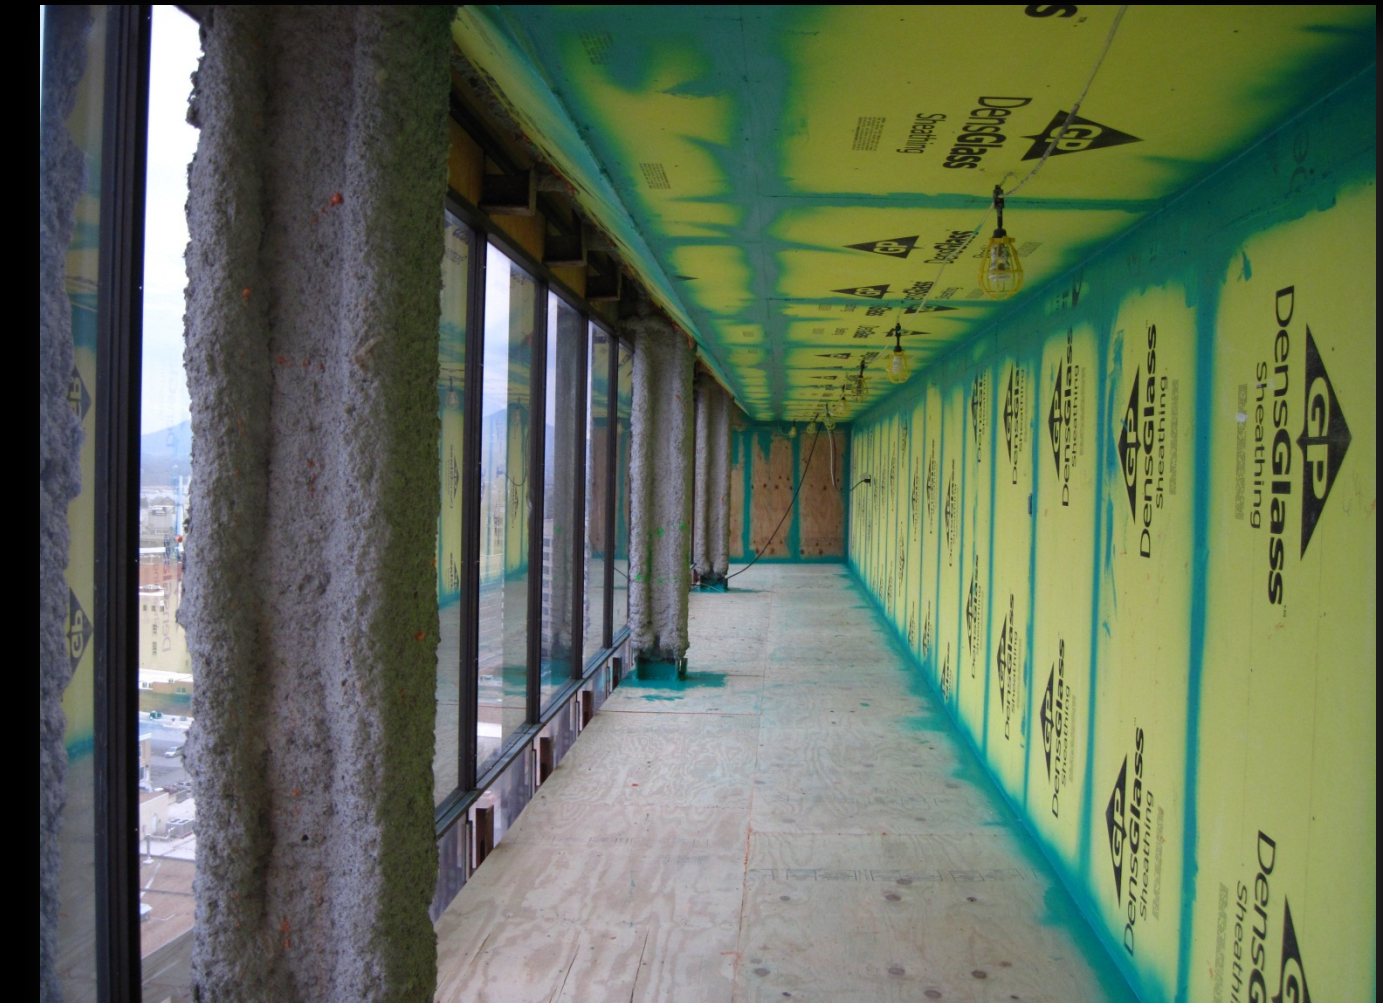
Existing Schedule:

- Oct. 11, 2011 – Sept. 16, 2013 (101 weeks)
- 8 week schedule gap between North and South
- Longest activity requires 100 days (North finishes)

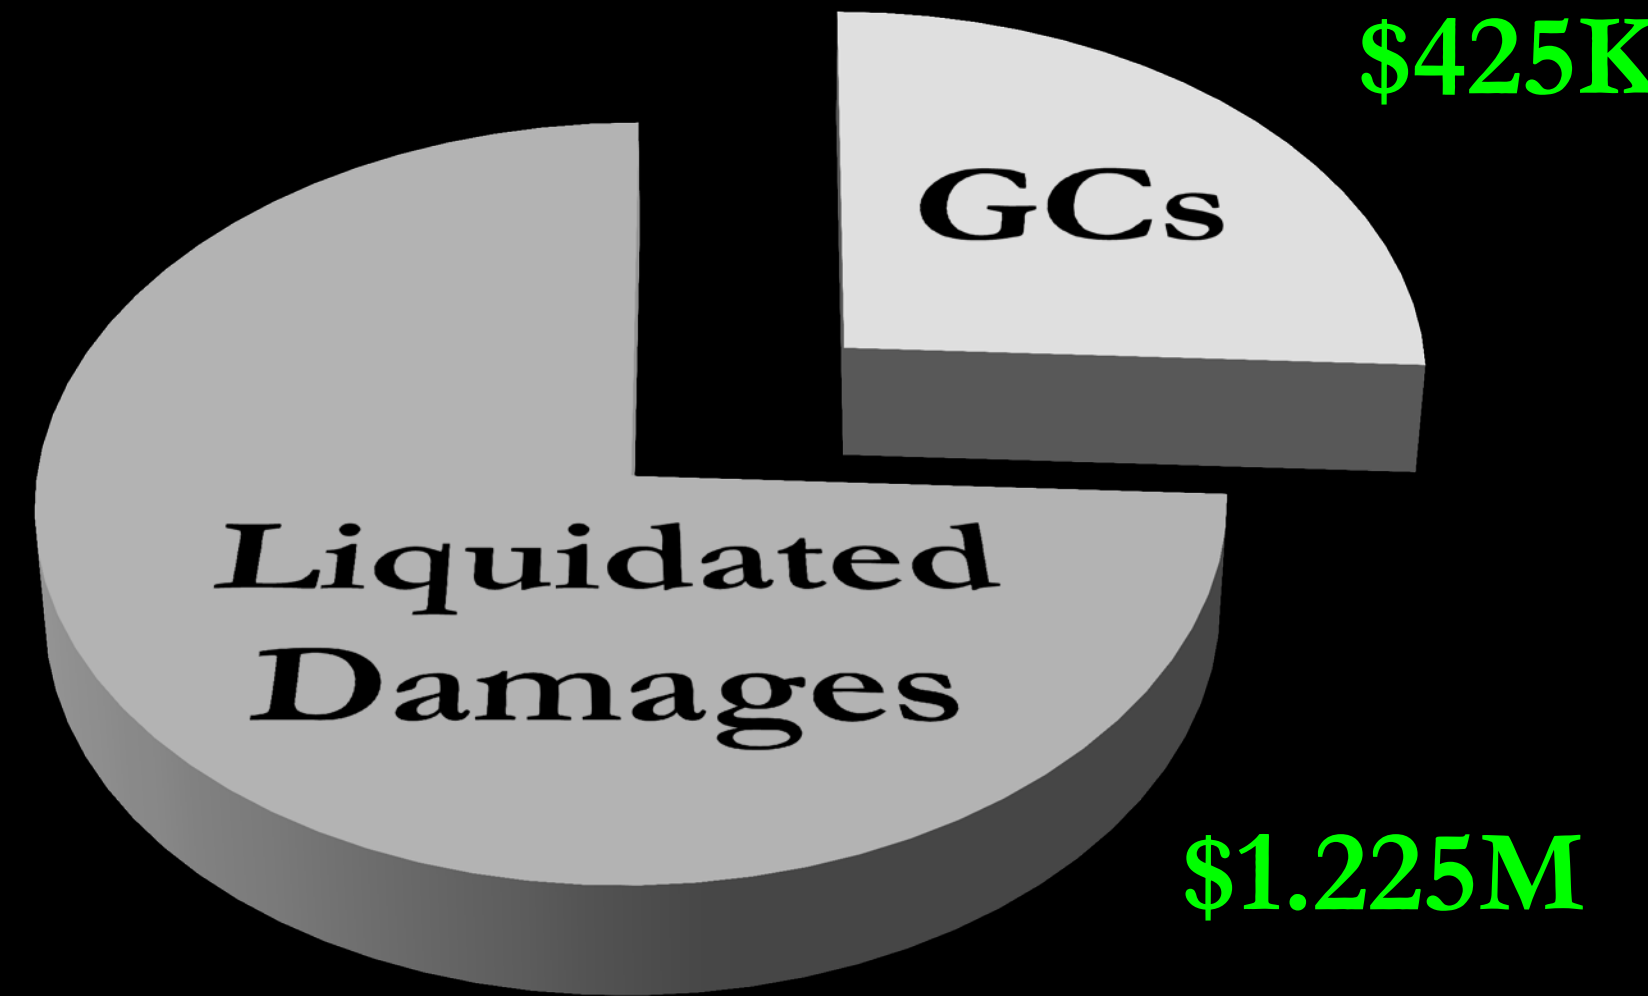
25 Weeks Saved

\$1.65M Total Value

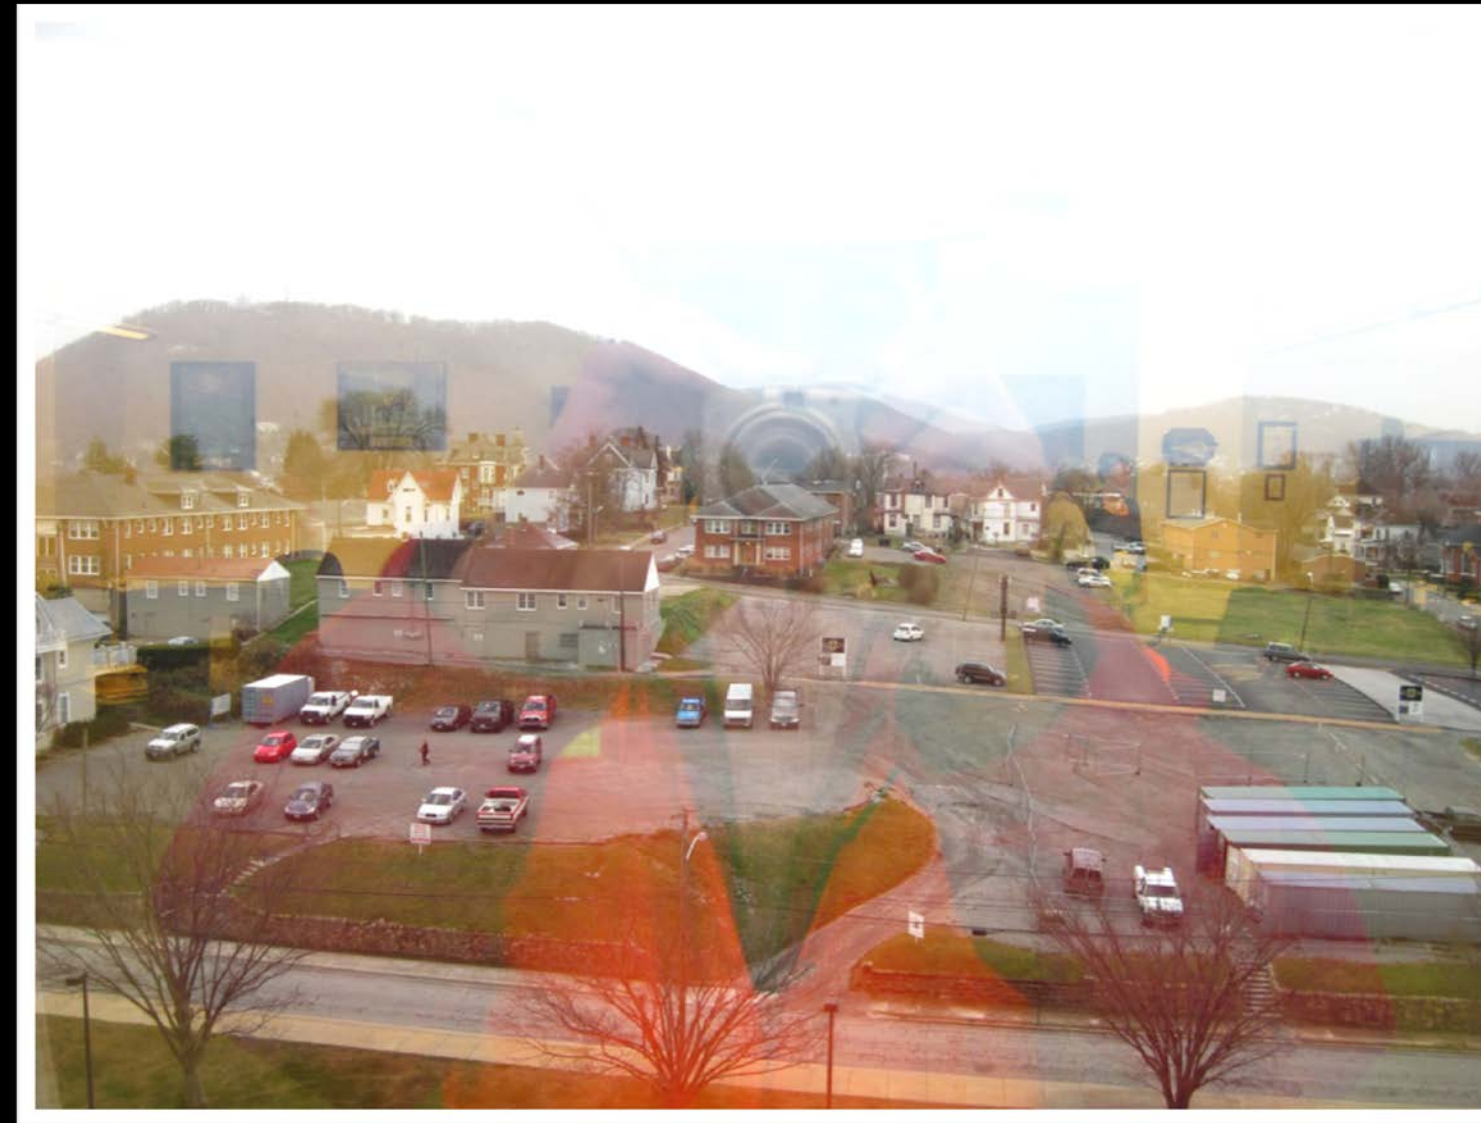
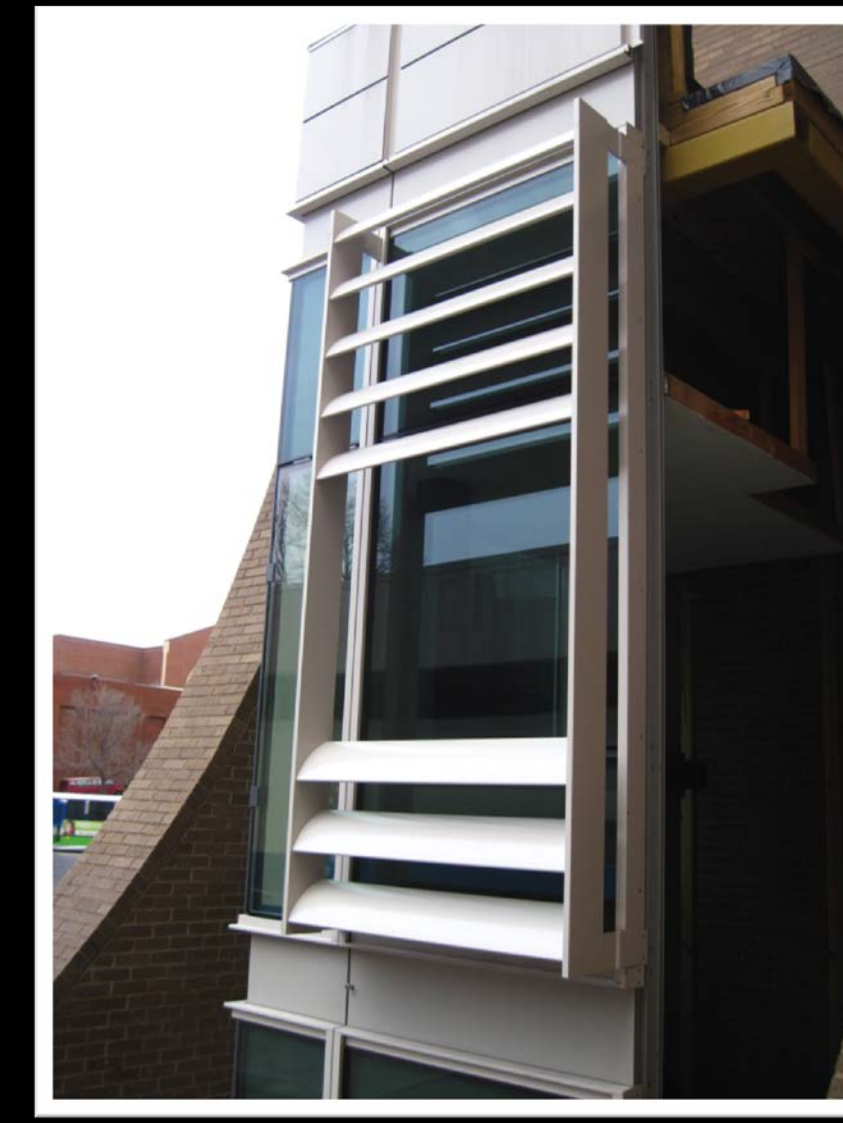
Station Identification	
City:	Richmond
State:	Virginia
Latitude:	37.50° N
Longitude:	77.33° W
Elevation:	50 m
PV System Specifications	
DC Rating:	202.1 kW
DC to AC Derate Factor:	0.770
AC Rating:	155.6 kW
Array Type:	Fixed Tilt
Array Tilt:	90.0°
Array Azimuth:	180.0°
Energy Specifications	
Cost of Electricity:	8.0 ¢/kWh

Results			
Month	Solar Radiation (kWh/m ² /day)	AC Energy (kWh)	Energy Value (\$)
1	3.92	19014	1521.12
2	3.72	16063	1285.04
3	3.53	16039	1283.12
4	3.00	11904	952.32
5	2.55	9729	778.32
6	2.33	7991	639.28
7	2.44	8685	694.80
8	2.77	10614	849.12
9	3.47	13977	1118.16
10	3.76	16716	1337.28
11	3.68	16705	1336.40
12	3.45	16491	1319.28
Year	3.21	163928	13114.24

Feasibility:

+\$404,200 for PV marginal cost
 -\$382,500 for sunshades deduction
 =\$21,700 net marginal cost
 ~\$13,000 per year in energy savings

Payback < 2 years

Need to consider heat gain, constructability, etc.
