Fort Pickett Regional Training Institute Phase II  
Blackstone, VA

## Technical Assignment 3

Submitted 11/16/11  
Kendall Mahan  
Construction Management  
Advisor: Craig Dubler  
Senior Thesis: AE 481W

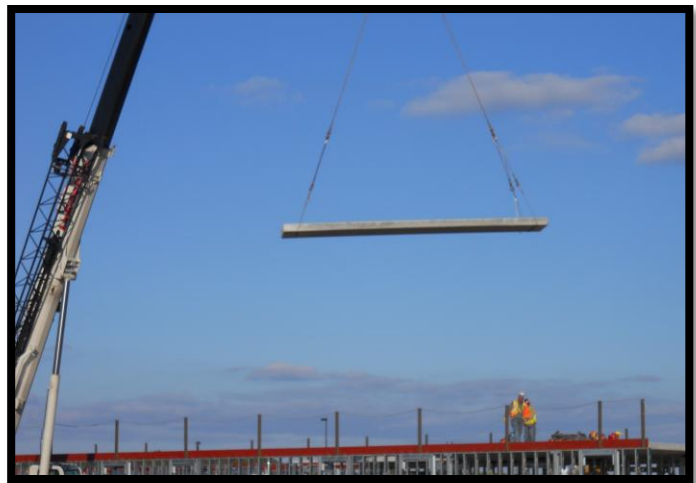
Prior to erecting the planks, it was critical that the first floor load bearing walls were constructed and inspected properly. The planks were then laid down along the length of the building, so that the cranes could minimize pick times, as well as reduce confusion of what planks to lift. A crane was located on each side of the building, where it ran the length of the building using the same repetitive process. As seen in Fig. 2 to the right, the hollow-core planks were set with 75 ton and 100 ton cranes that were also used to set the trusses for each building.

Figure 2: Setting Hollow-core Planks – Courtesy of Barton Malow

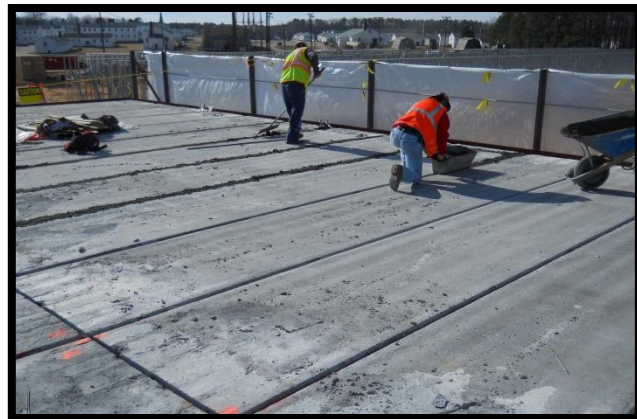
After the hollow-core planks were set properly, it was then critical to secure them into place using reinforcing grout, and a topping slab. Continuous reinforcing in the form of #5 rebar was installed along all joints where it was then grouted, a task that can be seen in Fig. 5 below. In addition, each core in the precast members was grouted 12" from the ends to further the strength of the connection. Once the planks were properly grouted, it was then time to pour the topping slab. The topping slab was designed to enhance the structural integrity of the structural system, as well as provide continuity in the floor by removing aesthetically unpleasing joints. Since hollow-core planks were used in Phase I of the project, the construction

Figure 5: Grouting – Courtesy of Barton Malow

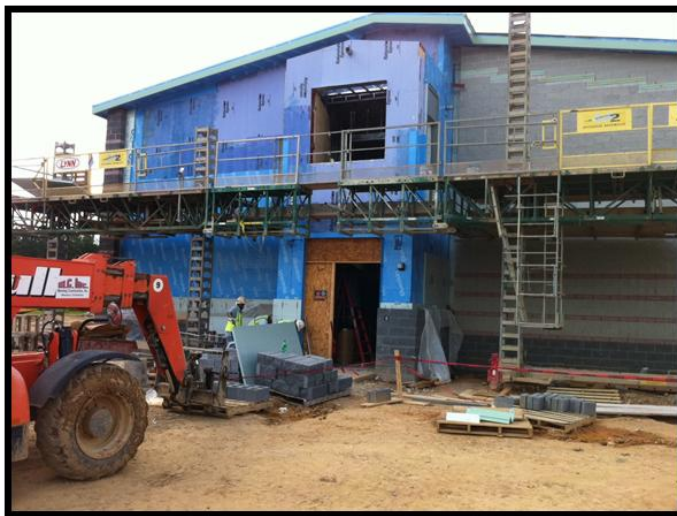
Construction of the façades started on the ends of the buildings, so that at least one stairwell could be constructed immediately to give access to the second floor. Once the first flight of stairs was completed, work began immediately on the second floor, and the masonry work continued across the rest of the exterior of the buildings. Shown in Fig. 8 below, the jack scaffolding had the capability of spanning a significant portion of the perimeter at one time, which was incredibly beneficial to the productivity of the work. Where issues arose was in the block placement of the second end of the buildings. According to OSHA regulations, there must be two usable exits in every construction area, a regulation that posed an enormous barrier for the project team when work began on the second end of the building. In order to correct this problem, Barton Malow constructed temporary steps and ladders to windows on the sides of

Figure 8: Scaffolding – Taken by Kendall Mahan

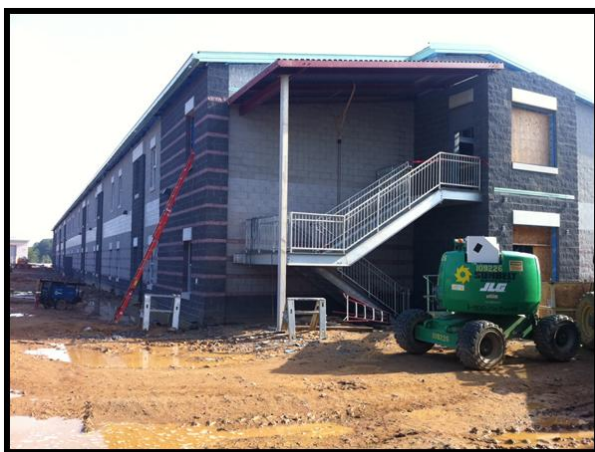
Figure 11: Masonry Veneer – Taken by Kendall Mahan

properly and even more planning was needed for material handling. Some block courses were comprised of only one block and color, which made the quick interchange of materials critical to meeting durations. For example, parts of the wall design called for three courses of split-face gray block with gray mortar, followed by one red course of block and mortar, and then back to the gray block and mortar, which can be observed in

Fig. 11. It created a condition of extreme planning, material preparation, and material storage. The mason held a heavy dependence on the laborers to provide the correct materials, so that their work flow was not interrupted. Another design setback with the veneer occurred with the top course of the block. The top course utilized split-face CMU, which created an uneven joint between the roofing soffit and the block, a condition that was considered to be aesthetically unappealing to the Architect. In order to correct this flaw, a design change switched the block from split-face CMU to smooth CMU.

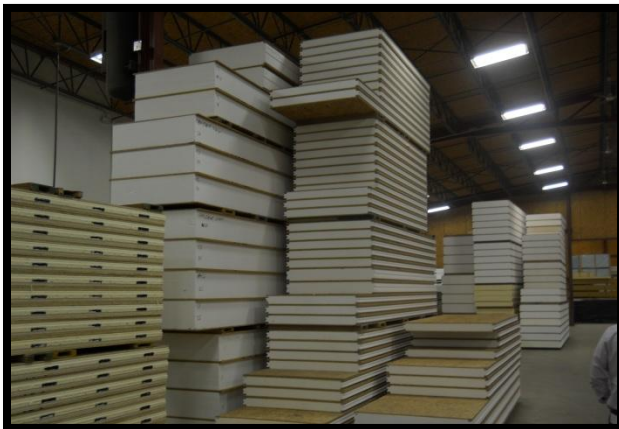
SIPS are a composite material that consists of OSB sheathing that is filled with spray foam insulation. In order to meet the quality and standards proposed by the Architect, the Barton Malow project team visited the factory where the panels were constructed. Pictures of the panels manufactured for the Fort Pickett project and the manufacturing line can be seen below in Fig. 12 and Fig. 13. Again, thanks to Phase I of the project, Barton Malow had the opportunity to learn from past mistakes and changed the designs of the panels. The SIPS used in in the Phase I construction were 9' in length and were considered to be time consuming in the erection process. In order to increase efficiency, Phase II was designed with significantly larger 24' panels that minimized the amount of butt joints, fasteners, and panel lifts required to erect the roofing system.

Figure 12: SIPS – Courtesy of Barton Malow

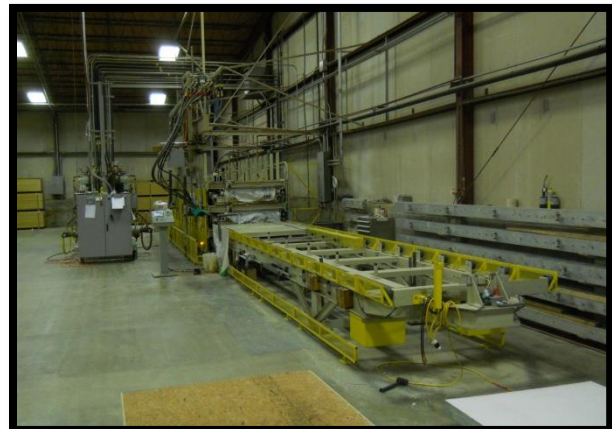
Figure 13: Manufacturing Line – Courtesy of Barton Malow

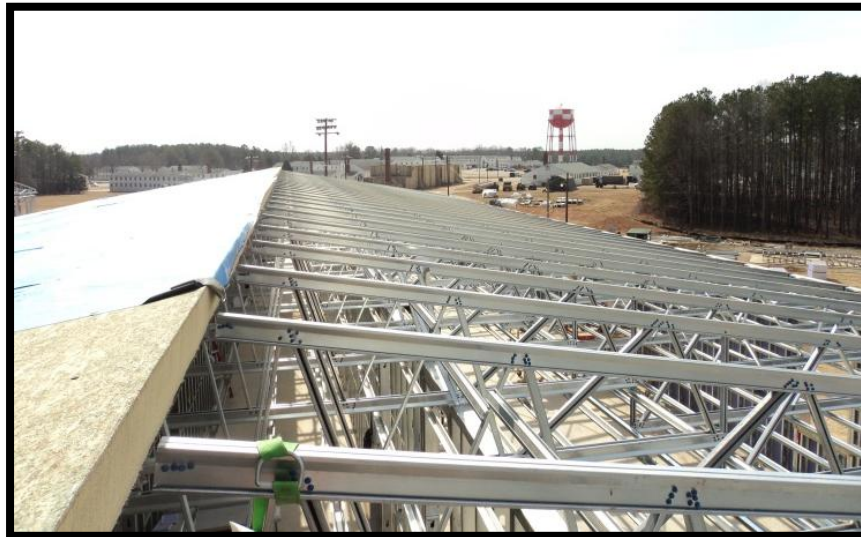
Although the design size of the panels were altered to aid in the construction process, the work was still unprecedented for the responsible Subcontractor. In addition, the panels required an enormous amount of planning towards deliveries, storage, and erection. A picture of the panels set in place can be seen in Fig. 14 below.

Figure 14: SIPS Erection – Courtesy of Barton Malow
