# TECHNICAL ASSIGNMENT 1

Construction Management

Michael A Carbonara  
Biological Research Laboratory  
9/23/2011

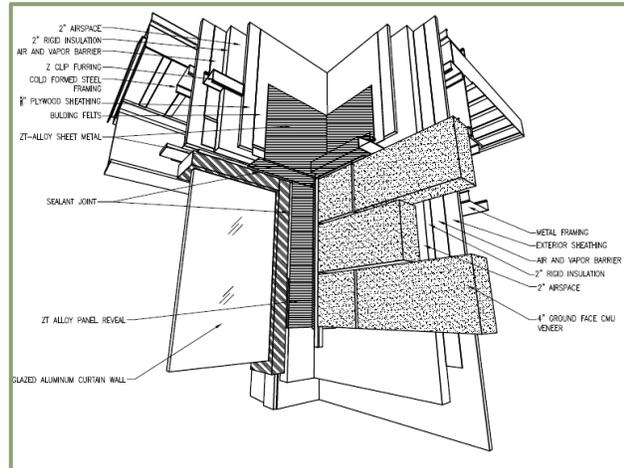
Figure 3 -Courtesy of Payette Associates

The exterior masonry on the ABSL-3 is a CMU decorative veneer. The wall type will have a two inch air space behind the wall along with a two inch piece of polystyrene rigid insulation with an expected R-Value of 10. The wall is supported by hangers that attach to a cold formed steel stud wall, as seen in figure 3.

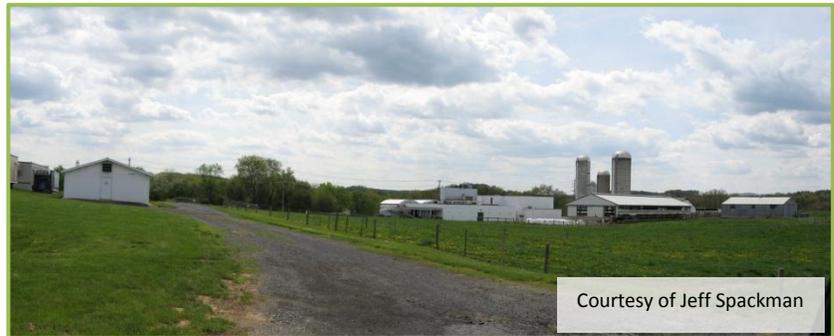
Figure 6

Through research Centre County does not contain any bylaws on construction. The permitting process in the region is however a bit difficult. Construction documents must be approved by the county which could take up to a couple of weeks to review. One fact about building permits in Centre County is they do not expire so if a building is put on hold as long as the design does not change the permit is still valid. Looking at parking at the site, the construction area for the building allows for multiple parking for cars as well as a new parking lot installed in front of the proposed facility. Crews as well as the Construction Management team should have ample parking during times when peaks crews are performing work on the structure which can be seen in Figure 6.

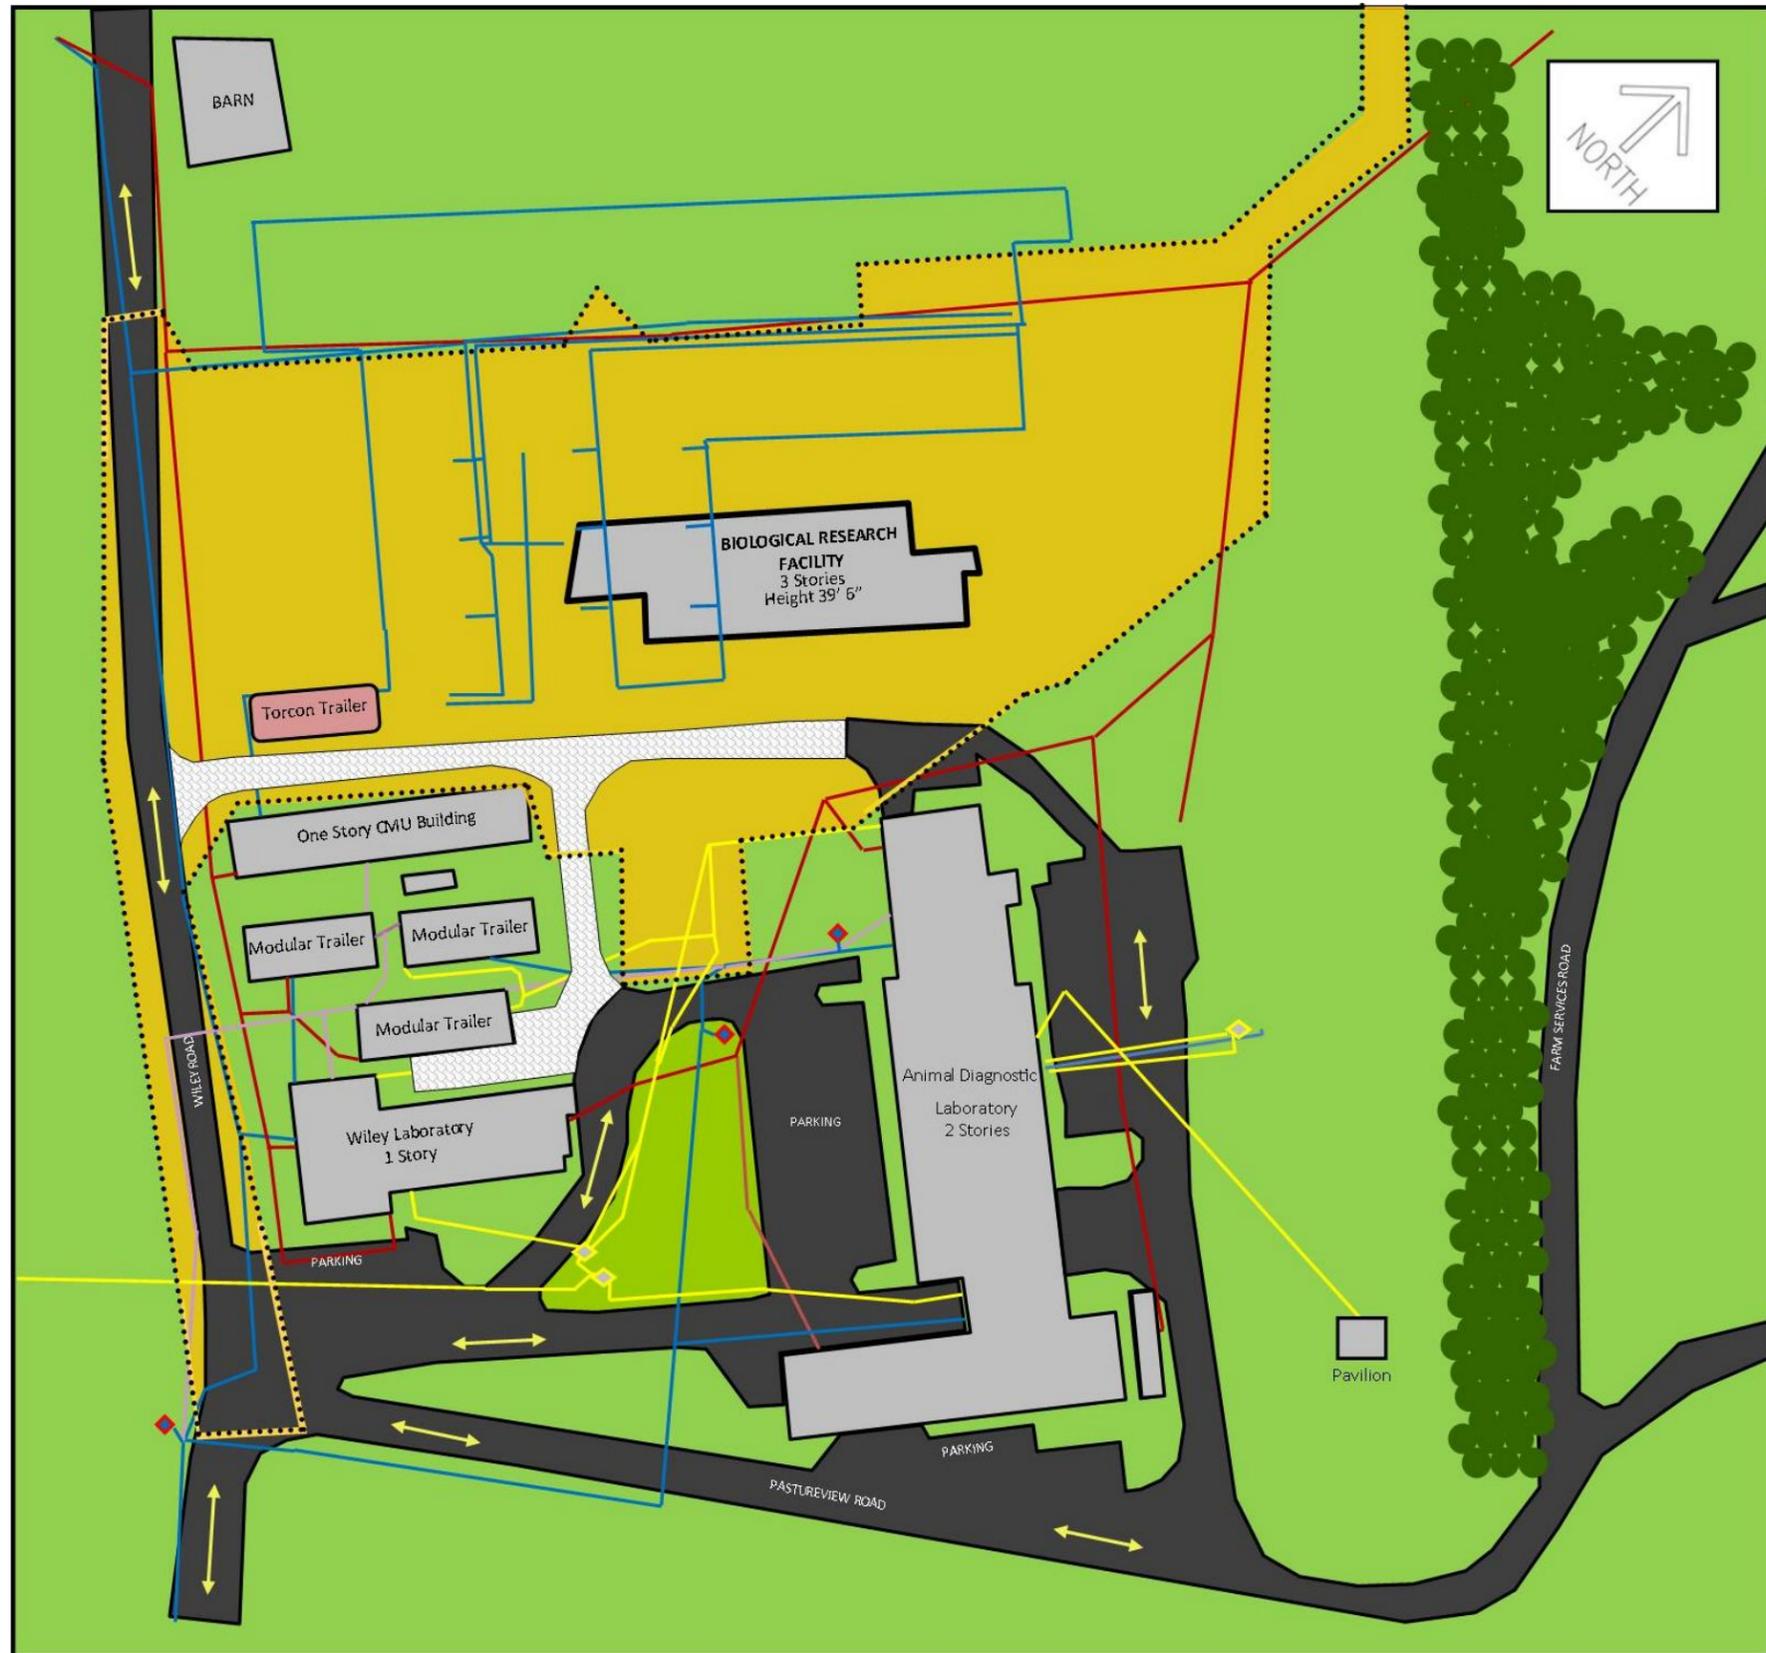
EXISTING CONDITIONS SITE PLAN

determined based on other similar facilities that are present in the general region. The contour on the site contains a gradient of 20 feet sloping down to the back of the proposed construction location. An environmental assessment also had to be performed

The actual site itself has major utilities that need to be modified in order to place the Laboratory in its desired position. Animal fencing for cattle grazing needs to be removed around the site to make room for the approved blue wind screen fencing by the university. The building foot print lies directly on a cow pasture with an abundance of irrigation and other utility lines as seen in appendix C. As per design requirements, all the utility lines that lie in the construction zone must be remove and relocated. More importantly is the existing sanity sewer line that runs in the construction area which is planned to be capped, removed, and redirected. Another utility underground that needs to be removed is a water line which falls directly under the building foot print of the Biological Research Lab.

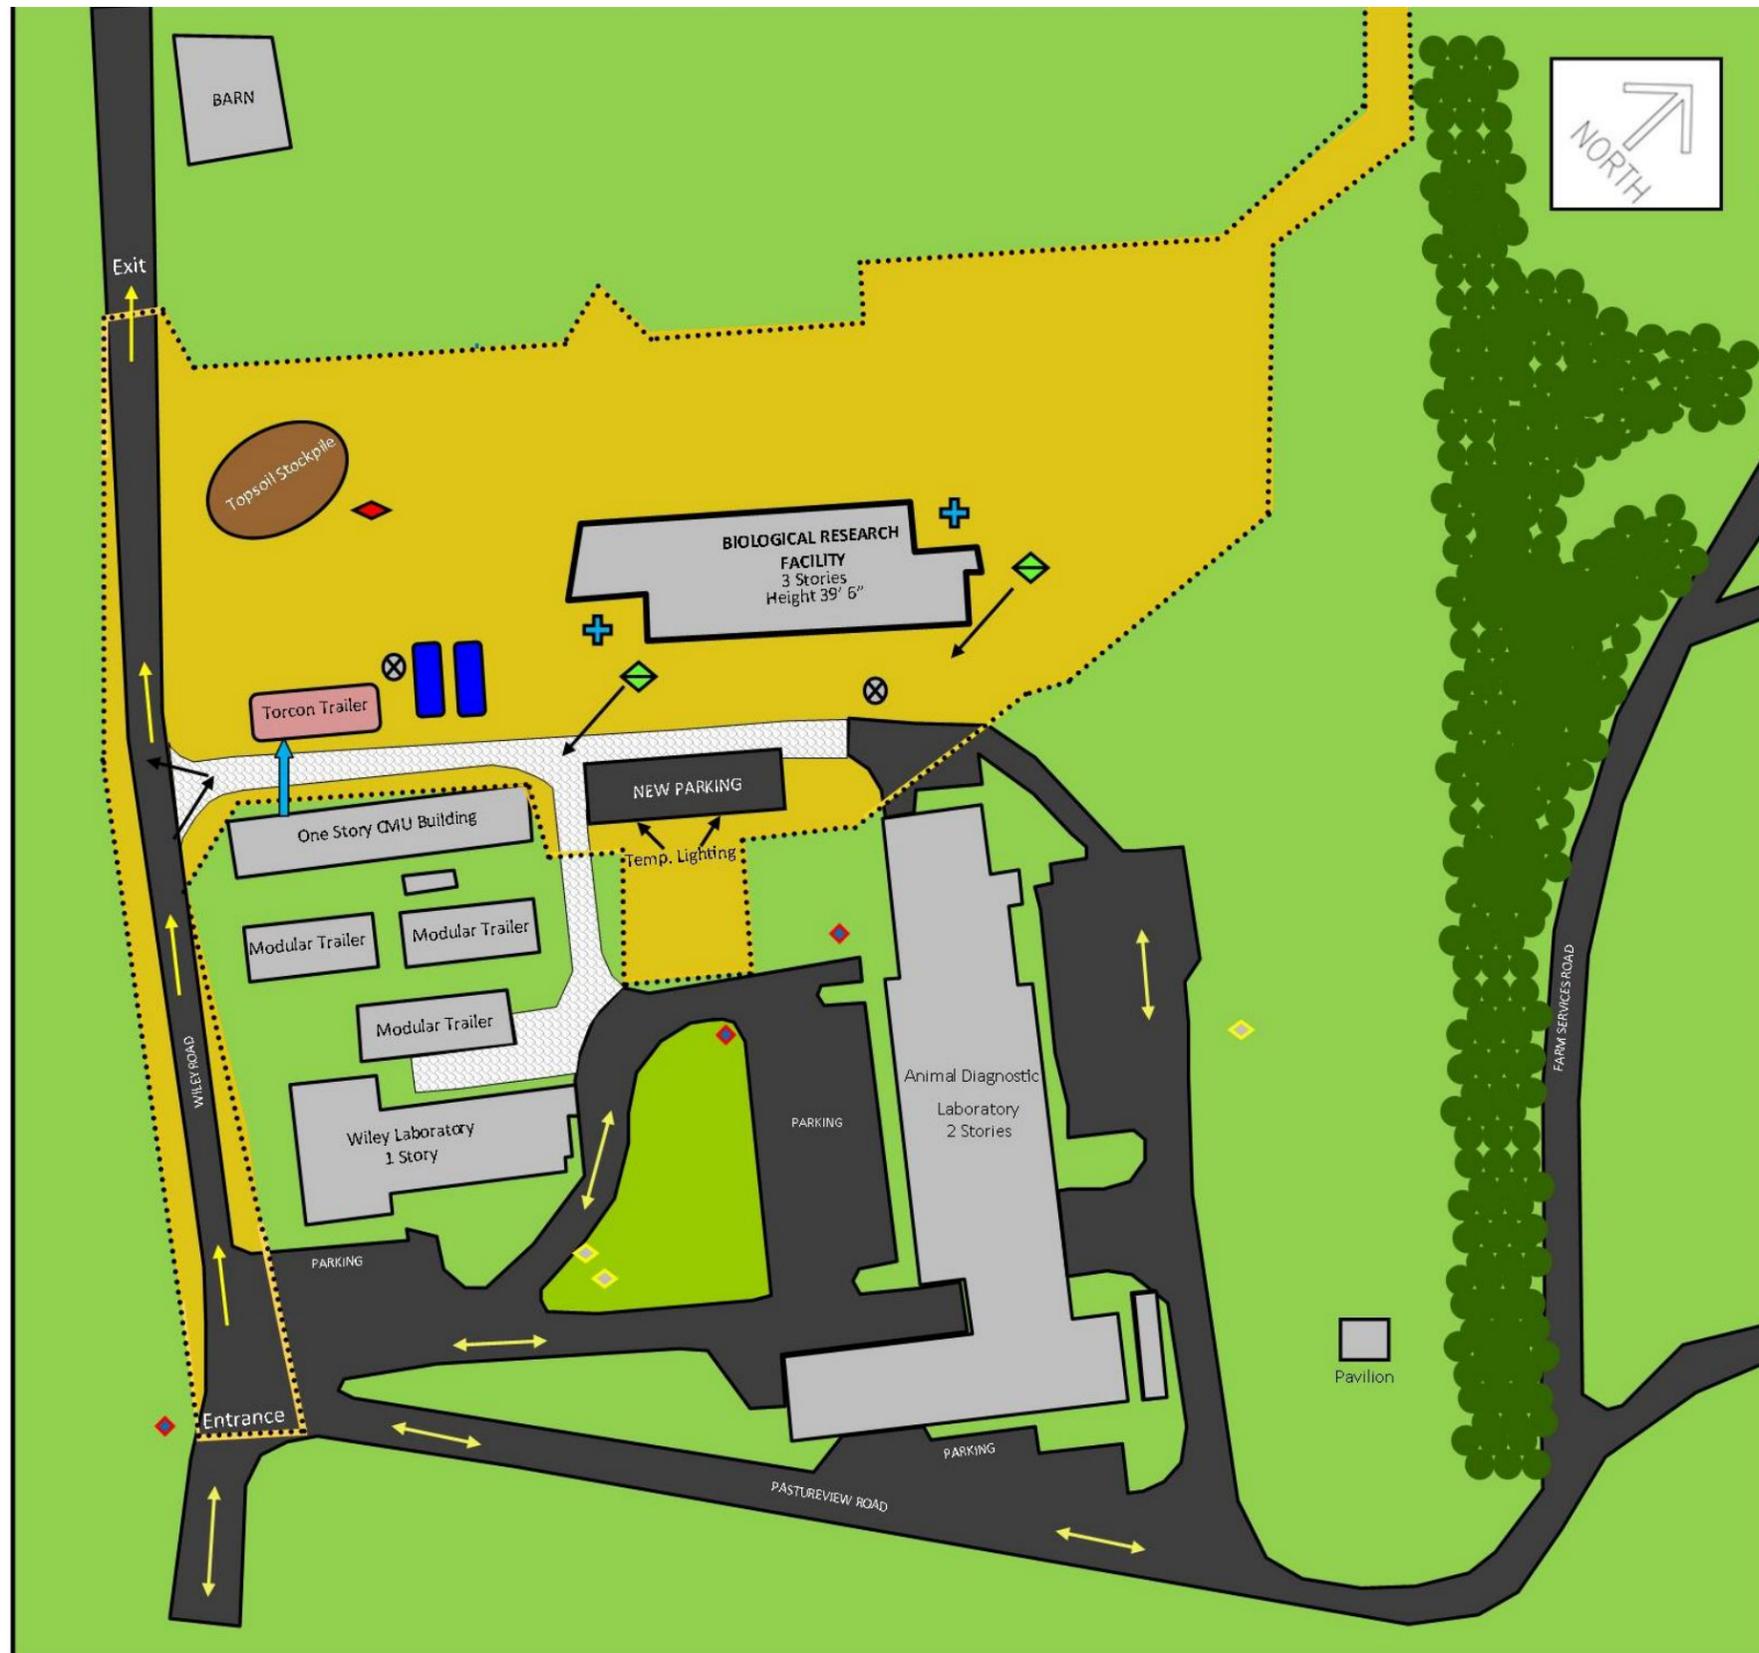
EXCAVATION SITE PLAN

In preparation for excavation plan (Appendix C-1), a site fence was placed around the construction area to enclose further work from the general public while maintaining all university protocols. Torcon, the Construction Manager on the project, placed their trailer near the gravel road leading up to the site. One of the first delays on the site involved getting temporary utilities to the trailer. On the site for the excavation phase will be dump trucks, bull dozers, and excavators preparing for foundations and the superstructure.

The soil stock pile will be located in the back corner of the site remaining out of the way for the duration of the project. One reason why the topsoil stock pile was placed in this region was to prevent labor and equipment moving material twice. During this phase a new parking lot was added, ultimately to be a paved lot for faculty parking at the facility. Temporary lighting was also provided in this lot for safety reasons. Material storage trailers are also placed on site and used by the sub-contractors for storage and equipment while working on the project. In an effort to make work more productive during the excavation phase of the project convenient bathroom locations were also planned to cut down on walking time to and from the bathrooms.

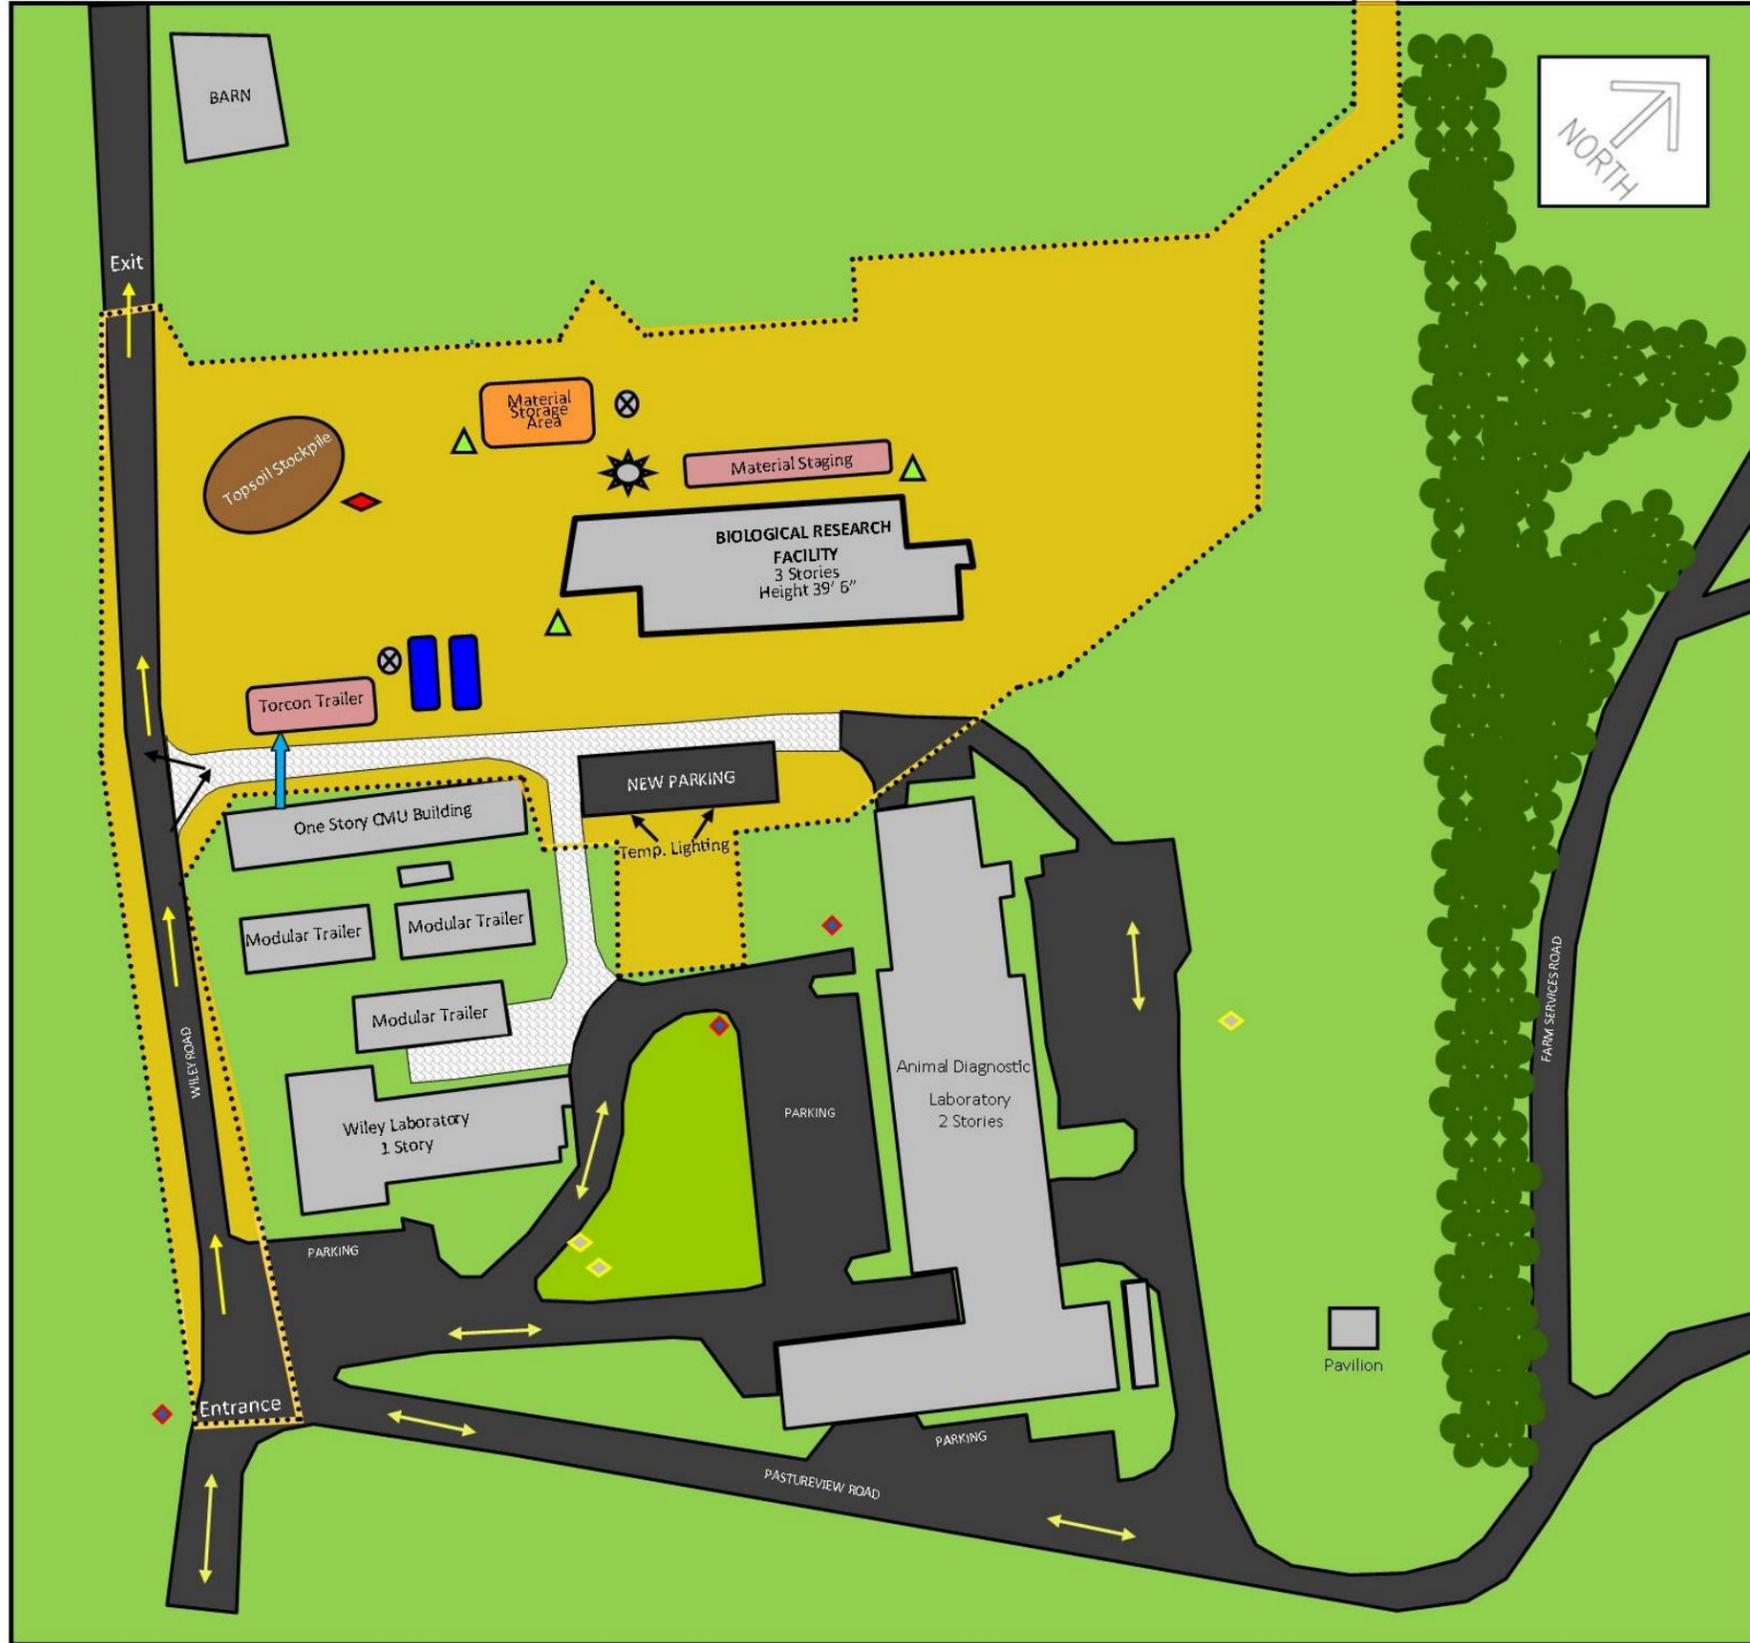
SUPERSTRUCTURE SITE PLAN

The construction of the superstructure involves moving certain equipment off site while preparing different areas for laydown in order to speed up the erection process. At the beginning of the superstructure phase, a mobile crane was introduced to the site in order to erect the structural columns and beams. During this phase the dump trucks and excavators are vacated from the site to reduce equipment costs on the project. The bull dozer, however, stays to ensure there is a solid and level base for the mobile crane as it travels around the site performing steel picks. The site plan can be referenced in (Appendix C-2) for more detail.

Looking at the site logistics for the superstructure site plan also has changed in comparison to the previous excavation plan. First the portable bathrooms have moved to locations such as the material storage area to be closer to the work being performed. Dumpsters have also been dispersed around the site to not only comply with the LEED silver rating but also to keep the site clean with convenient locations around the building. Crane placement, material staging, and storage area was critical because it allows the project to have efficient production. The placement of the crane would have been better if placed in front of the building but could not due to sloping topography. This resulted in placing the material storage and the crane behind the structure, allowing the crane to walk along the back of the building when performing different steel picks. A downside to placing material in the back of the site is difficulty getting to and from the material storage area, slowing production.

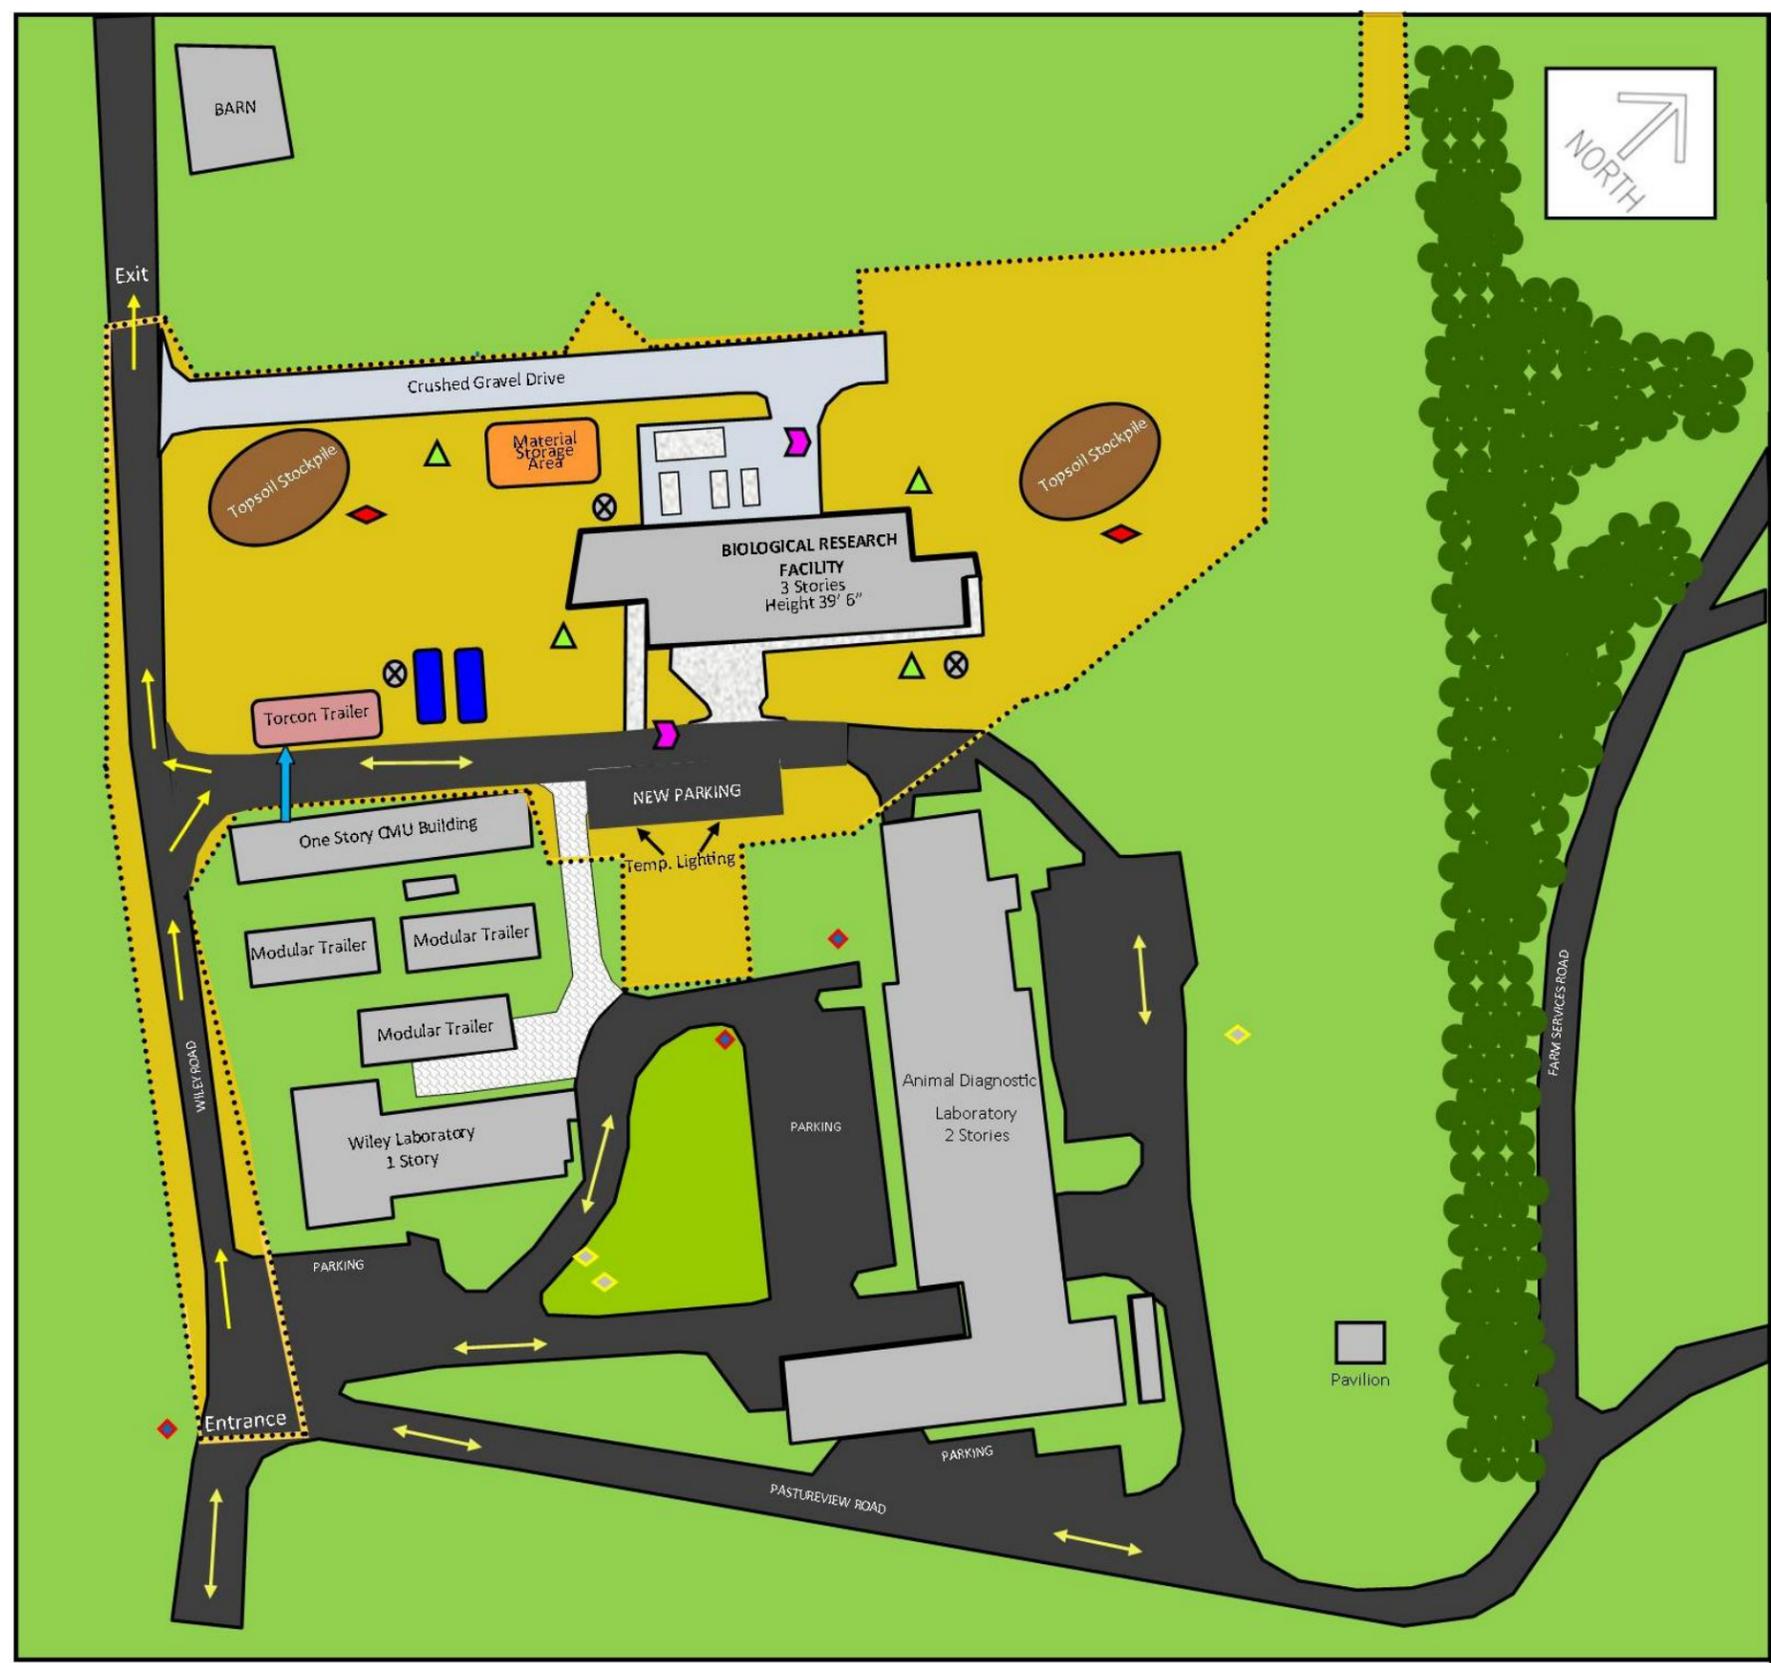
FINISHES SITE PLAN

Upon completing the project, the finishes site plan prepares and implements site re-grading and final paths for the site which can be referenced in more detail in (Appendix C-3). Bull dozers are brought back to the site in order to finish the top soil grading for final landscape and placing grass seed. Referencing the site plan the soil stock pile is split in half to increase efficiency to the left and the right of the laboratory. During this phase a compacted gravel road is installed leading up to the back of the facility. Concrete trucks are also on the site delivering material to both the front and back of the laboratory, finishing the walkways, steps and concrete pads for utilities.
