Central Bed Tower Expansion

University of Virginia | Charlottesville, VA

Technical Assignment 3

November 16, 2011

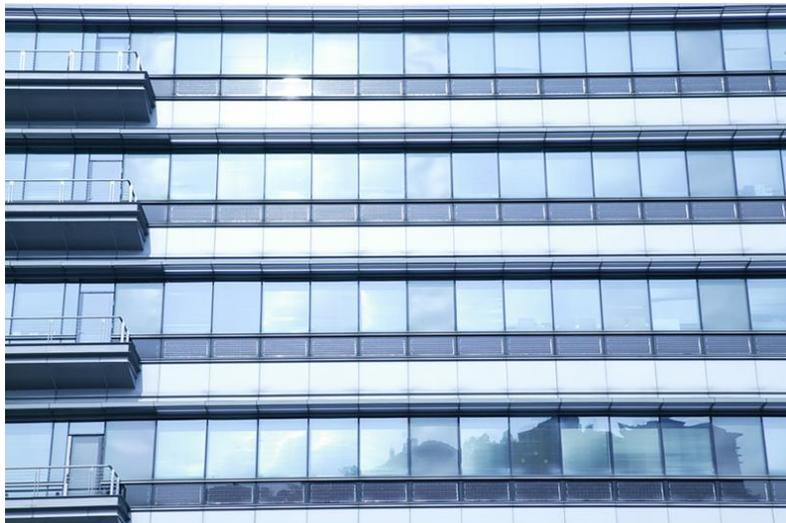
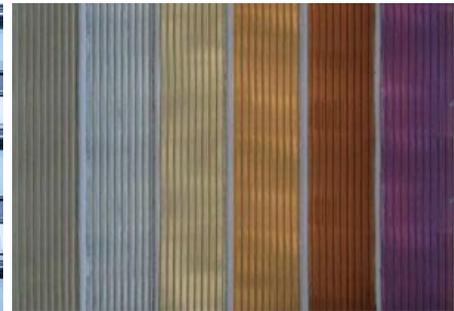
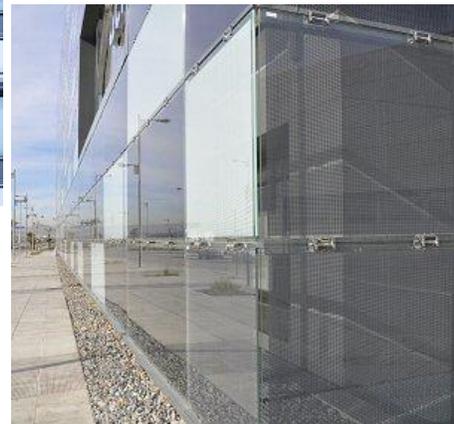
Figure 7 & 9 (Upper & Lower Right) show samples of façade layout incorporating Transparent Solar Glazing. Figure 8 (Upper Right) shows colors that can be used with the Solar Glazing.

Transparent solar glazing (See Figure 7,8,&9) is a system of window glazing that essentially has a solar panel built into the glass panel. These systems can come in varying colors and styles so there
