LIGHTING / ELECTRICAL

TECHNICAL REPORT 1: EXISTING CONDITIONS AND DESIGN CRITERIA

HUNTER' POINT SOUTH INTERMEDIATE SCHOOL AND HIGH SCHOOL  
QUEENS, NY

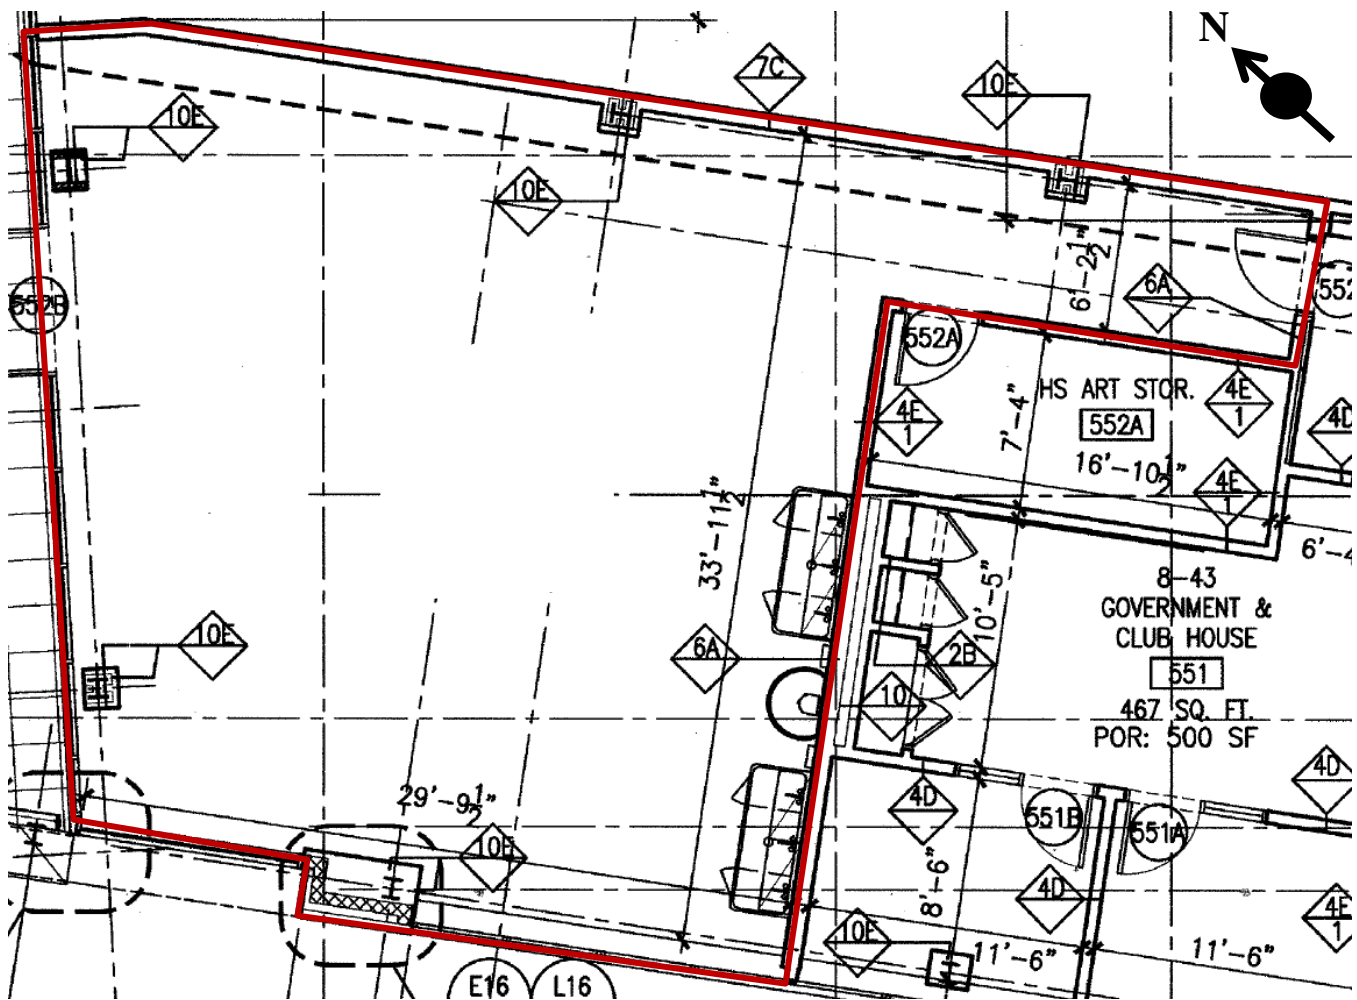
The HS Art Room (on the 5<sup>th</sup> floor) is located on the (plan) South wall of the building and has direct access to the exterior terrace via double doors on the west wall. The true orientation of this wall, which contains a large portion of glass, is approximately North-West. Although attached directly is the HS Art Storage Room, this room will not be considered in the calculations and design of the art room.

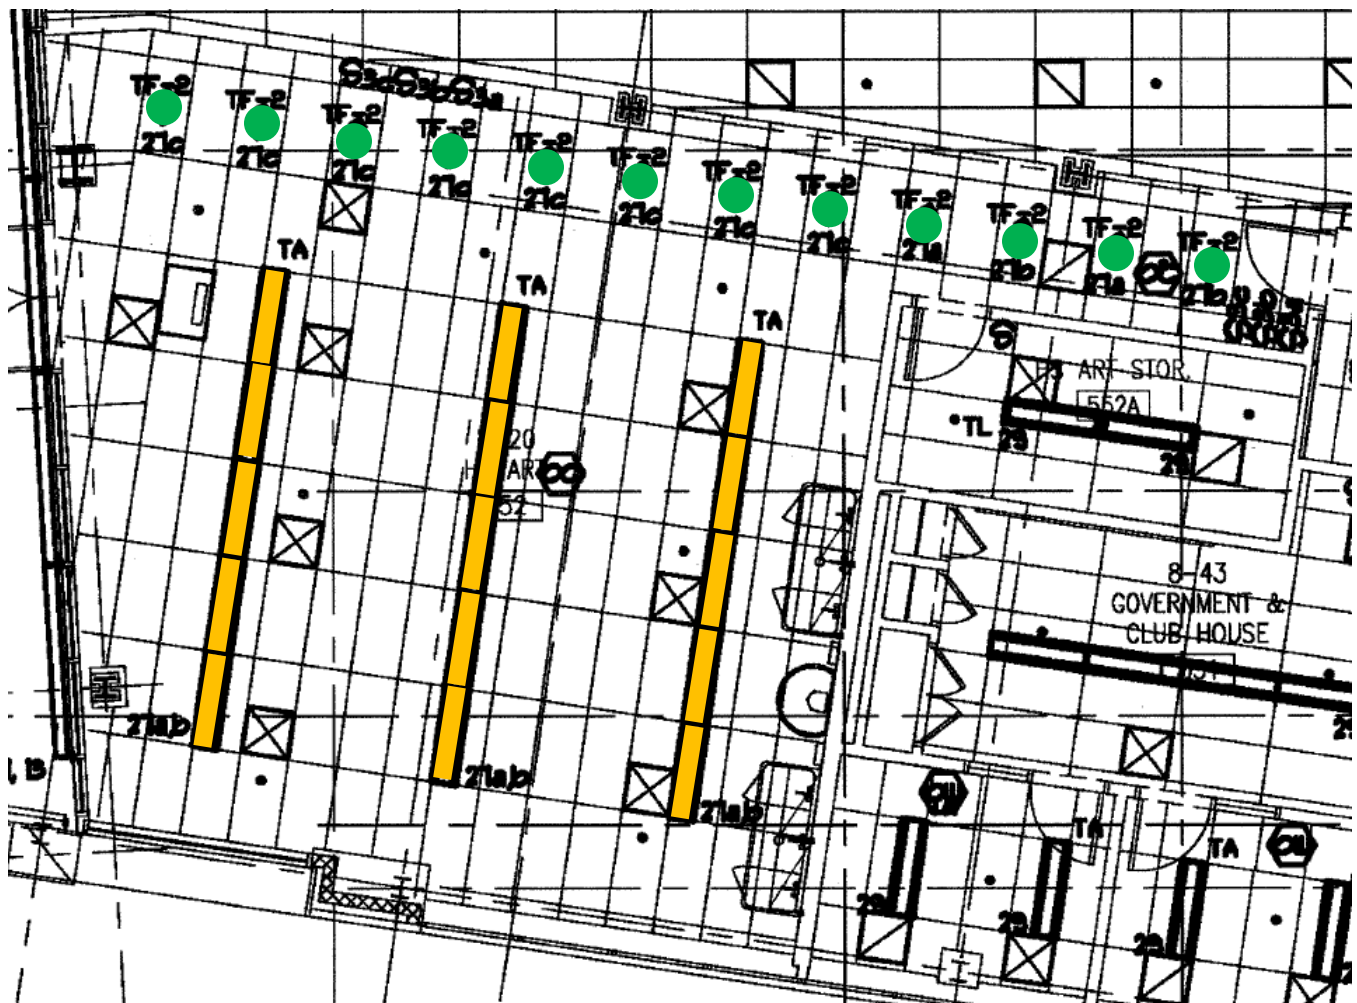
The HS Art Room utilizes suspended direct-indirect linear fluorescent pendants over the main student seating area, and multiple recessed downlight/double wallwash fixtures along the front wall. The wallwash fixtures not only wash the front wall of the room, also throw light backwards into the main student seating area. Two occupancy sensors, one located at the entrance of the room and the other in the main student seating area, are responsible for controlling these fixtures. The plan and table above indicate the location and quantity of the fixtures.

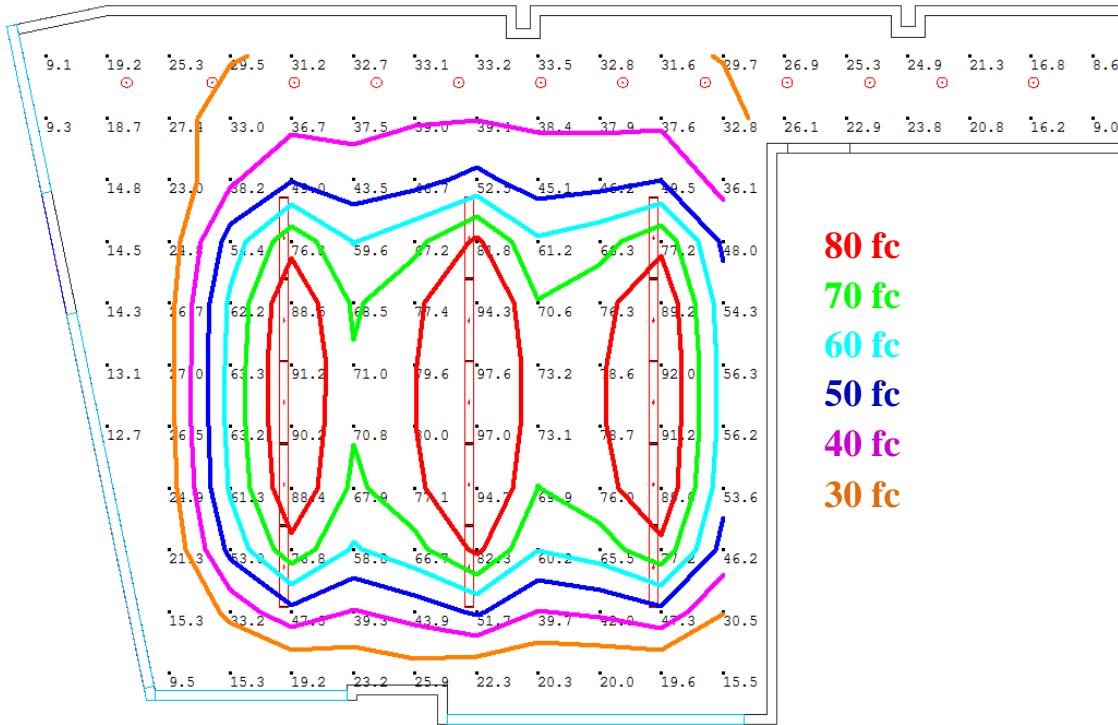
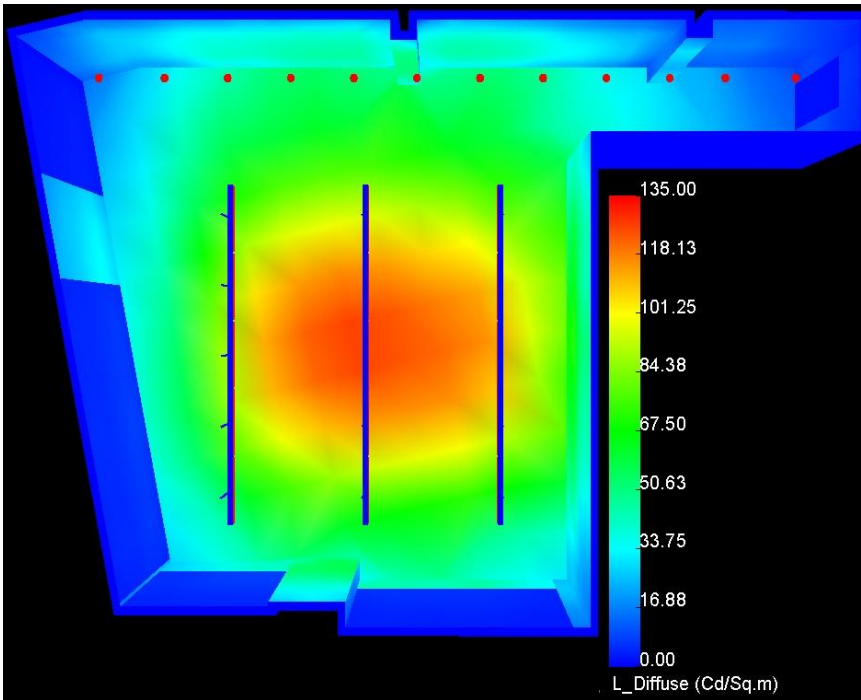
Iso-line and pseudo-color diagrams are presented below for aid in the analysis of the uniformity performance. Besides the iso-line diagram is a legend indicating the illuminance value of each iso-line. Besides the pseudo-color diagram is a scale representing the luminance in the space.

Analyzing the data shown above, it is evident that the achieved illuminance levels in this space are well over the I.E.S recommended levels for an educational art room. Additionally, the achieved uniformity ratios do not comply with I.E.S's recommendations. These two problems could be solved by adjusting the mounting height of suspended luminaires, or reducing their wattage. Reducing the wattage is justifiable by the fact that the system is performing well above where I.E.S recommends it to be. Additionally, the wattage must be reduced to comply with the AHRAE 90.1 required power density. As viewed in the power density table above, this space does not comply with the allowable power density.

Taking a look at uniformity (illustrated by the above ISO-line and pseudo diagram), we see that this space is performing sub-par. The close proximity of the different iso-lines represents the poor uniformity of this space. As seen in the pseudo diagram, there is not only a large hot-spot in the center of the room, but a large lack of illuminance on the front wall. Although the front wall is to be used for lecture purposes, and previously stated to be a secondary task of the space, it should still be lighted to adequate levels for viewing purposes. Although perfectly uniform lighting in this space is not necessarily desirable as we want to create a visually interesting space to spark creativity, the students' desk should be (relatively) uniform.

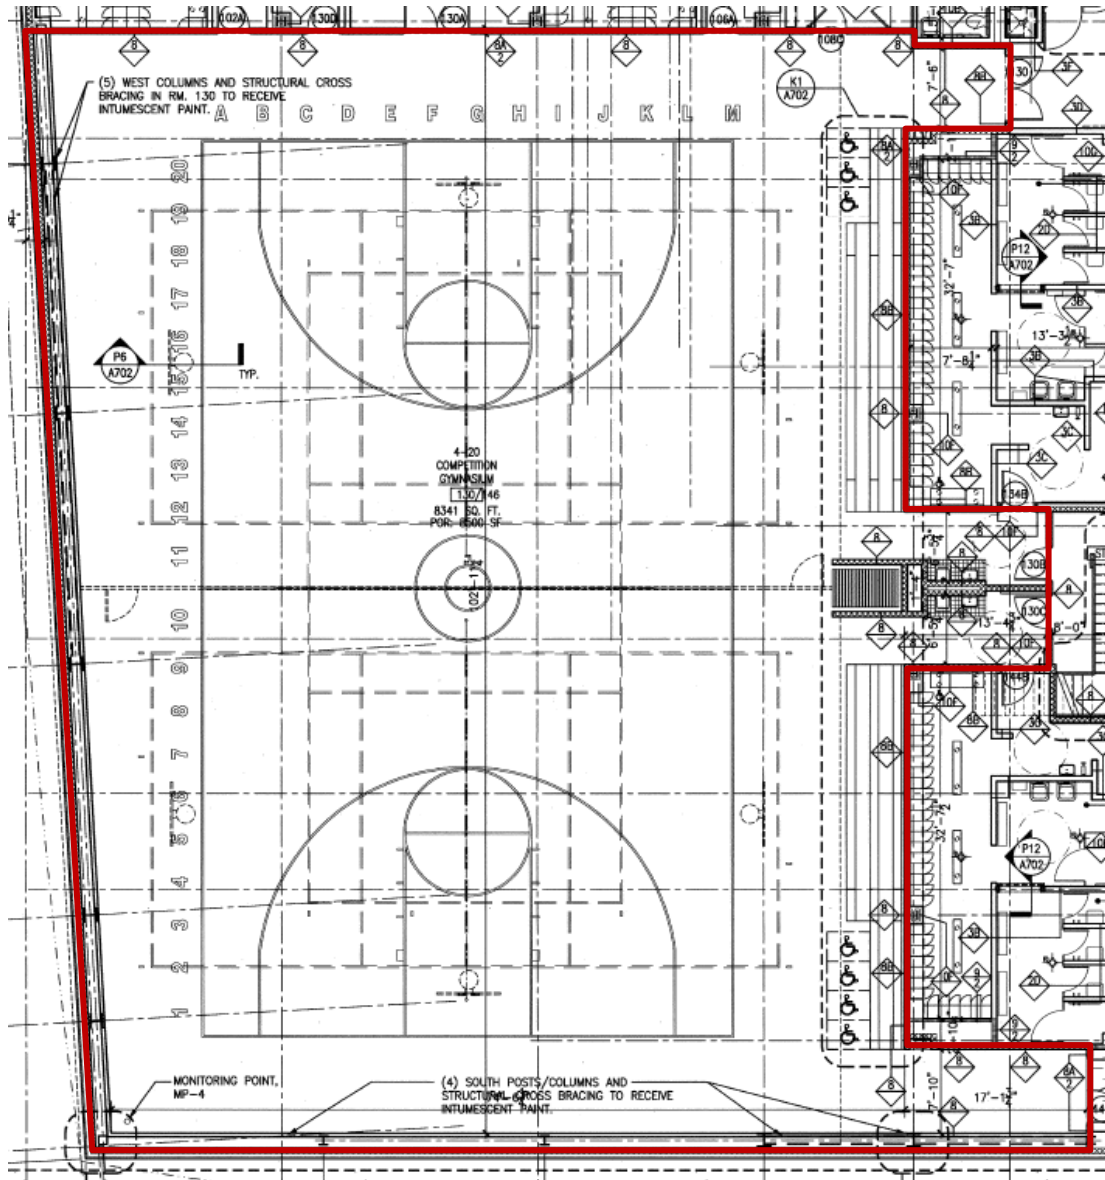
The Competition Gymnasium is located on the 1<sup>st</sup> floor in the (plan) South-West corner of the building. The West and South wall of the gym are covered largely by trapezoidal-shaped windows which will eventually lend this space to a daylight analysis. There is one large basketball court stretching the length of the gymnasium in the North-South direction, and two smaller ones in the East-West direction. There is a retractable partition that splits the space down the middle, separating the two smaller basketball courts. This splitting of the space into two

smaller spaces will eventually affect the redesign of the lighting system. The entrance and spectator seating of this space has 10 foot ceilings whereas the actual court area rises two stories (approximately 24 feet).

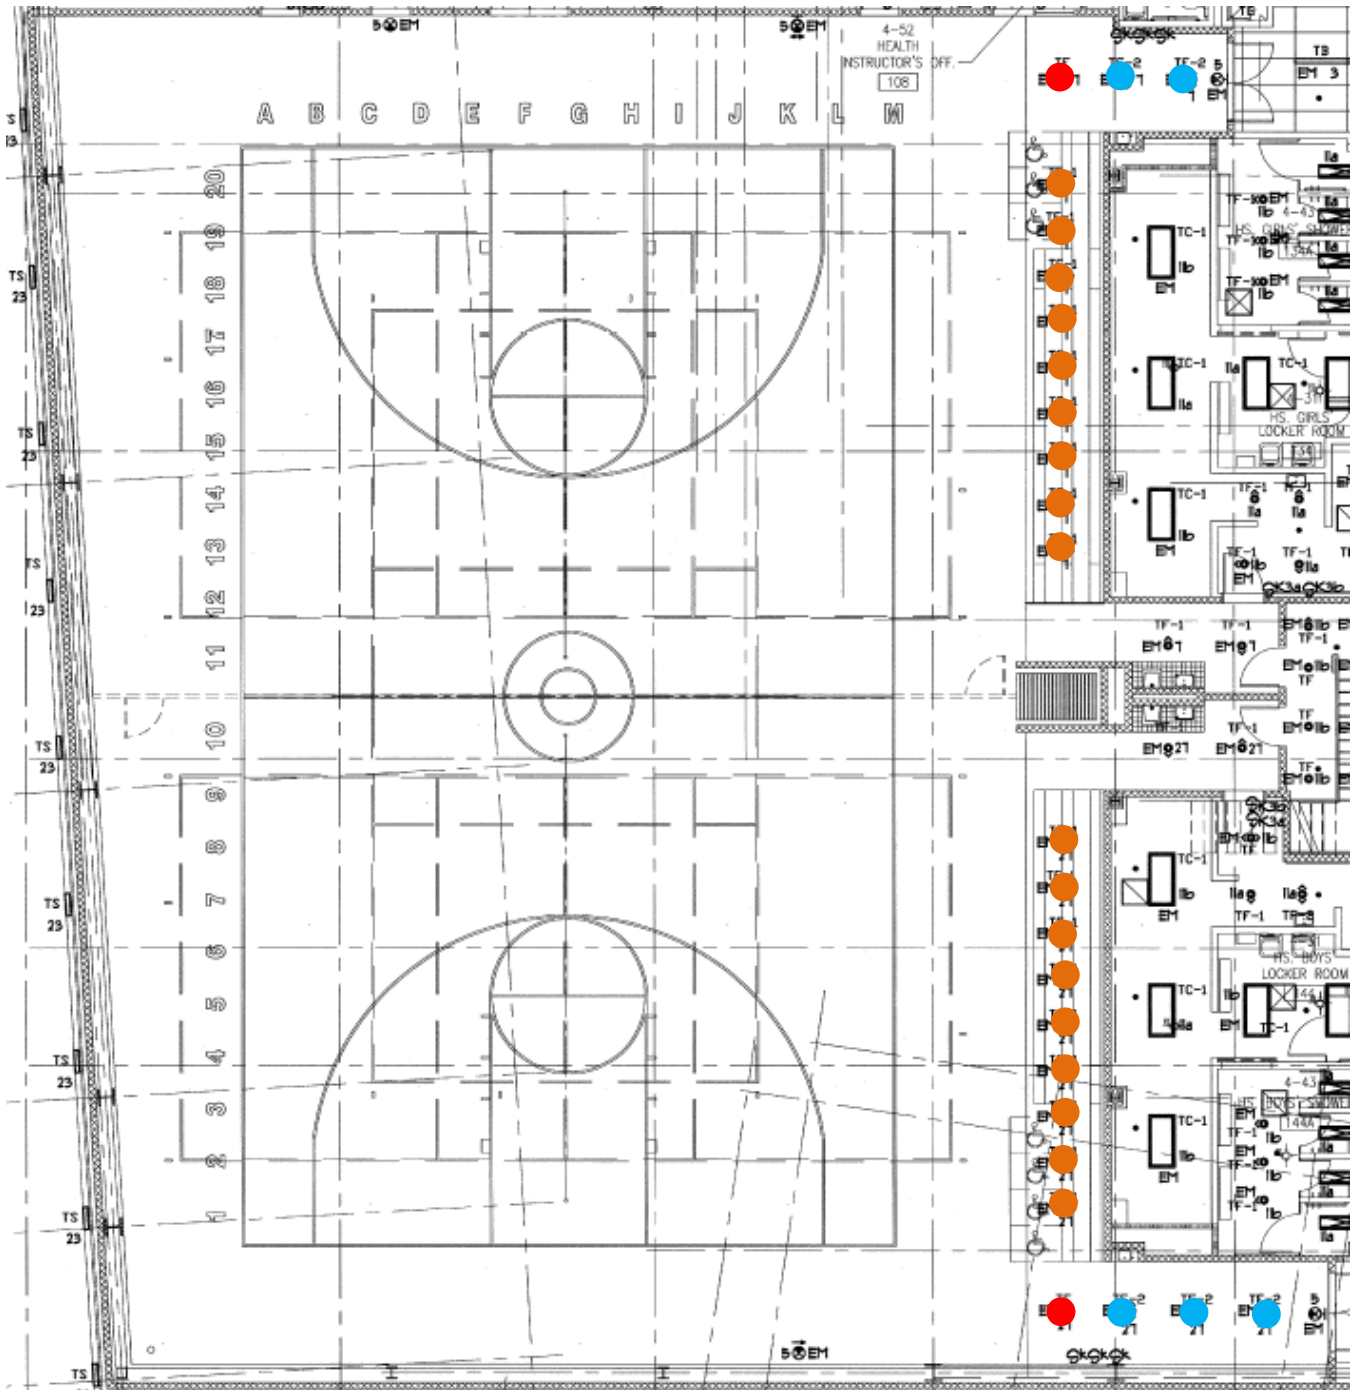
The entrance and spectator seating area, both having a 10 foot ceiling, utilize multiple circular downlights and wallwashers. These fixtures provide general illuminance and wash the side wall as to make it more inviting. The goal of the wall wash is to view the seating area as being dark and uninviting from the court area. In the area of open ceiling, 8-lamp CFL high bay fixtures are utilized to achieve adequate illuminance levels for sporting events. Locations of these fixtures are shown in the two figures to follow. The first figure represents the area with a 10 foot ceiling. The second is of the area with a 24 foot ceiling.

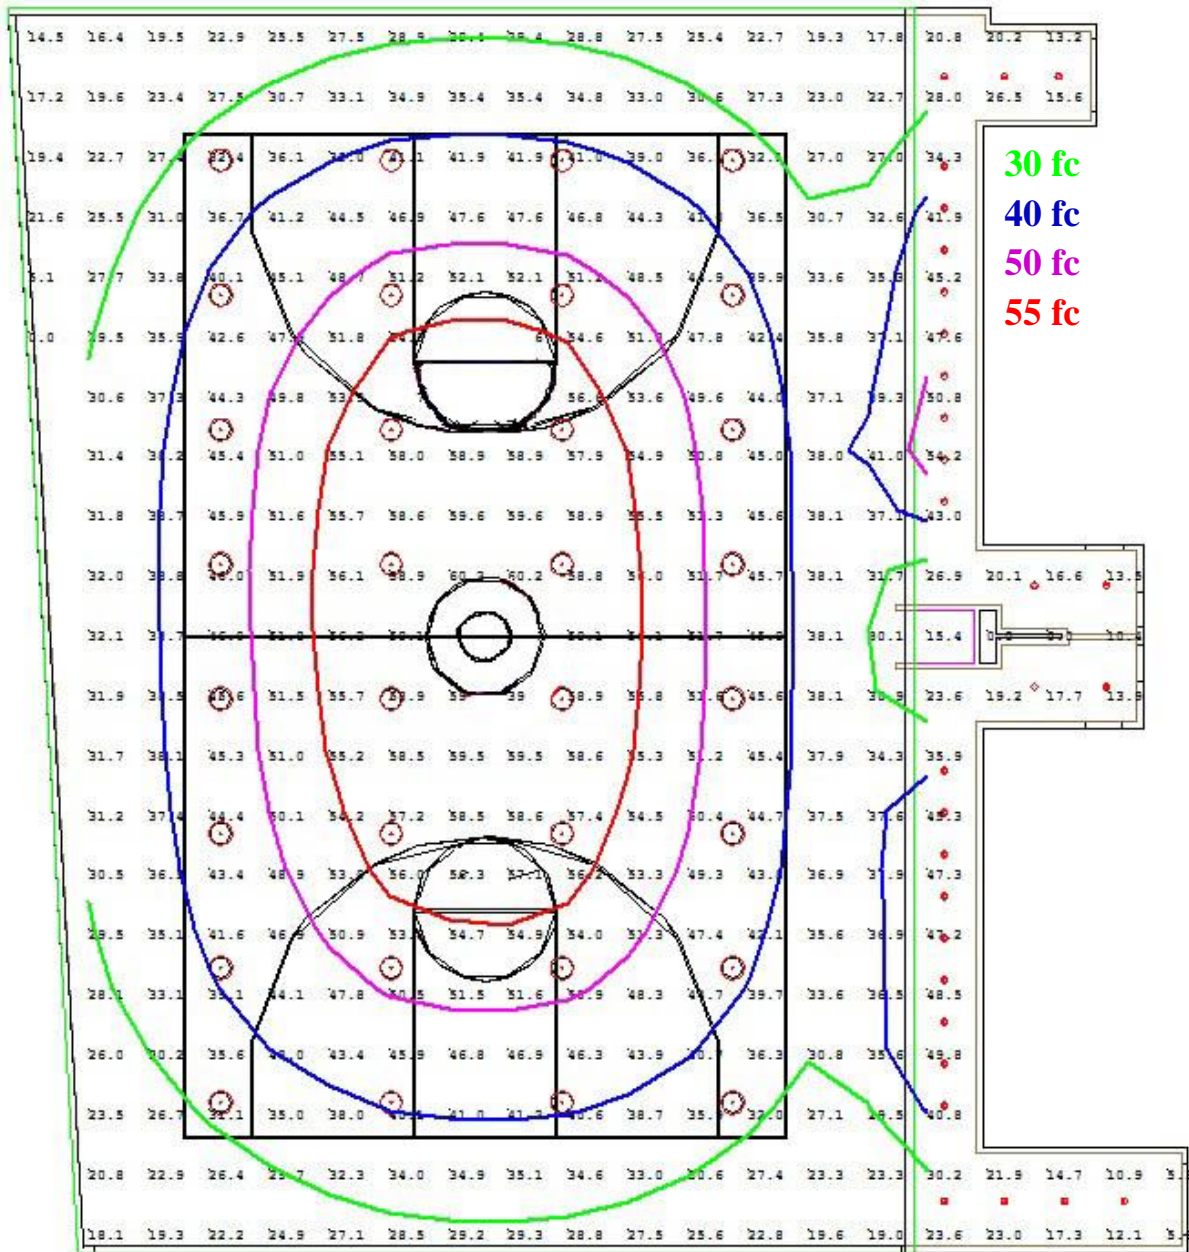
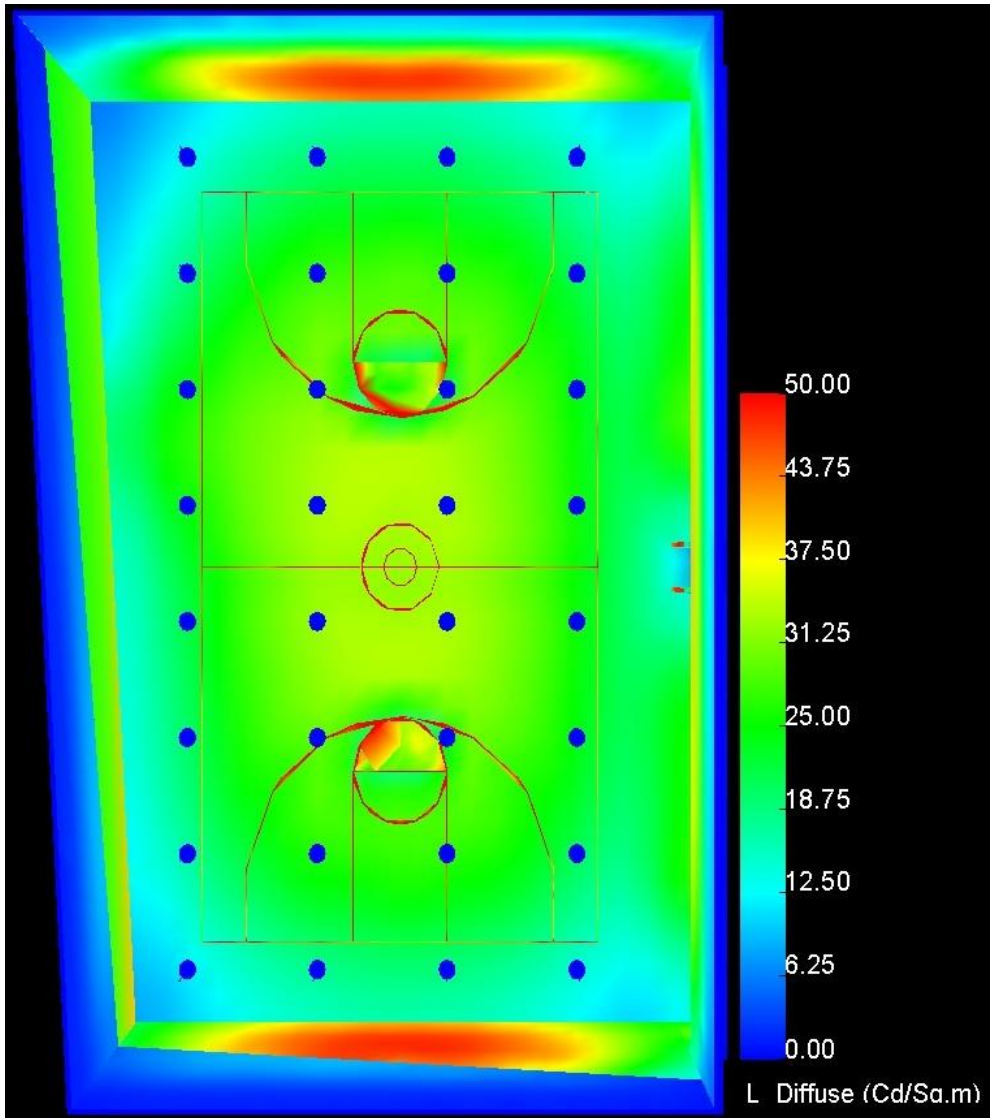
Iso-line and pseudo-color diagrams are presented below for aid in the analysis of the uniformity performance. Besides the iso-line diagram is a legend indicating the illuminance value of each iso-line. Besides the pseudo-color diagram is a scale representing the luminance in the space.

Analyzing the data shown above, it is evident that the achieved illuminance levels in this space are well over the I.E.S recommended levels for an educational gymnasium. Additionally, the achieved uniformity ratios do not comply with I.E.S's recommendations. These two problems can be solved by better placement of the luminaires, or a fixture with a better distribution. As shown in the power density table shown above, this space (although barely) complies with the AHRAE 90.1 required power density.

Taking a look at uniformity (illustrated by the above ISO-line and pseudo diagram), we see that this space is also performing sub-par. It does not satisfy the recommendations for an education gymnasium. The pseudo diagram shows two large hotspots on the North and South walls. This is not only undesirable on any wall of the space, but is especially undesirable on these walls due to possible distraction of the players during a basketball game.

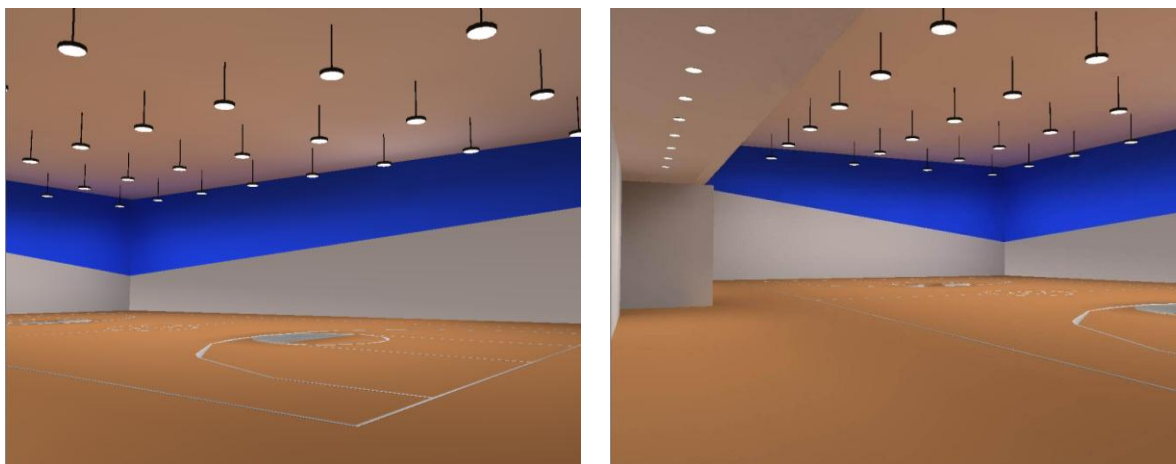
Two (preliminary) renderings are shown below to show the special composition of this space.

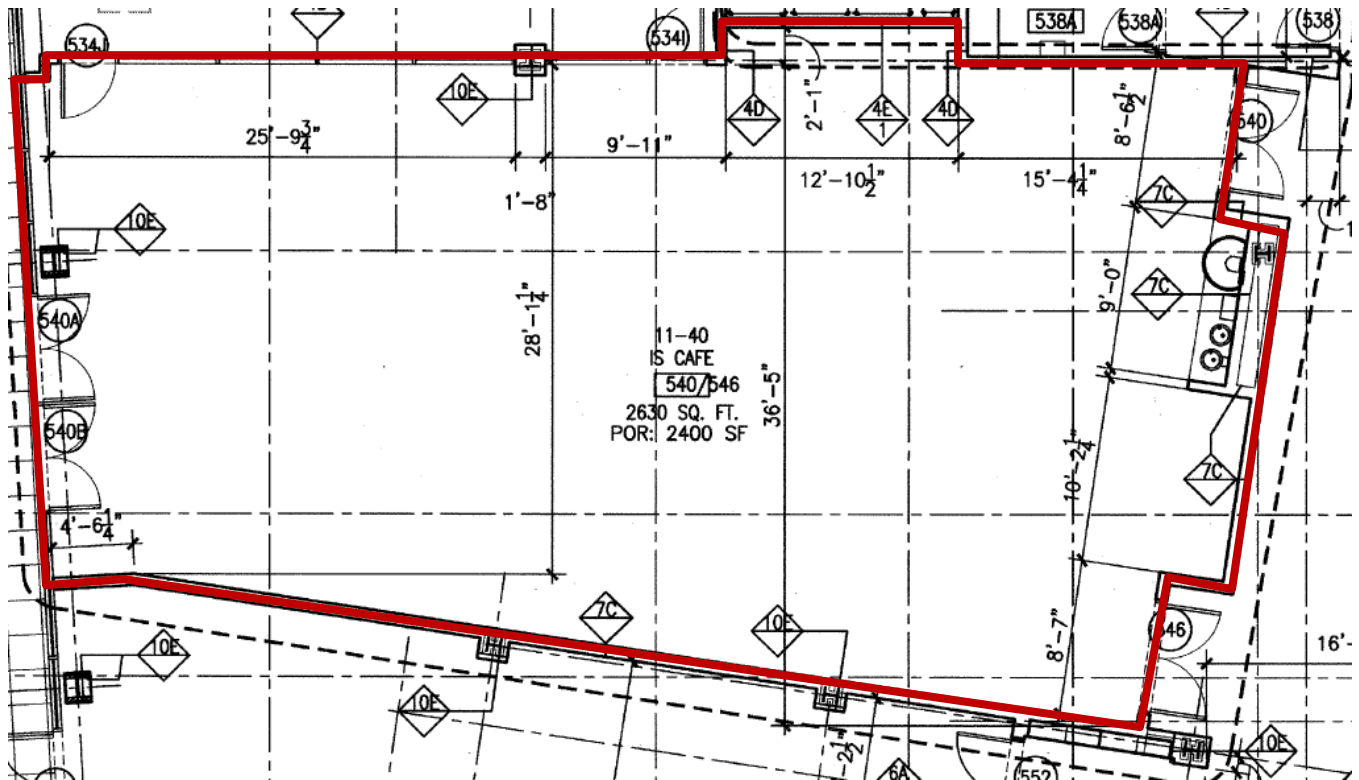
The Intermediate School (IS) cafeteria is located on the 5<sup>th</sup> floor directly north of the High School (HS) Art Room. There is no direct circulation between these two rooms, but like the High School Art room, the cafeteria has direct access to the exterior roof terrace. The two doors located on the western side of the North wall, lead to the lunch line, which served directly from the kitchen.

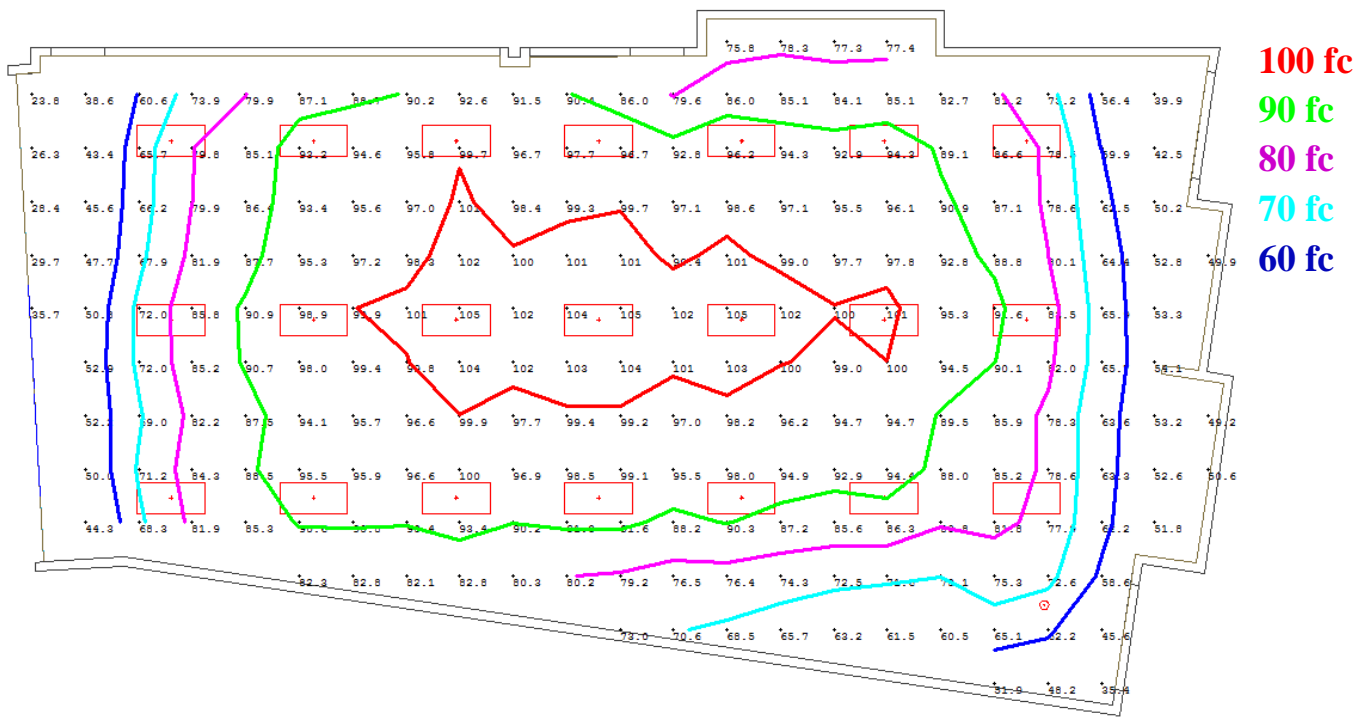
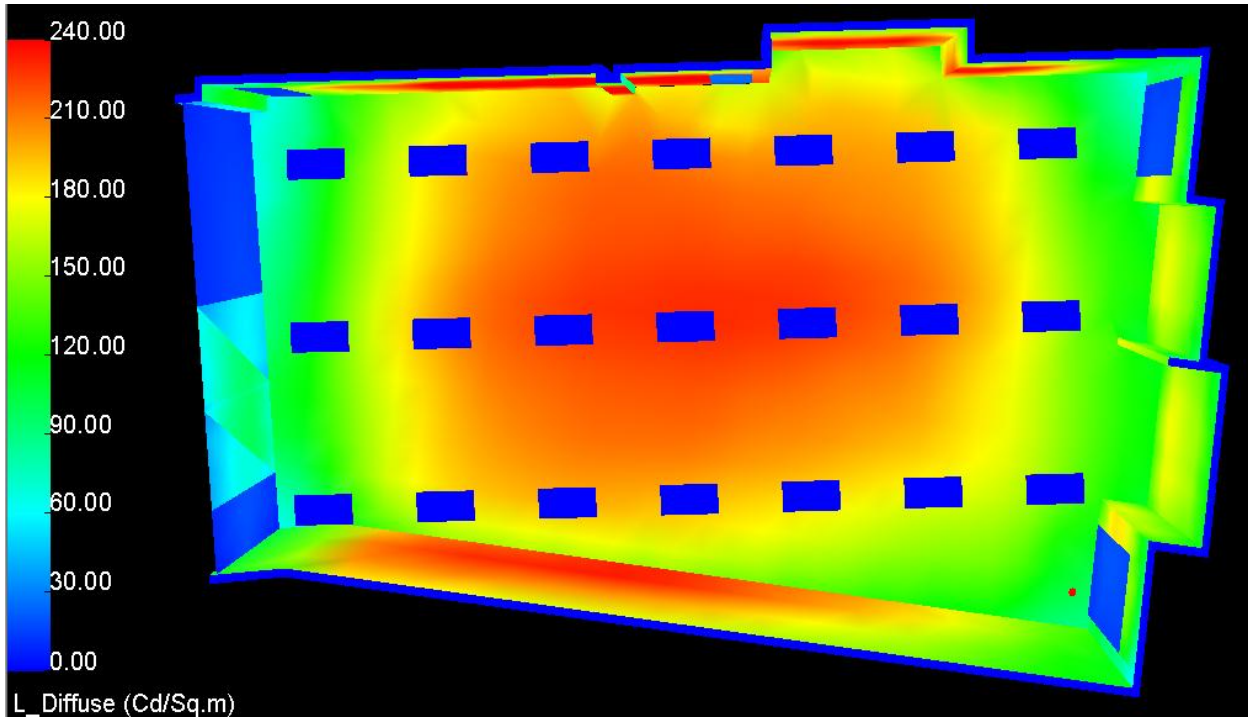
Iso-line and pseudo-color diagrams are presented below for aid in the analysis of the uniformity performance. Besides the iso-line diagram is a legend indicating the illuminance value of each iso-line. Besides the pseudo-color diagram is a scale representing the luminance in the space.

Analyzing the data shown above, it is evident that the achieved illuminance levels in this space are well over the I.E.S recommended levels for a cafeteria. Additionally, the achieved uniformity ratios do not comply with I.E.S's recommendations, although they are much closer than the previous two spaces analyzed. As shown in the power density table shown above, this space does not comply with the AHRAE 90.1 required power density.

Taking a look at uniformity (illustrated by the above ISO-line and pseudo diagram), we see that this space is performing much better than the previous two spaces analyzed. It was not considered in this model, but daylight entering the large west curtain wall has the capacity to drastically change the uniformity in the room.

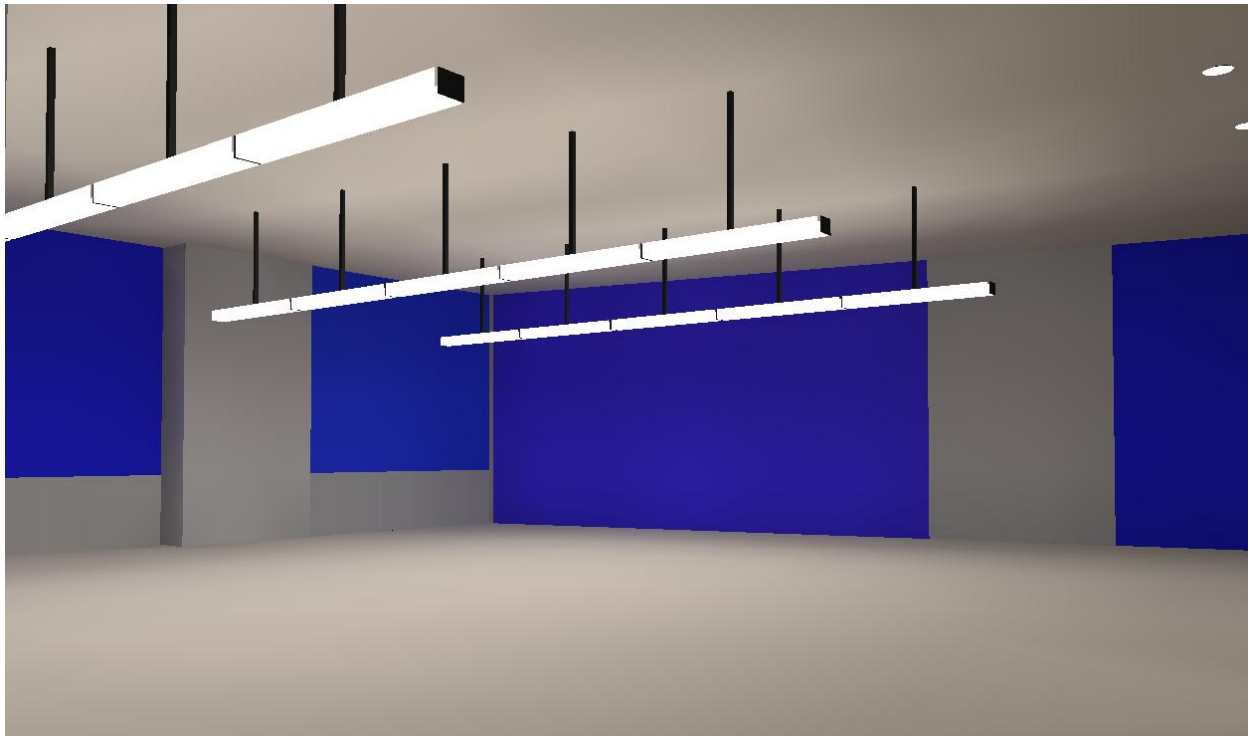
A (preliminary) rendering is shown below to show the special composition of this space.

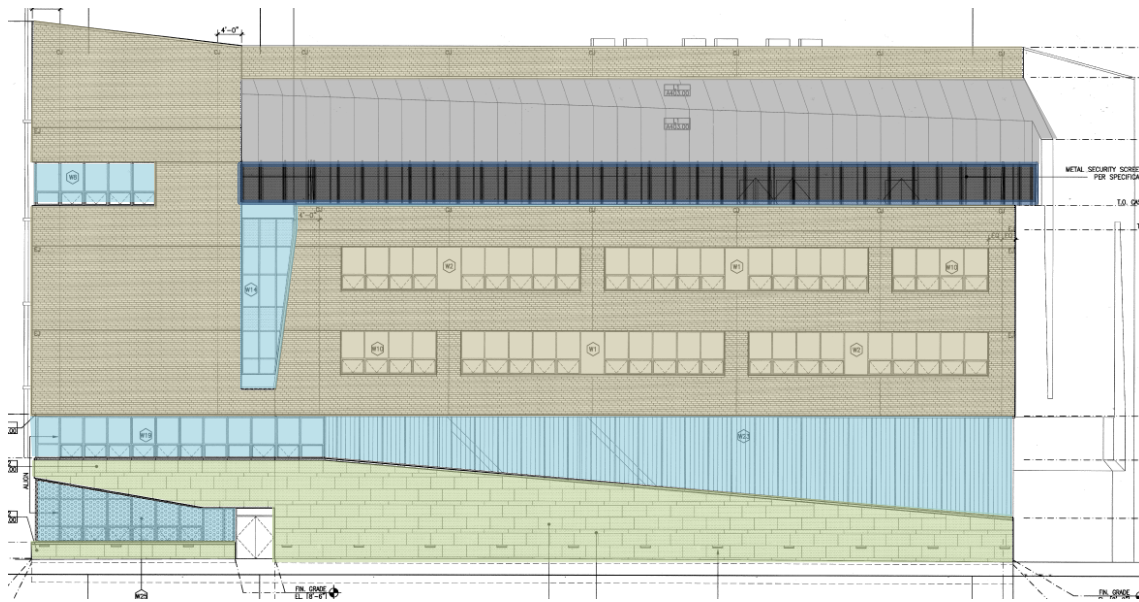
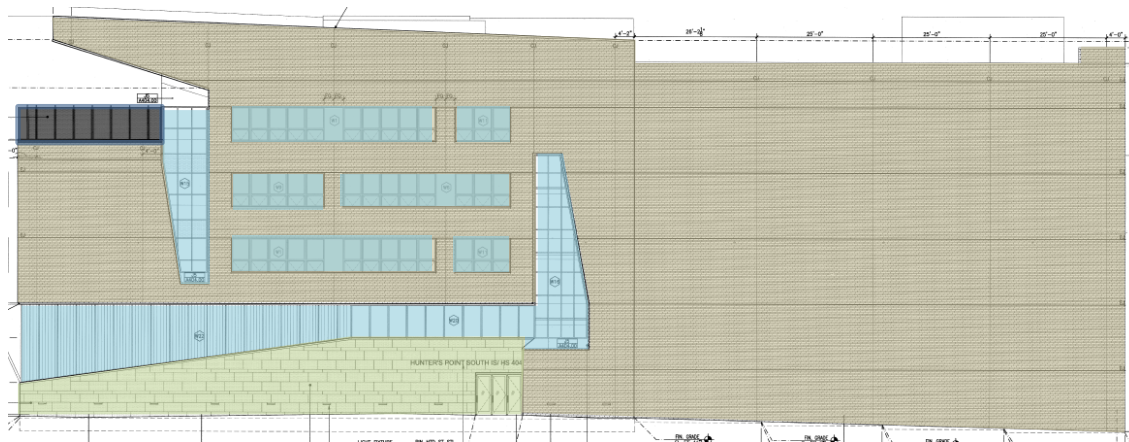
The façade of this building utilizes multiple material types. Grey stone and glazing are used to establish the first and second floors as the “base” of the building. A combination of dark grey utility brick and glazing are used in most of the upper portion of the building. The exterior roof terrace on the 5<sup>th</sup> floors has an aluminum composite panel cantilever. The actual roof terrace itself is outlined in a dark grey/black security screen for safety purposes. The table below gives information about each material, and a color swatch indicating its locations on the building elevations.
