Kaiser Permanente Largo Medical Office Building – Largo, MD

Technical Assignment 1

September 21, 2012

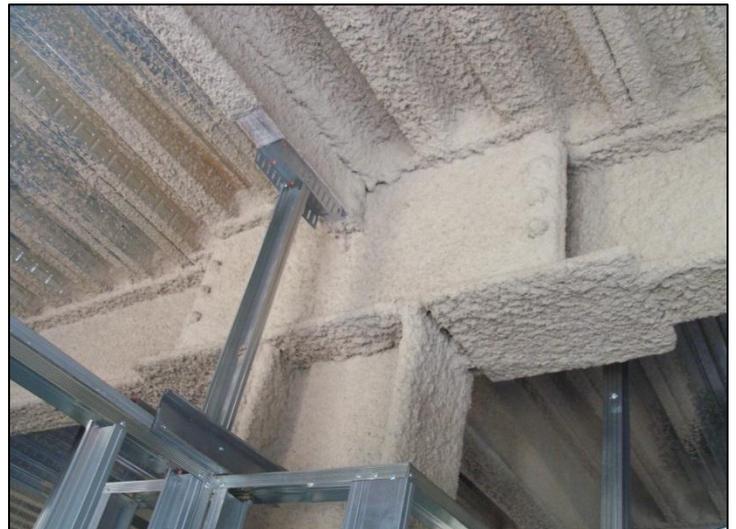
Figure 2 – Photograph of a Sideplate system. This is a moment frame that connects columns to beams and girders and can be single or double sided, shown above is a double-sided connection. Spray-on fireproofing has already been applied to the structural steel at this point of construction. Personal photograph taken by Chris Pozza.

A unique aspect of this project is the structural steel connections. A Sideplate Frame System, seen in Figure 2, has been selected. This is much more popular on the west coast, not traditionally being done on the east coast. This system will be discussed in more detail in the Structural Steel section to follow.

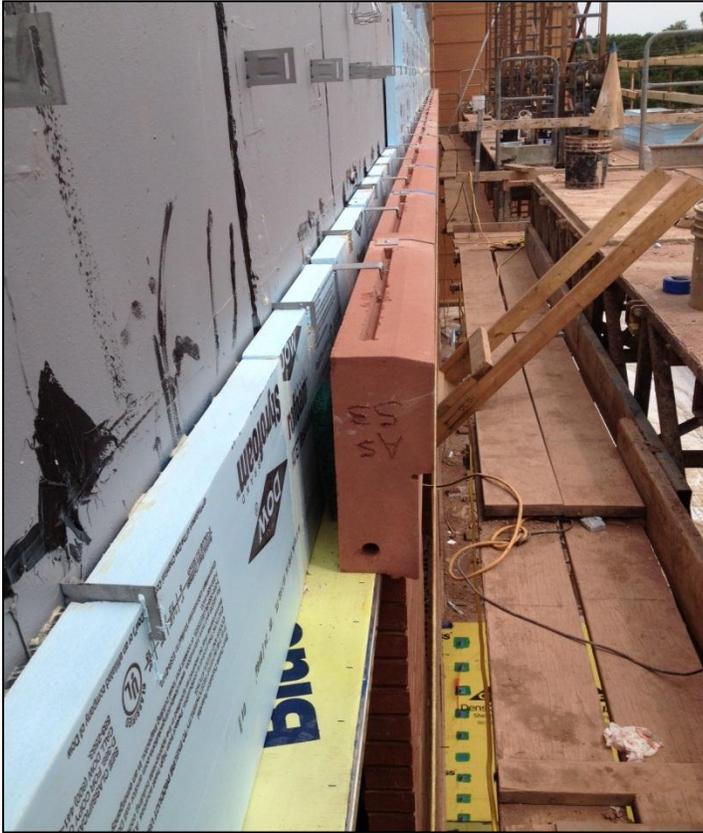
Figure 6 - Precast concrete can be seen above which make up the accent band along with east elevation. Personal photograph taken by Chris Pozza.

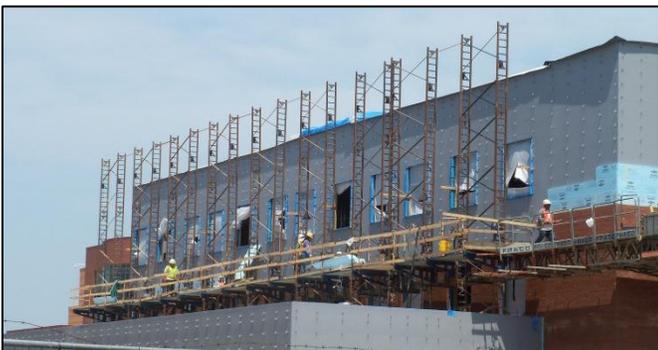
Figure 9 - View looking at southwest elevation. A MasonKing lift is required in areas where work is done above rooftops. These lifts have to be simultaneously cranked by hand to be lowered or raised. Personal photograph taken by Chris Pozza.

Fraco Lifts were set up around the perimeter of areas placing brick. MasonKing lifts were required in areas where veneer work was done above rooftops, which are shown and described below in Figures 9 and 10.

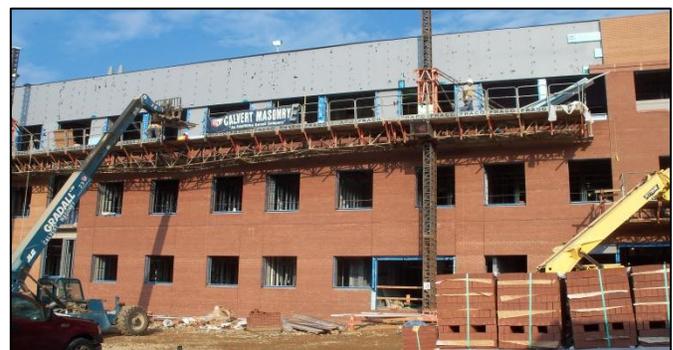
Figure 10 - View looking at east elevation. Fraco Lifts are used around exterior to provide efficient flow of construction along a large percentage of elevation at a time. Materials are lifted into place with a boom lift. Personal photograph taken by Chris Pozza.

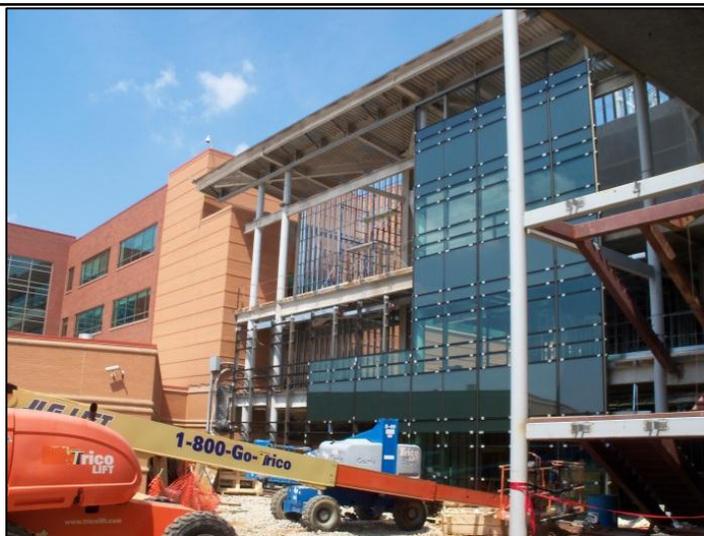
Figure 11 - View of west elevation curtain wall system under construction. The boom lift used during construction of the façade system can be seen at the bottom of the photo. Personal photograph taken by Chris Pozza.

An exterior view of glass curtain wall going in place is shown above in Figure 11. To the left is Figure 12, an interior view looking at the same area on the second floor is seen.

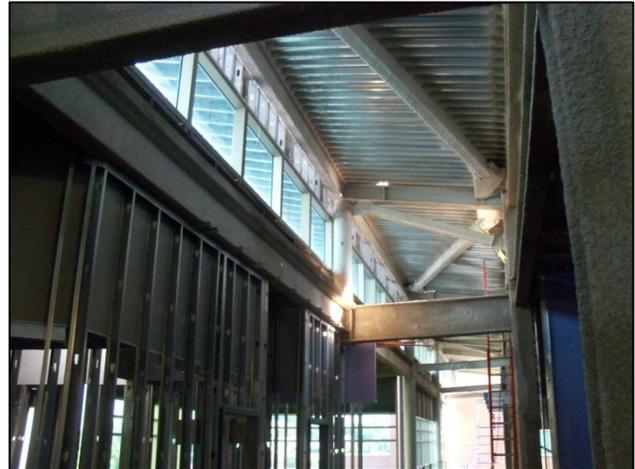
Figure 13 - Shown above is the clerestory that stretches over 200 feet long and bringing in natural light. Personal photograph taken by Chris Pozza
