Kaiser Permanente Largo Medical Office Building – Largo, MD

Final Thesis Report
April 3, 2013
Advisor – Rob Leicht

Kaiser Permanente Largo Medical Office Building

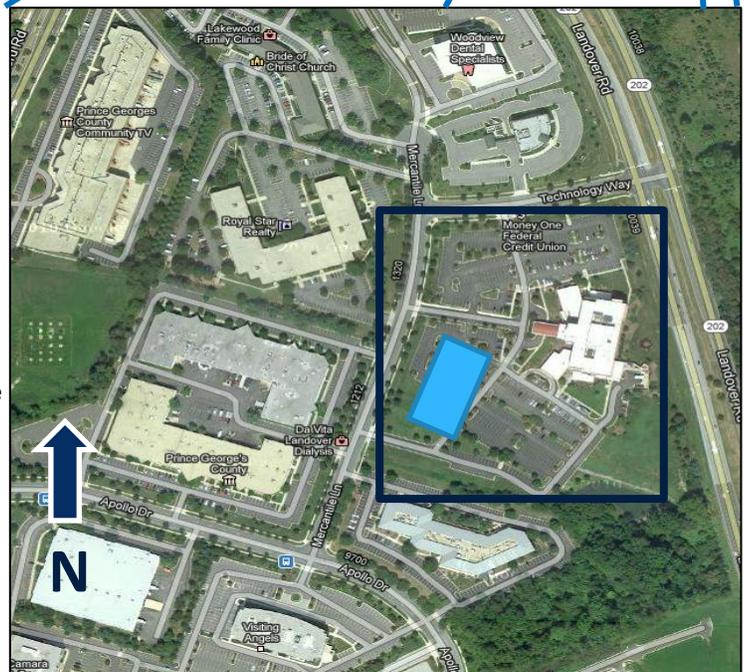
Figure 3, right – Zoomed in site view of the existing medical office building. The majority of the site surface is hardscape for vehicle and pedestrian traffic. Due to the outdated image, the existing parking garage was drawn in blue. Neighboring low-rise buildings can be seen a large distance away, thus construction had little to no impact on neighboring properties. Image taken from maps.google.com.

It can be seen that most buildings in this area have a large footprint and are relatively low, ranging from two to four stories. KP's medical office building is no different, with the existing building standing as one of the tallest at four stories and 51' 4". It can be seen in Figure 3 that the majority of the site is parking lot, even though the image is outdated due to the current parking garage that has been added, which is highlighted in blue.

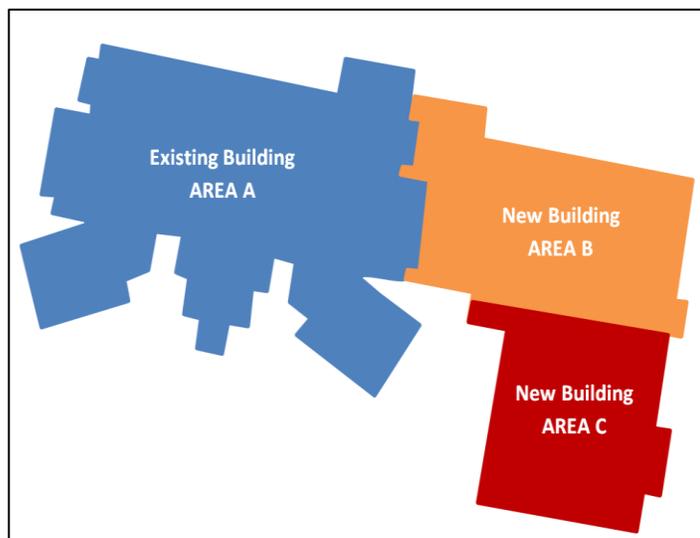
Figure 5 - Footprint of the existing building and addition, separated into different areas based off construction. These references will be used throughout the report. Image created by Chris Pozza.

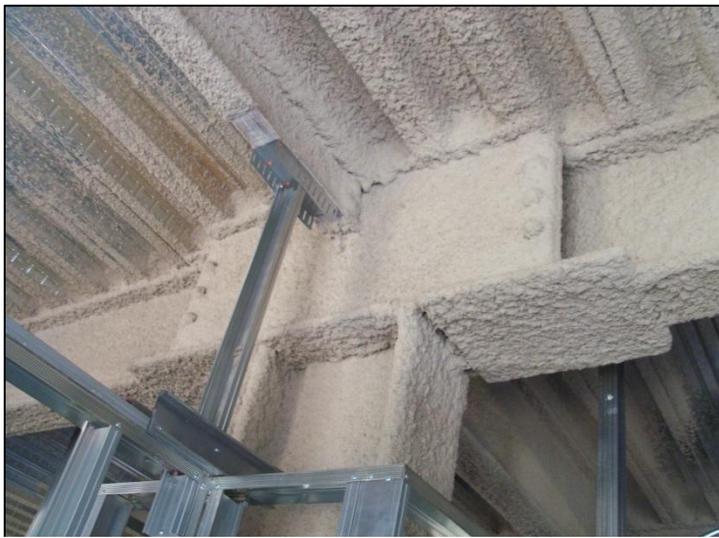
Figure 6 – Photograph of a SidePlate system which is a moment frame that connects columns to beams and girders and can be a single- or double-sided connection. Spray-on fireproofing has already been applied to the structural steel at this point of construction. Personal photograph taken by Chris Pozza.

A unique aspect of this project is the structural steel connections. A Sideplate Frame System, seen in Figure 6, has been selected. This is much more common on the west coast to deal with seismic loading.

This structure uses a unique moment connection, a SidePlate Frame System, which is shown in Figure 7 and Figure 8, and has previously been used on west coast KP facilities. SidePlate connections were chosen over braced frames because they allow lateral framing to be located more conveniently and offer a greater cost economy. Smaller members were able to be used; allowing for more space above ceilings and quicker steel erection. The building weighs less with smaller members; therefore, smaller foundations can be utilized.

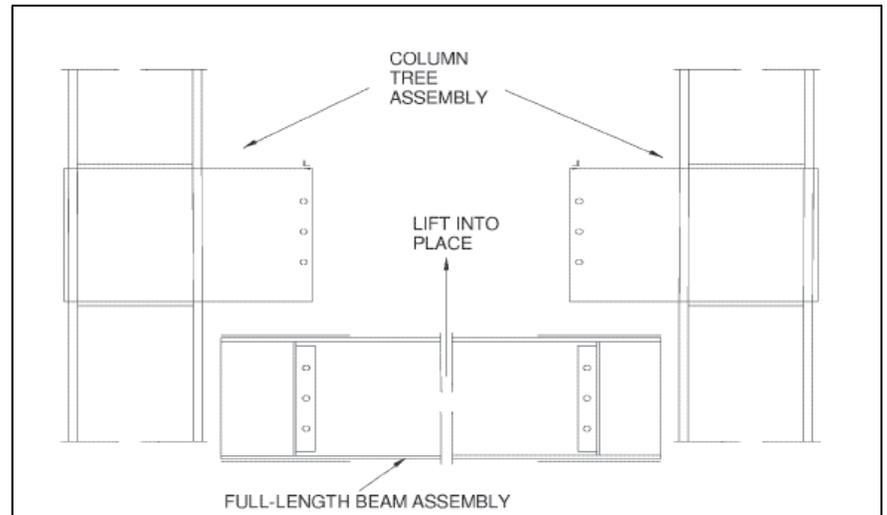
Figure 7 - Field erection method of a SidePlate Frame System. Image courtesy of Ellerbe Becket.

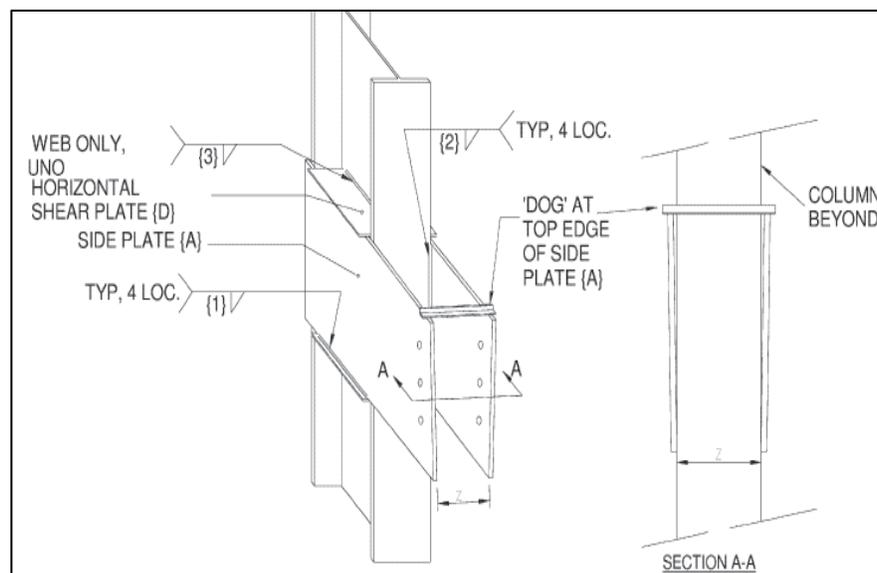
Figure 8 - 3D drawing of a Sideplate Frame System. Image courtesy of Ellerbe Becket.

Connections are prefabricated and require minor field work to bolt and weld members. The system itself is a beam-to-column moment connection. This can be a one- or two-sided connection that saves space and construction time. A shear plate is welded to the web of the column above and below the physical side plate with one on each side. The side plate itself extends beyond the column where the beam is then placed and bolted. Figure 9 is an elevation and plan view of the SidePlate Frame System.

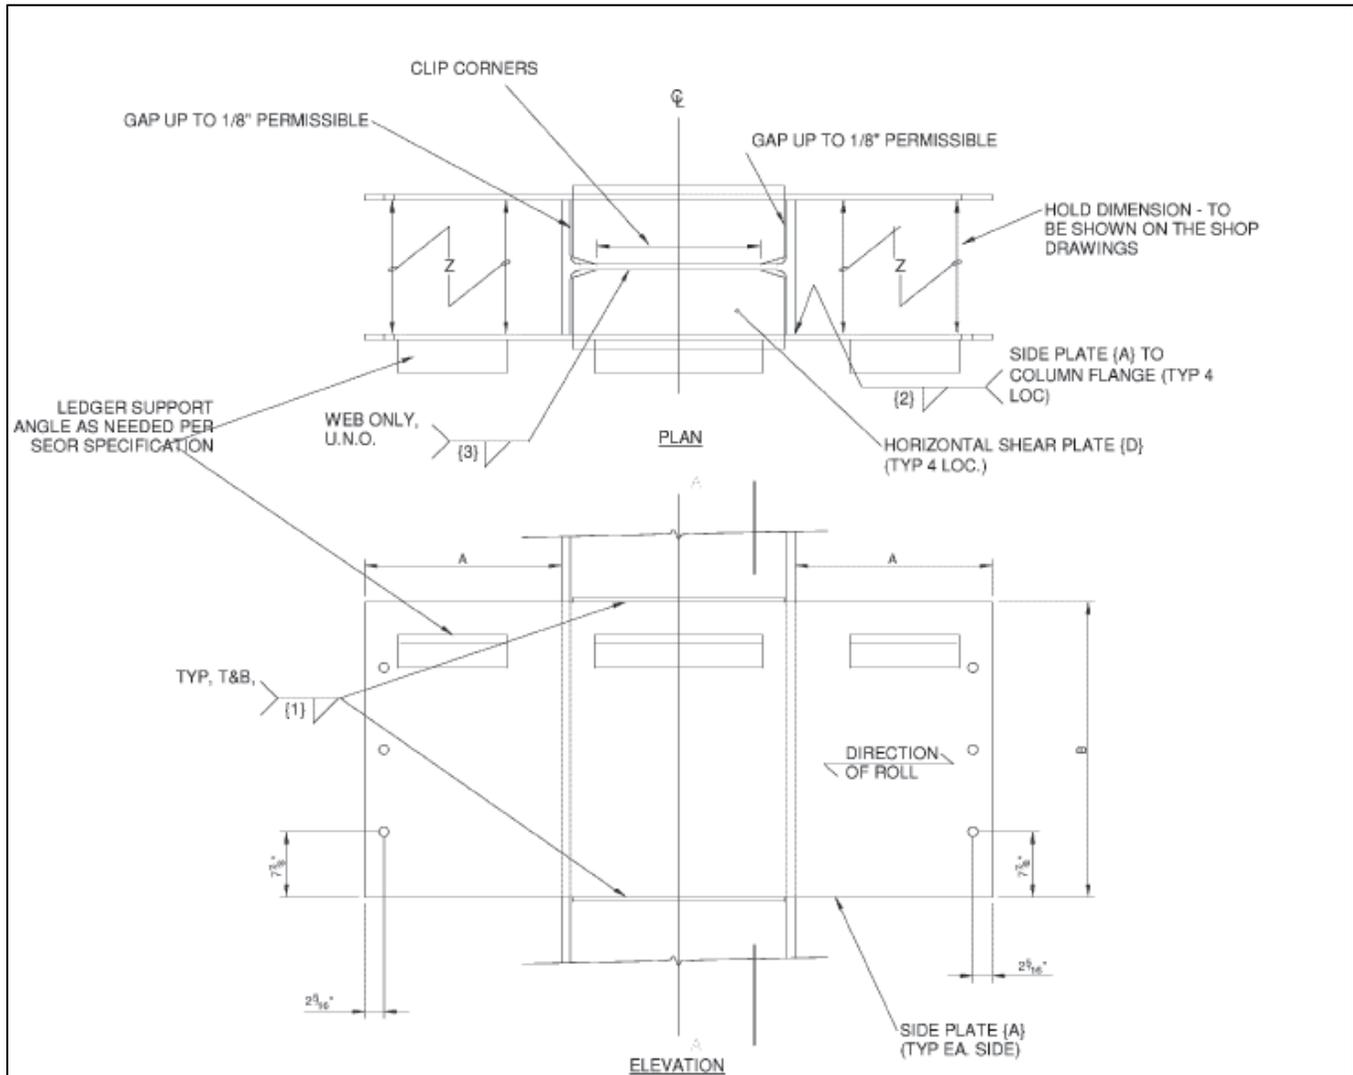
Figure 9 - Elevation and plan view of a SidePlate Frame System. Image courtesy of Ellerbe Becket.

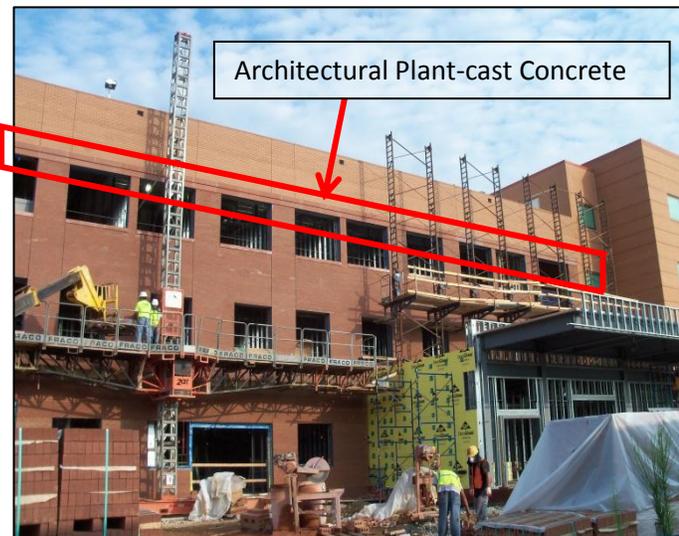
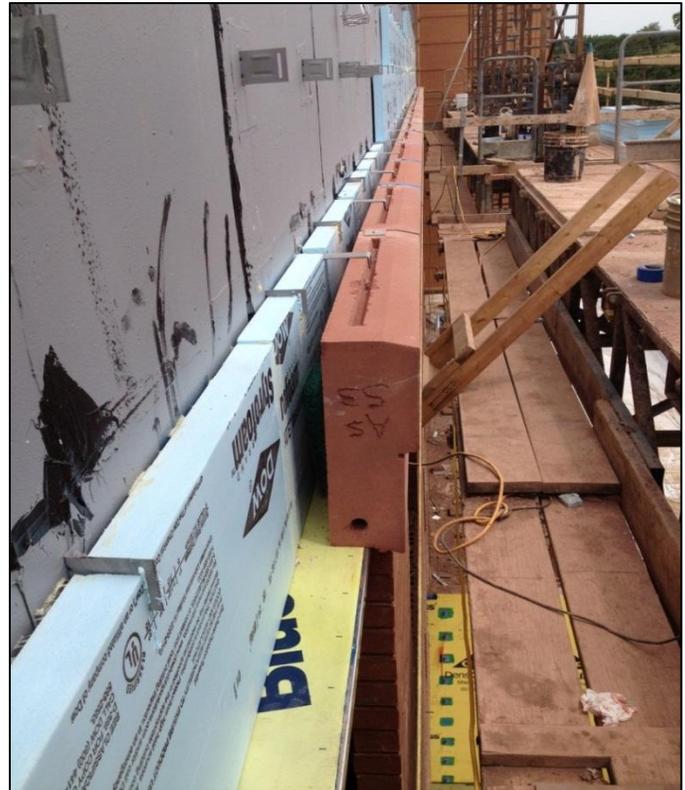
Figure 10 - Precast concrete can be seen above which make up the accent band along with east elevation. Personal photograph taken by Chris Pozza.

Use of solid precast panels with an architectural thin brick finish has been investigated with the primary intention of saving construction schedule time. Please refer to **Analysis 2** to for more details of the findings that have been discovered. Both structural and mechanical breadths can be found in the same analysis as a complete investigation was performed to determine whether an alternate system would be practical for this project.

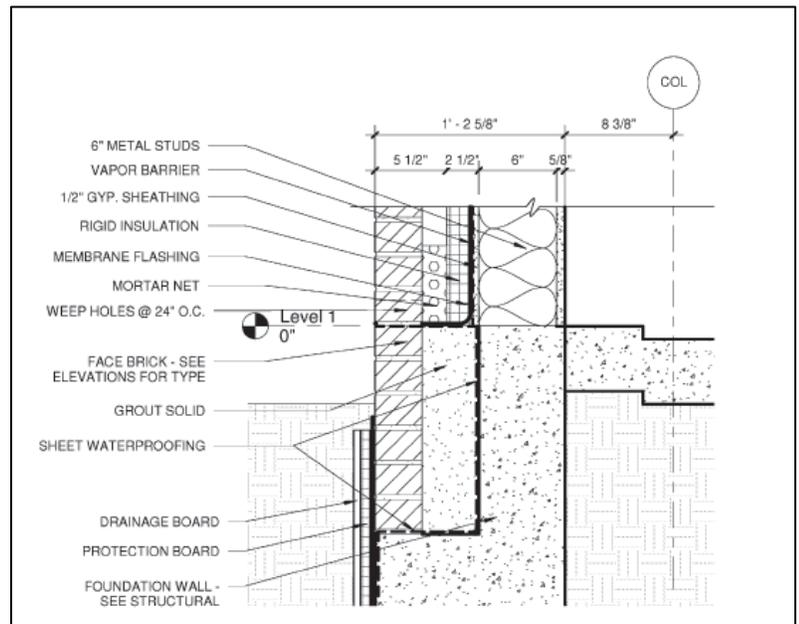
Figure 13 - Detail of exterior masonry wall at foundation. Image courtesy of Ellerbe Becket.

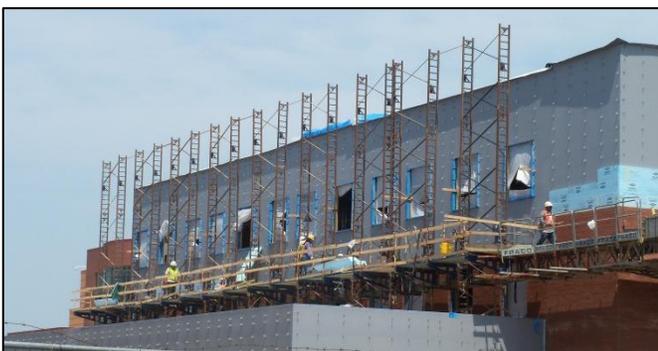
Figure 14 - View looking at southwest elevation. A MasonKing lift is required in areas where work is done above rooftops. These lifts have to be simultaneously cranked by hand on each side to be lowered or raised. Personal photograph taken by Chris Pozza.

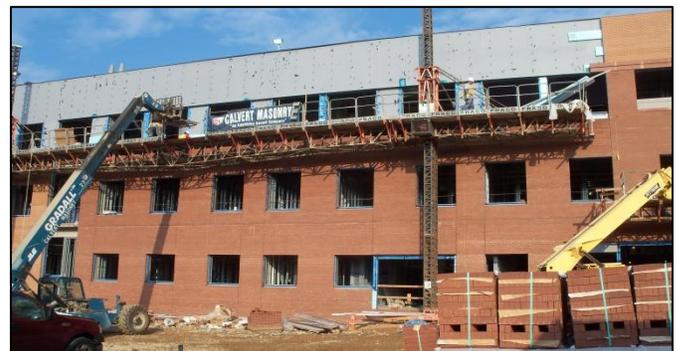
Figure 15 - View looking at east elevation. Fraco Lifts are used around the exterior to provide an efficient workflow along a large percentage of elevation at a time. Materials are lifted into place with a boom lift. Personal photograph taken by Chris Pozza.

Fraco Lifts were set up around the perimeter of areas placing brick. MasonKing lifts were required in areas where veneer work was done above rooftops, which are shown and described below in Figures 14 and 15. Several challenges were presented due to the masonry façade; therefore, use of precast panels was chosen as an analysis. See **Analysis 2** for more detail of challenges on the project.

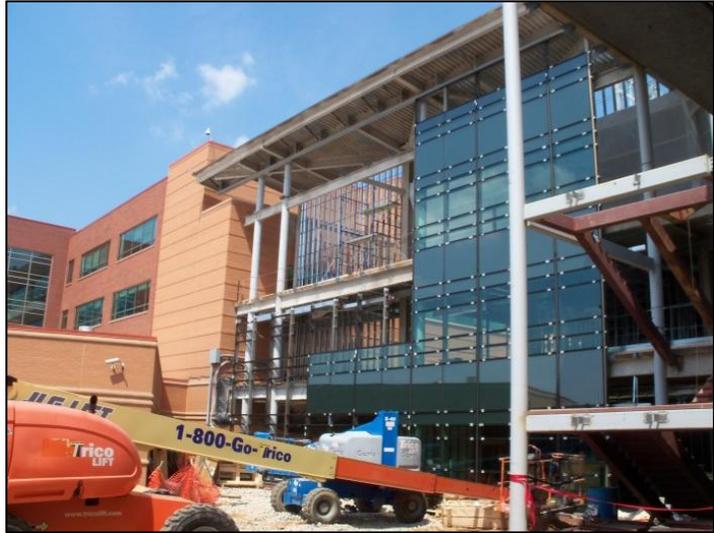
Figure 16 - View of west elevation curtain wall system under construction. The boom lift used during construction of the façade system can be seen at the bottom of the photo. Personal photograph taken by Chris Pozza.

An exterior view of glass curtain wall going in place is shown above in Figure 16. To the left, Figure 17, an interior view looking at the same area on the second floor is seen. This area is a corridor into the existing building (straight ahead) with waiting areas to the right, that will get plenty of natural daylight. Issues with building connection details and constructability were discovered during construction; therefore, that is a key area of focus for using virtual mock-ups and creating a short interval production schedule.

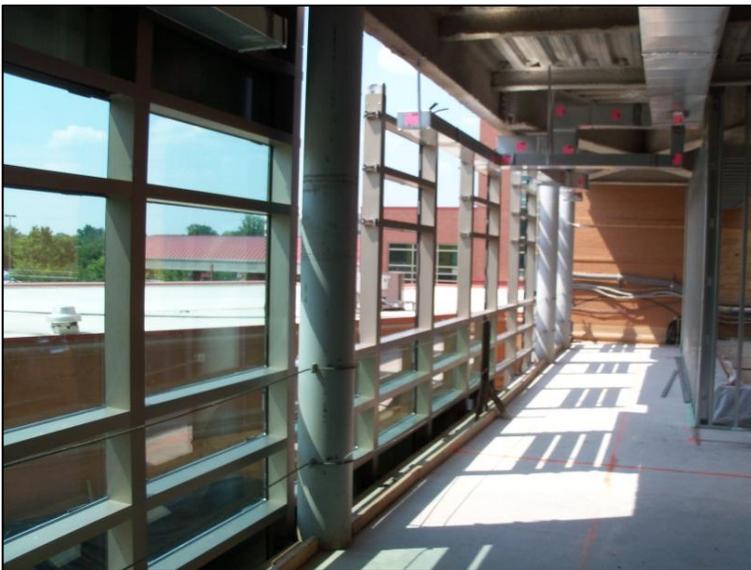
Figure 17, left – Interior view of west elevation curtain wall system under construction. Personal photograph taken by Chris Pozza.

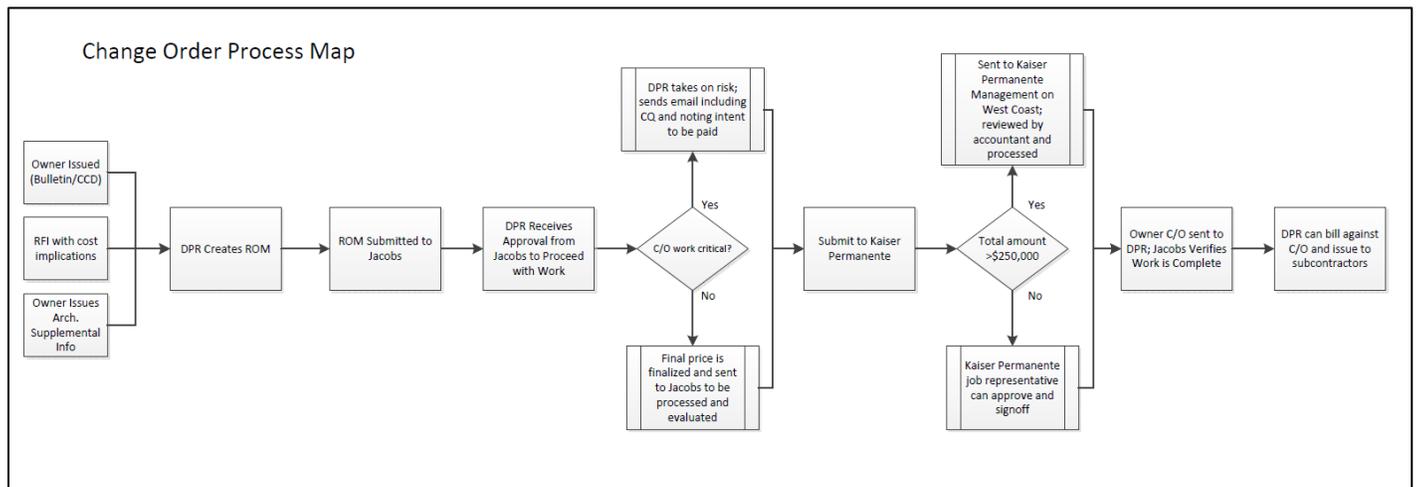
Figure 19 - Change order process summary. See Appendix C for enlarged detail. Process map created by Chris Pozza.

Before any project impacts caused by change orders could be determined, the entire process first had to be understood. A process map, Figure 19 on the following page, was created after conducting interviews with two project managers on site. Each step necessary to take place, from the time a change is established until the change order is approved and work can be billed against it, has been summarized.

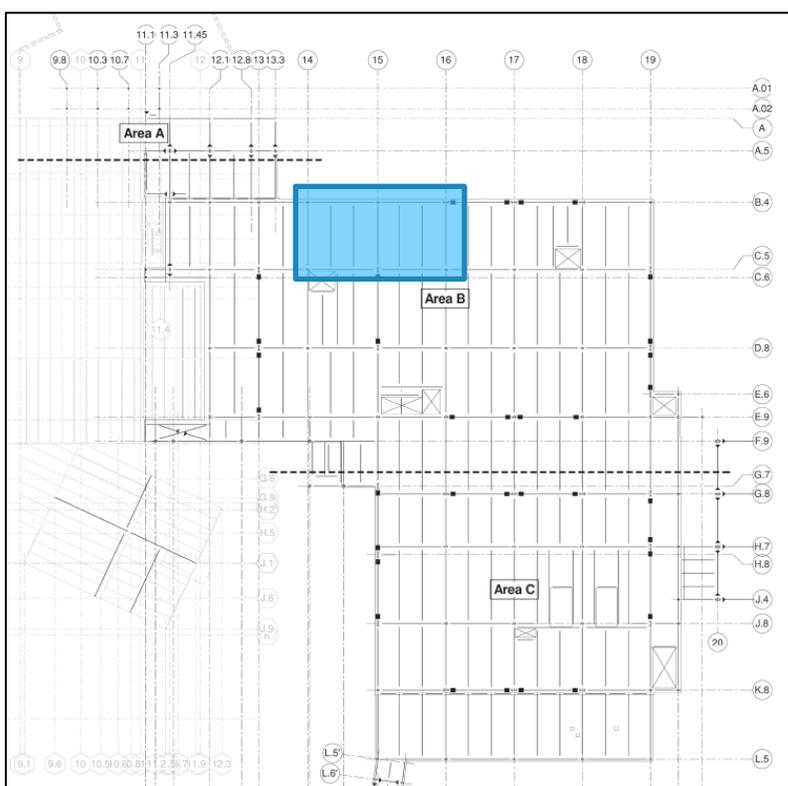
Figure 27 - Plan view of the addition's structure. The area being analyzed can be seen calling out on the east elevation, column lines 14, 15, and 16 along column B.4. Image courtesy of Ellerbe Becket.

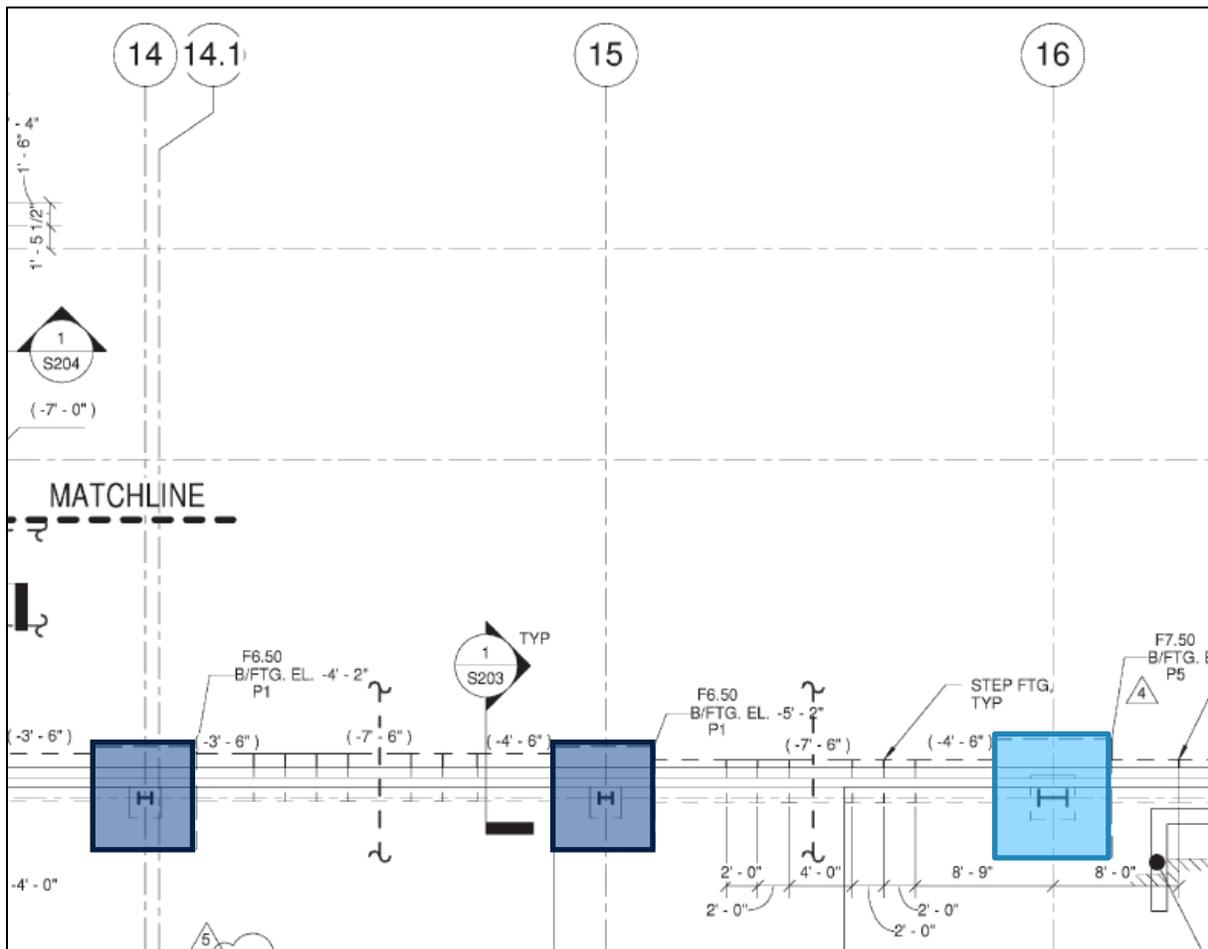
Figure 28 - W10x39 beams can be seen on column lines 14 and 15, while the W21x111 to the right on 16/B.4 is noticeably larger and requires a stronger foundation. Image courtesy of Ellerbe Becket.

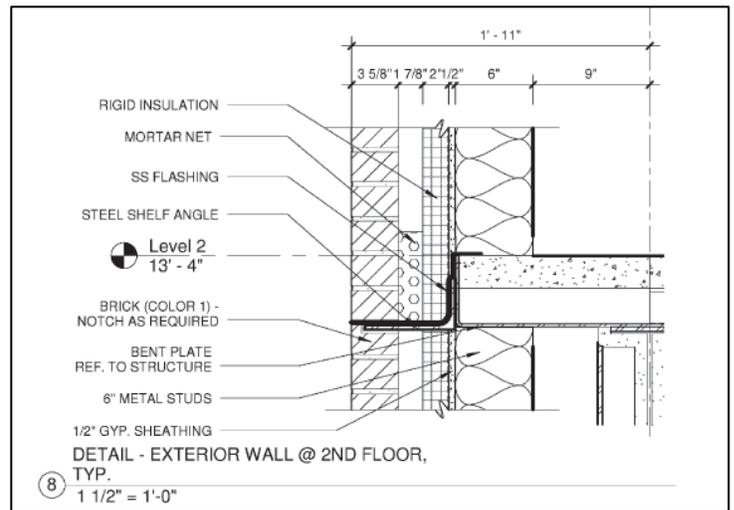
Figure 29 - Detail of the steel relief angle used. Notice the connection of the shelf angle directly connected a shelf angle and second floor level. This detail shows that little is done to prevent thermal bridging as no measures are taken to prevent energy from passing through the building’s envelope. Image courtesy of Ellerbe Beckett.

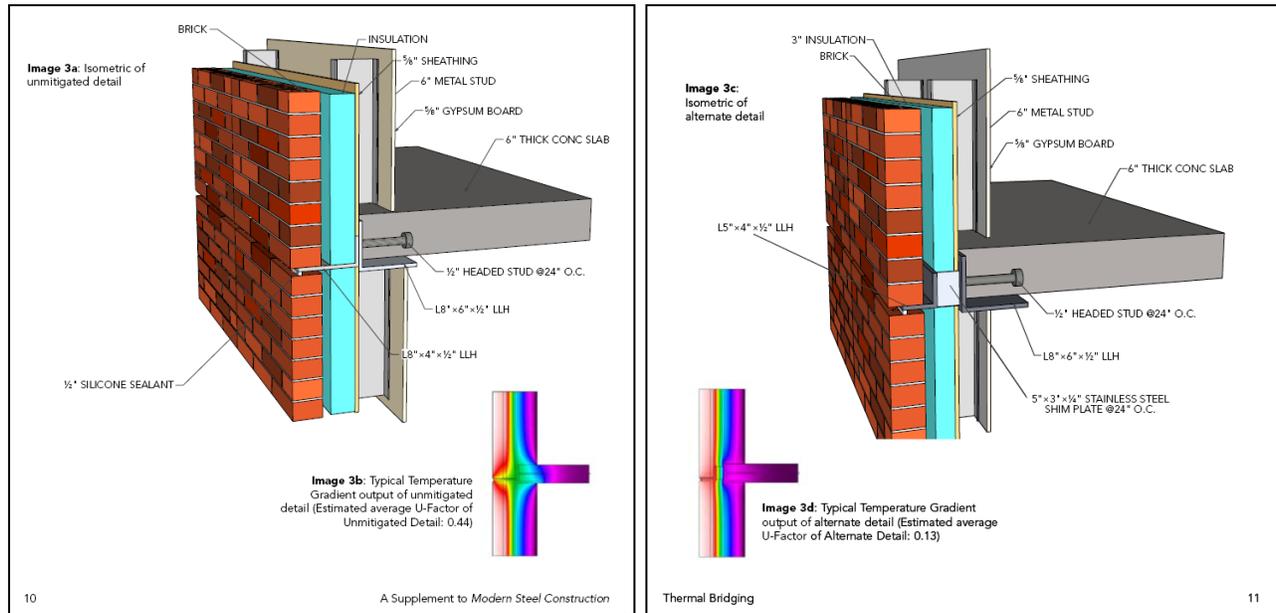
Figure 30 - Detail comparison between masonry facades using a relief angle. The right detail uses a stainless steel shim plate to reduce the U-factor by roughly 70%. Image from Modern Steel Construction.

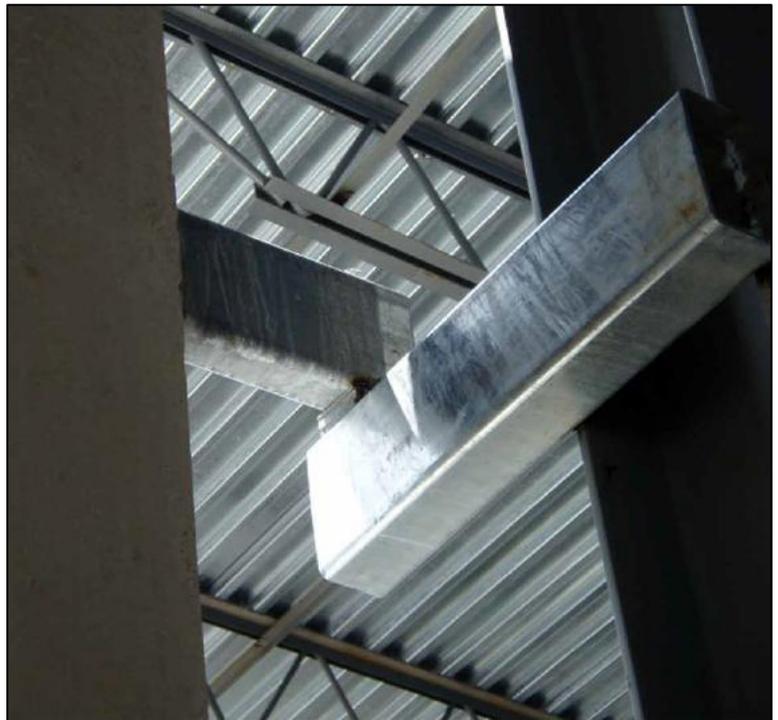
Figure 31 - Photo of a similar connection supporting a precast panel. Shims can be seen between the tub steel used, similarly to the left section, to prevent thermal bridging. Image from the NCPA Architectural Precast Connection Guide.

The first connection determined was a load-bearing column connection. It was recommended to use a detail provided by Nitterhouse, Figure 32. Two pieces of tube steel are used to support horizontal precast panels at each end of the panel. Plastic shims can be seen in the connection section and are used between both pieces of the tube steel. Although the piece of tube steel that is embedded in the precast panel will be penetrating through the exterior insulation, the shims used will effectively separate the two pieces of steel and prevent significant energy from being lost.

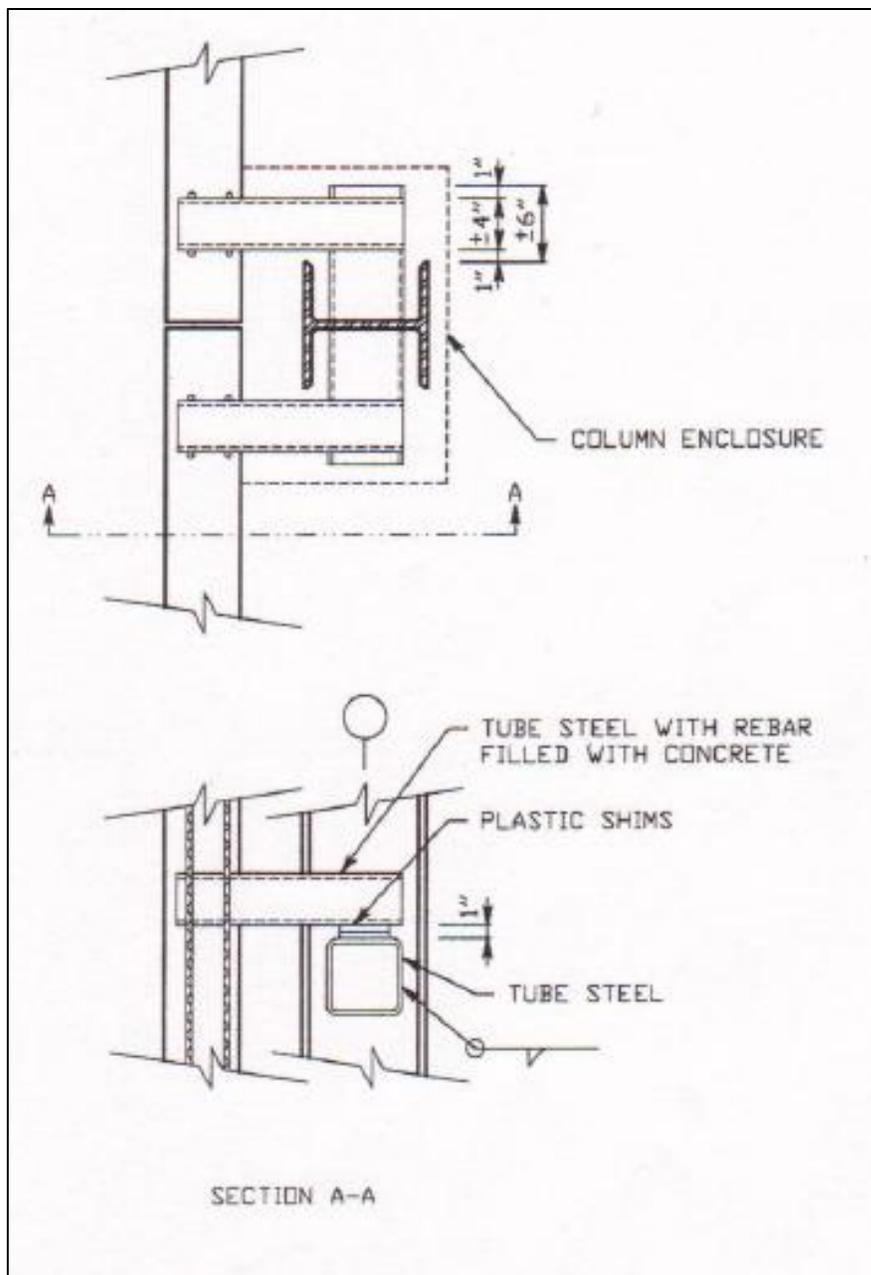
Figure 32 - Plan view and section of the load-bearing panel connections selected. Plastic shims are used between the tube steel supports which protect the system from transferring energy. Image courtesy of Nitterhouse.

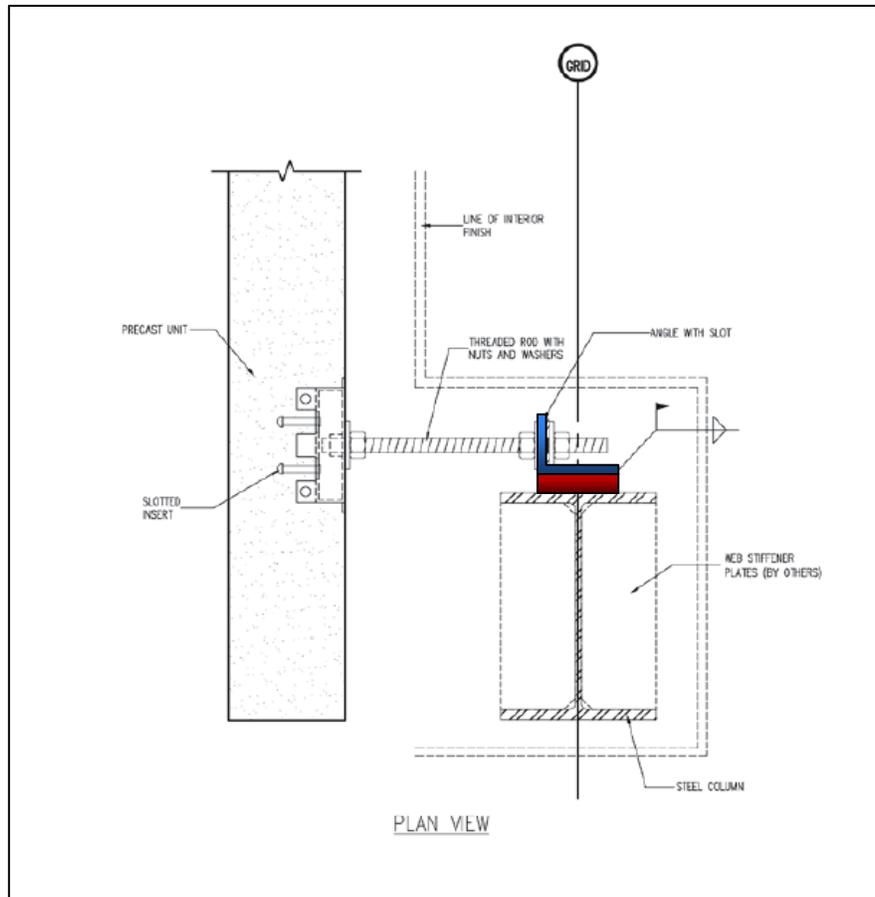
Figure 33 - Plan view of a panel tie-back connection. The red represents a shim angle used to separate the column and the steel angle, shown in blue. Image from the NCPA Architectural Precast Connection Guide.

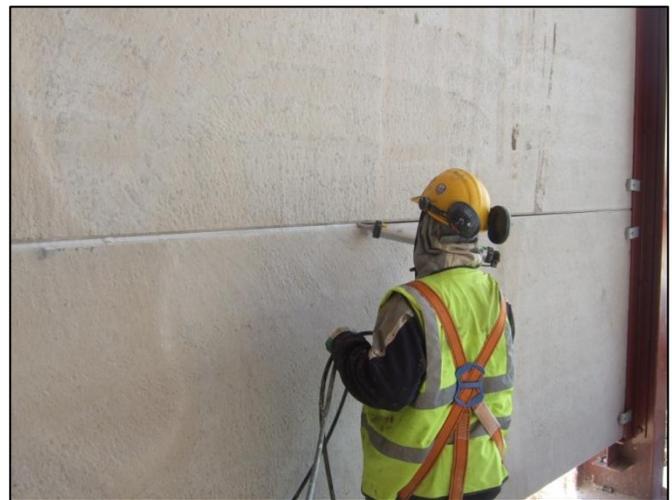
Figure 34 - Silicone sealant is necessary for application between panels for waterproofing. Image from ACP Concrete.

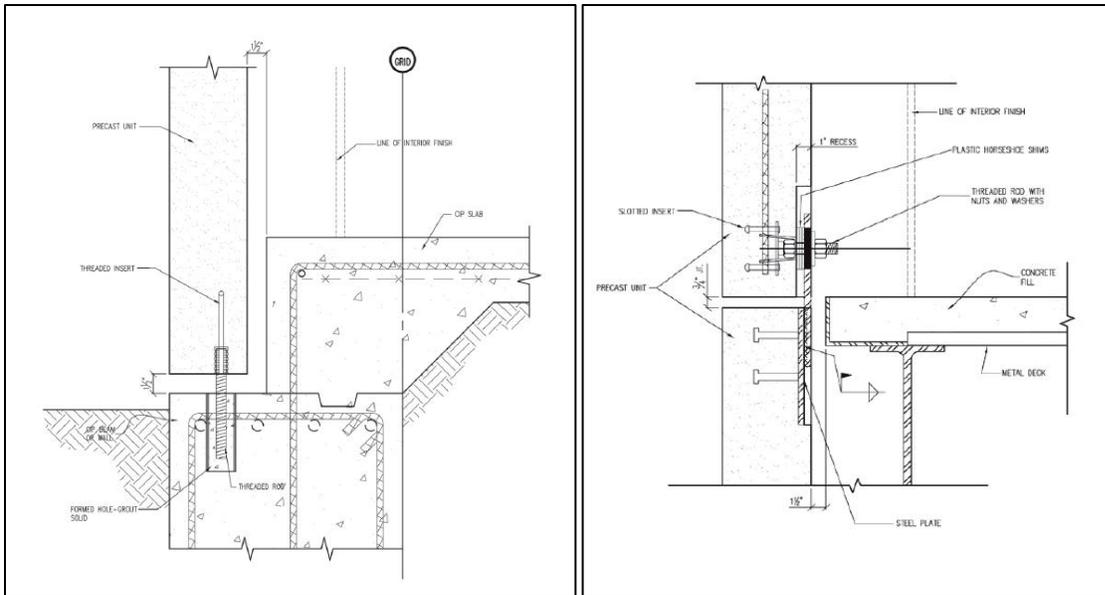
Figure 35 - Far Left: Panel-foundation connection detail and panel-to-panel connection. Image from the NCPA Architectural Precast Connection Guide.

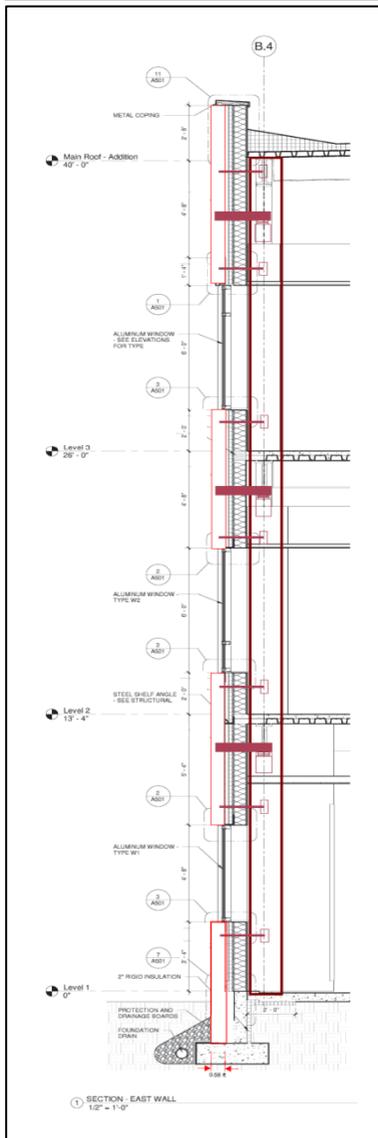
Figure 36 - A section located at column lines 15 and B.4 which has been analyzed in the structural analysis. Connections based off of Figures 32 and 33 are represented in their approximate locations. Each penetration is larger than brick tie-backs, but much less numerous. Each connection requires the use of plastic or stainless steel shims, while the connections between panels and openings require silicone sealant. These two systems should adequately prevent the passing of air and moisture, greatly reducing the potential for thermal bridging to occur.

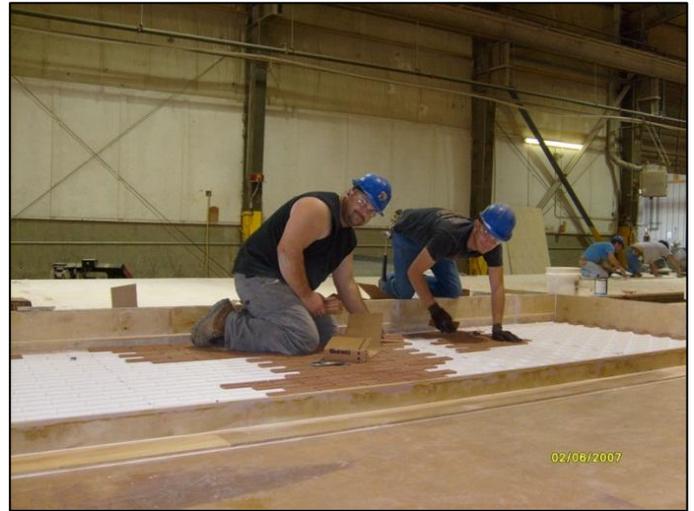
Figure 37 - Workers are able to fabricate panels comfortably in a controlled environment; increasing quality and productivity. Image taken from Gate Precast.

One of the biggest benefits listed in Table 7 is the working conditions which panels are fabricated. Being fabricated in a controlled environment allows for much safer and comfortable working conditions. The flexibility of design is another strong advantage which can be seen in Figure 37. As discussed in the Structural Breadth, a wide variety of panels is necessary to accommodate the varying bay widths and heights. A wide range of façade materials can be used with precast panels and windows can be framed out relatively easy; therefore, most shapes can be created to accommodate numerous design needs. Once formwork is constructed, architectural thin brick is placed within the forms. The biggest challenge is determining the most cost efficient design as it is not a perfect practice and does not always provide an obvious layout, this project being a prime example.

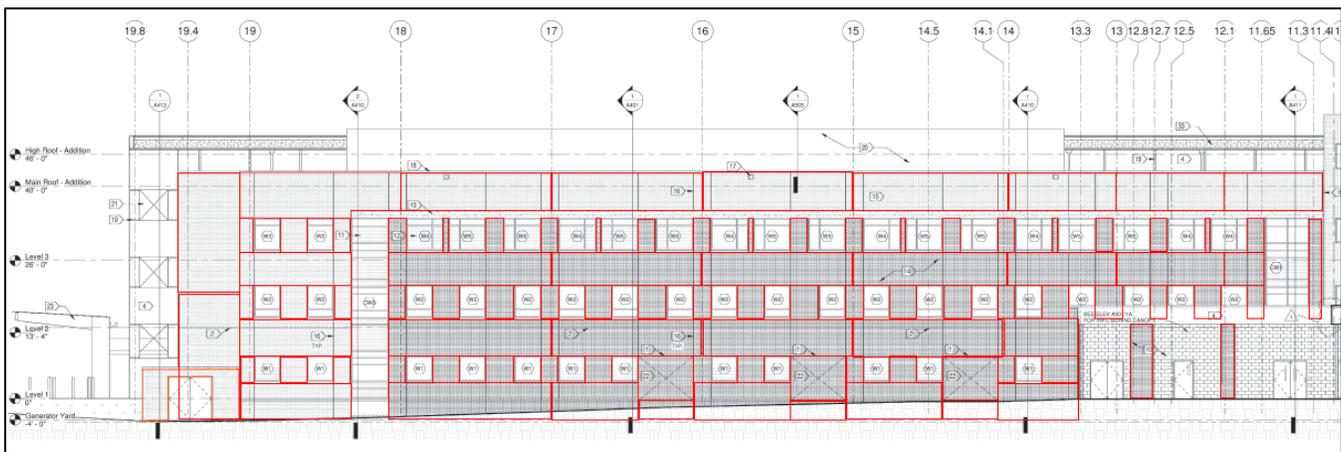
Figure 38 - Original design of precast panels using all horizontal panels. This image is the east elevation broken into different panels. Image courtesy of Ellerbe Beckett and edited by Chris Pozza.

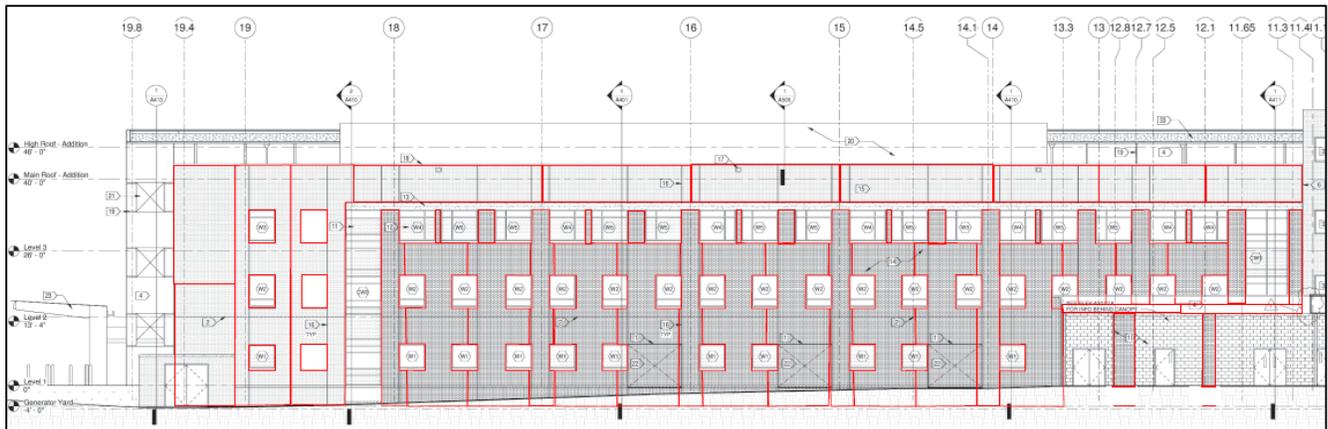
Figure 39, East Elevation - It can be seen that a combination of horizontal and vertical panels are used.

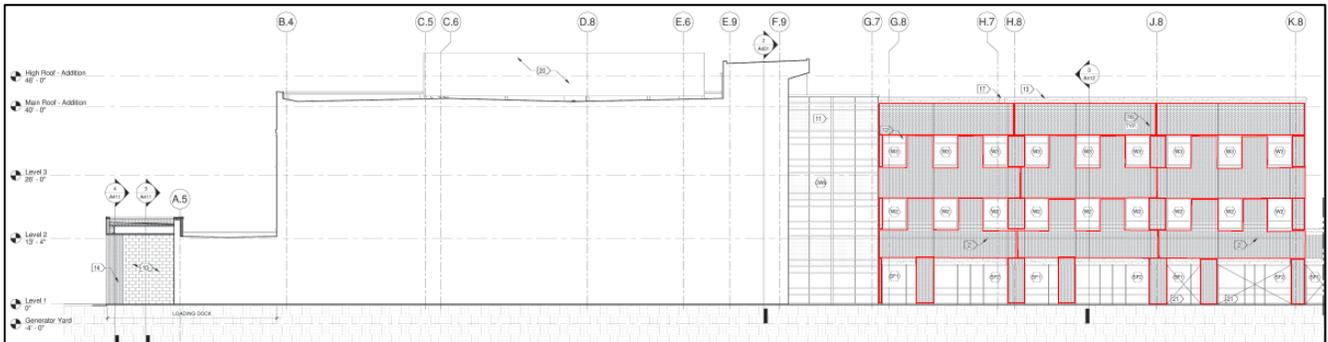
Figure 40, North Elevation – Storefront windows on the first floor do not permit use of vertical panels.

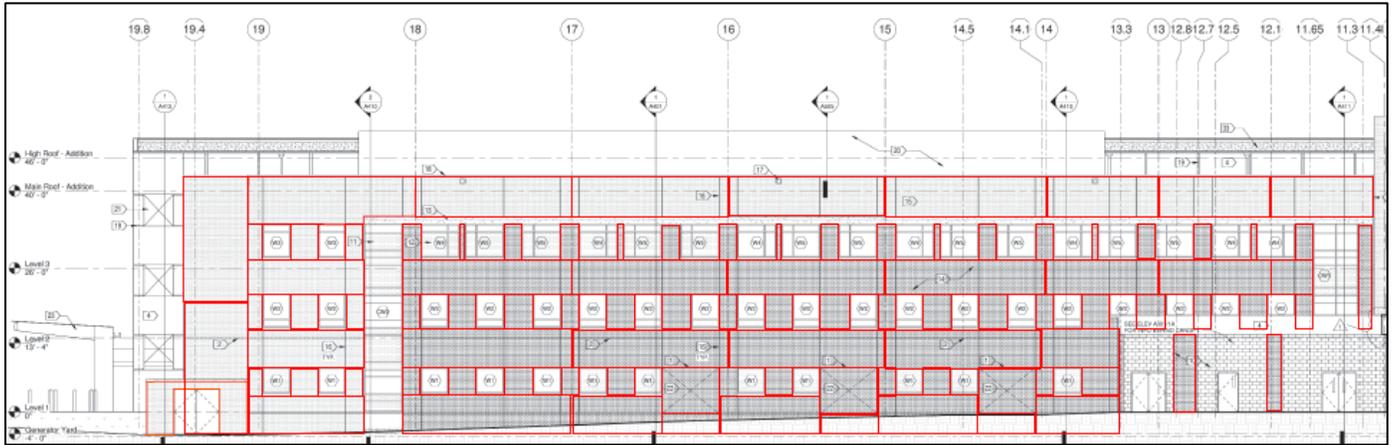
Figure 43, East elevation - Design using all horizontal panels.

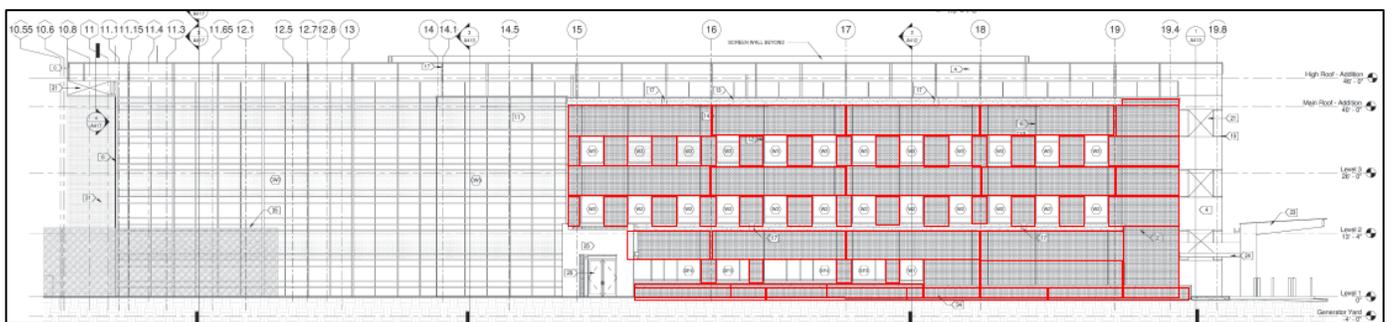
Figure 44, West elevation - The first floor pharmacy did not permit use of vertical panels on this facade.

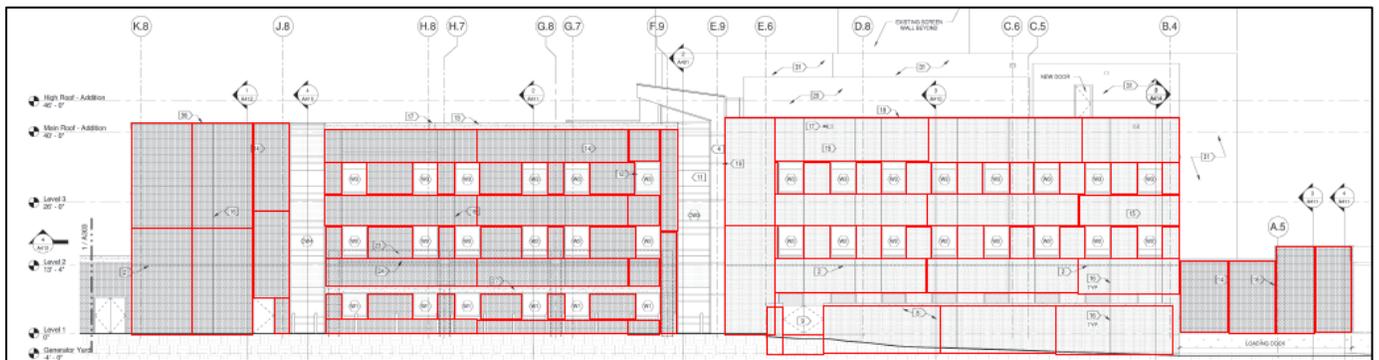
Figure 45, South elevation - The generator yard and loading dock can be seen in the lower right of the image.

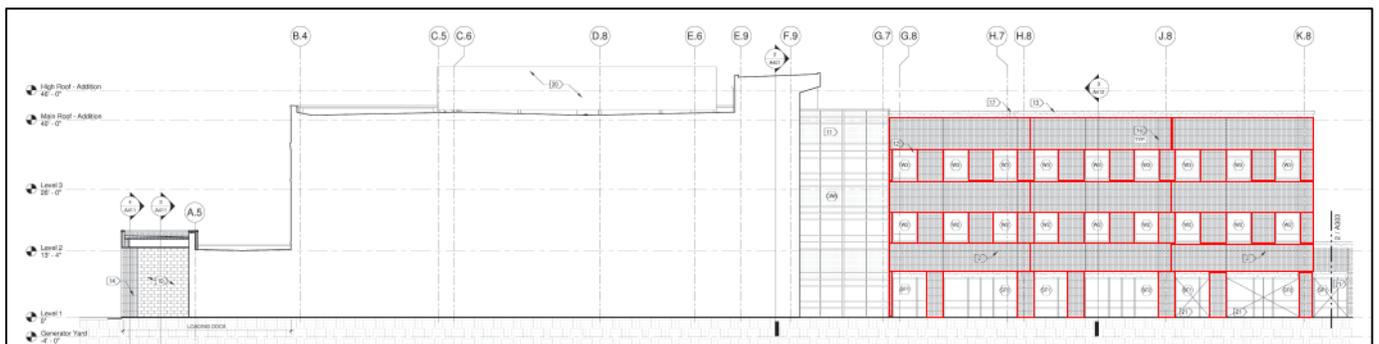
Figure 46, North elevation - Storefront windows on the first floor did not permit use of vertical panels on this facade.

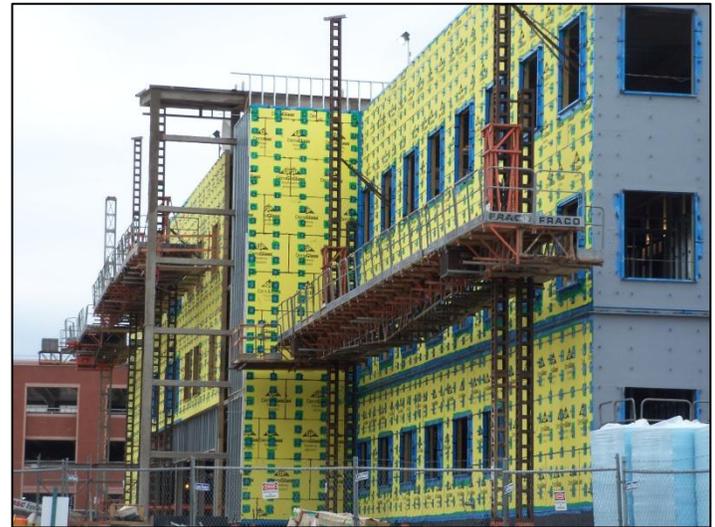
Figure 47 - View looking at the corner of the south and east façade. DensGlass can be seen in yellow, with each individual brick tie having Blueskin applied. This is a necessary step before the air and vapor barrier can be applied. Personal photograph taken by Chris Pozza.

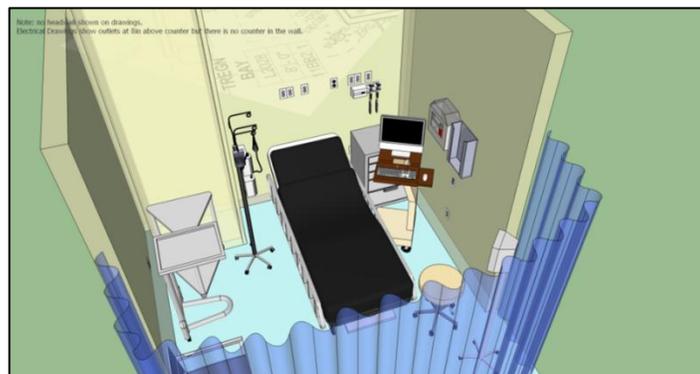
Figure 49 - Mock-up of a patient room for Tyson's Corner. A mistake found here was that electrical drawings specified outlets were to be placed 8" above the counter, but no counter exists in this room. Image courtesy of Shane Goodman.

DPR has worked with KP previously. One location is Tyson’s Corner, Virginia, where renovation of an existing office building was converted to a medical office building and outpatient service facility. Virtual mock-ups were created to be reviewed by the end users. It was estimated to cost about \$7,500 for the BIM Champion to model 32 rooms. Stemming from the mock-ups were 110 individual changes costing roughly \$38,000. Subcontractors were not released to price and proceed until three months after the reviews took place. Another interesting fact was that the changes took a long time to be approved. In correlation, finished rooms had to be changed and mock-ups weren’t practical for contractors putting the work in place (Goodman).

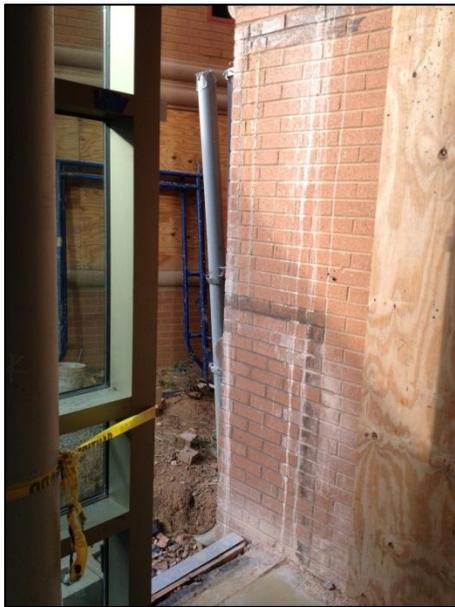
Figure 50 - Far Left - Corner of the existing building before aluminum curtain wall tied into it. Also, a board can be seen covering the opening of where the new doorframe will be placed. Personal photograph taken by Chris Pozza. Right image - Detail of the original tie-in connection. Detail courtesy of Ellerbe Becket.

A similar penetration on exists on all three floors in this location. The original detail created can be seen above in Figure 50. This area has been analyzed in more detail and will be discussed in the Implementation & Schedule section.

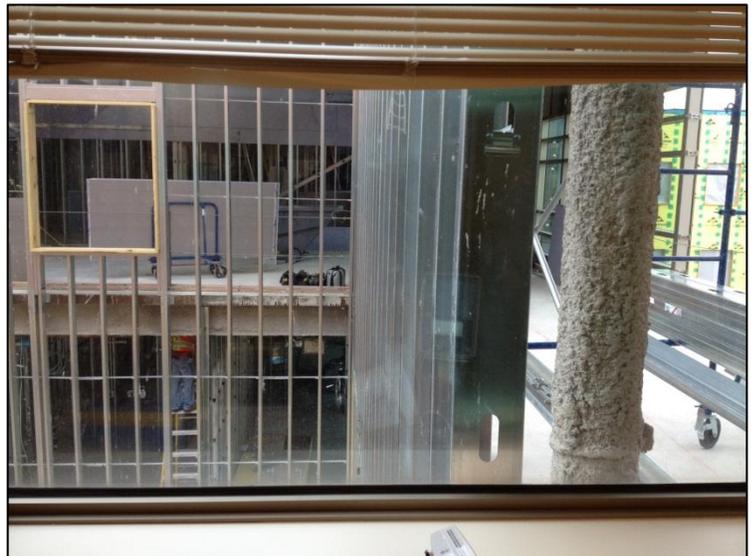
Figure 51 - 3rd floor window that was required to be removed and replaced with a smaller window and filled with brick for the addition to be able to tie. Work was performed off hours to limit the impact of building occupants. Photo taken from inside the existing building looking south at the addition. Taken by Chris Pozza.

Plans specified that the window seen in Figure 51 was to remain in place, although this is not possible as the addition ties into the building at this location. Coordination was necessary to try completing this work on premium time to avoid impacting this room’s occupants at any time throughout construction.
