Kaiser Permanente Largo Medical Office Building – Largo, MD

Final Thesis Report
April 3, 2013
Advisor – Rob Leicht

Kaiser Permanente Largo Medical Office Building

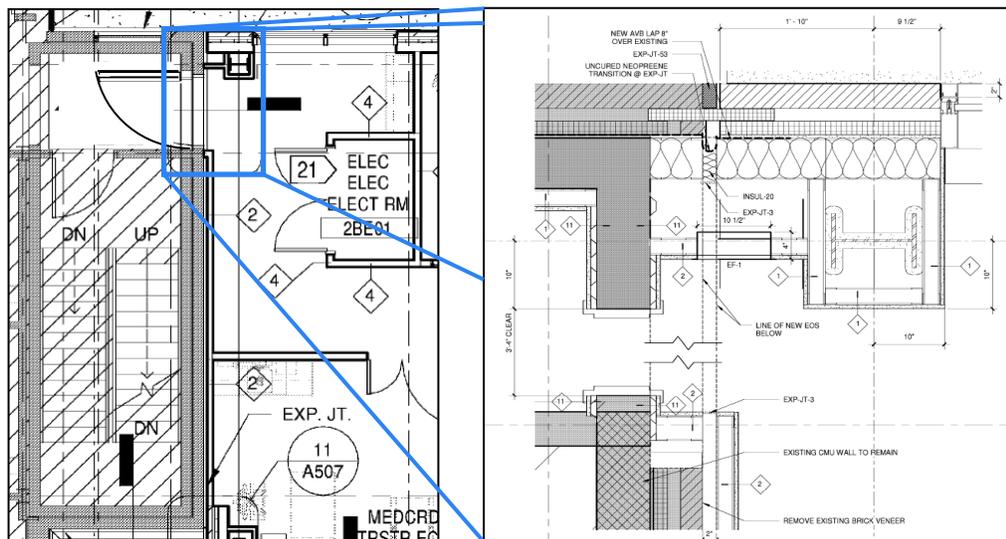
Figure 52, *Far Left* - Partial image of the second floor connection tying the addition to the existing stairwell. The diagonal hatching represents areas of the existing building not to be affected during construction. *Right* - Detail of the wall penetration which occurs on the second and third floor, as well as a final penetration providing access to the addition's roof. Images courtesy of Ellerbe Becket.

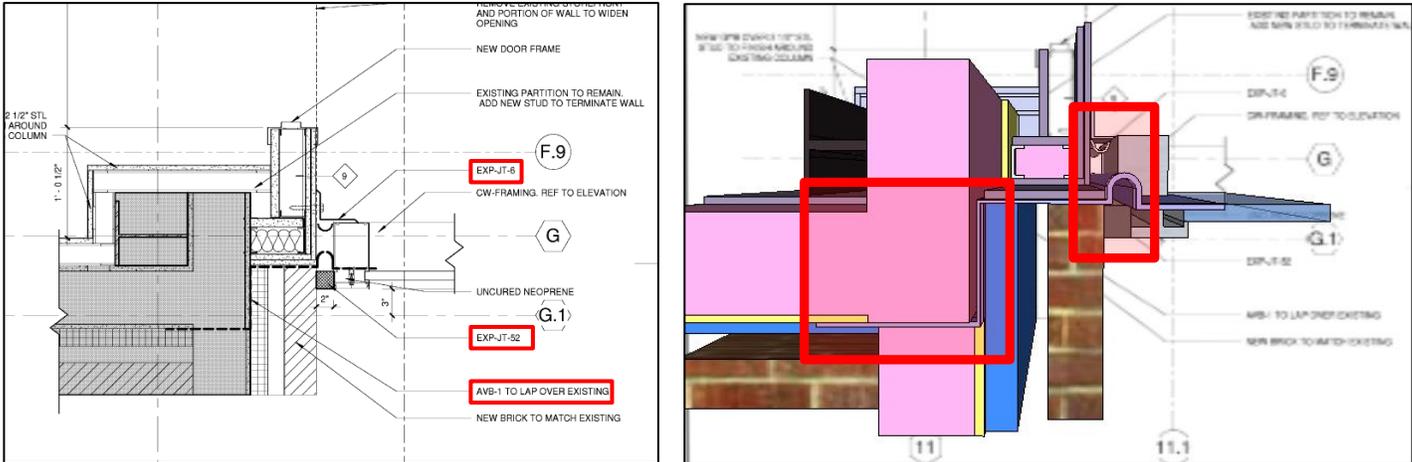
Figure 54, *Left* - Original detail for the addition tie-in to the existing structure. The three main concerns with this detail are highlighted in red; the two expansion joints and air/vapor barrier. *Right* - Plan view of the same detail created in Google SketchUp. It is much easier to see the challenges with this detail, especially with overlapping the air/vapor barrier on the existing exterior sheathing and beneath the rigid insulation.

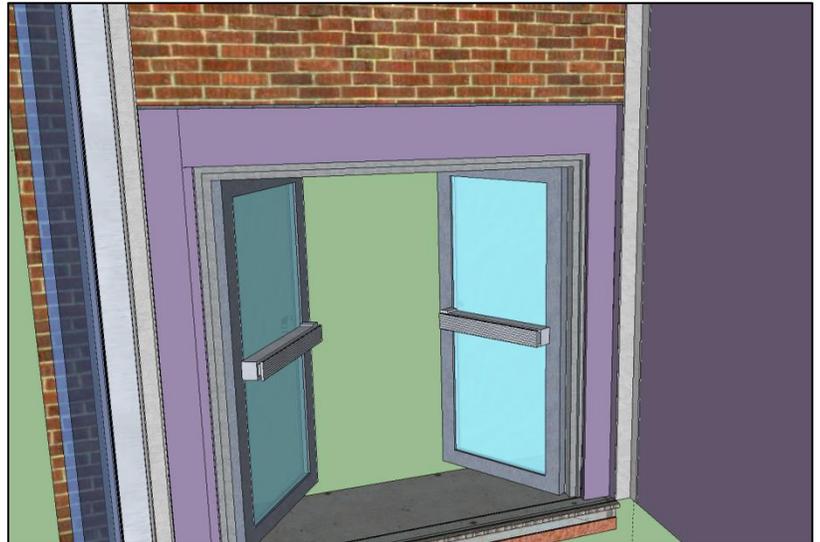
Figure 55 - SketchUp view of the proposed doorframe in place providing a means of egress to and from the existing building. Model created by Chris Pozza.

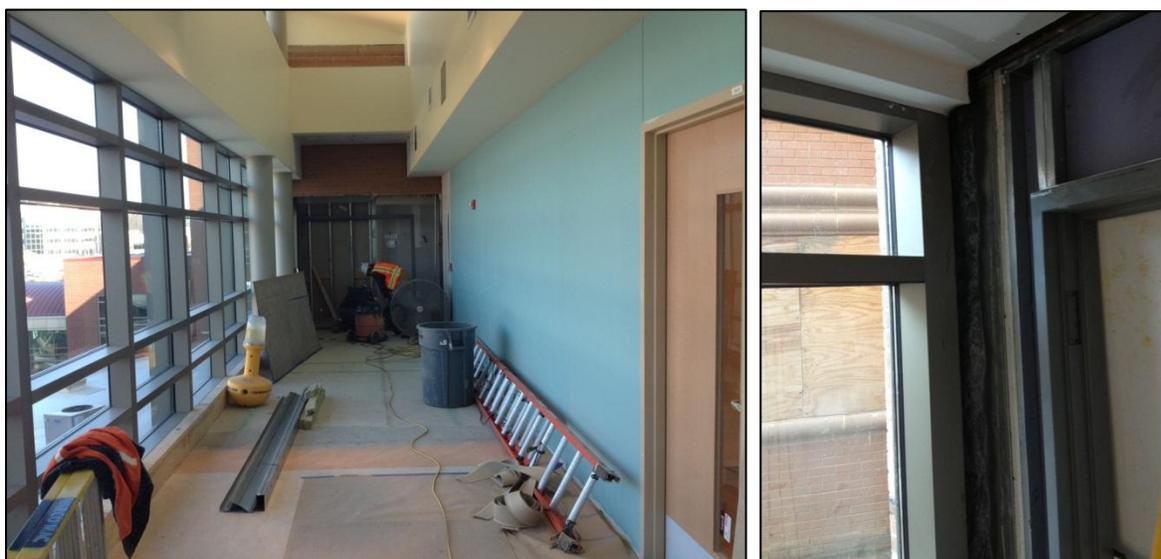
Figure 57, Left - Laborers working on the expansion joint between the floor slabs of the existing floor slab and addition. Issues required this scope of work to take much longer than anticipated due to the slabs not lining up as intended. **Right** - Building connection between the addition's aluminum curtain wall and existing building. Framing and a door frame can be seen already in place.

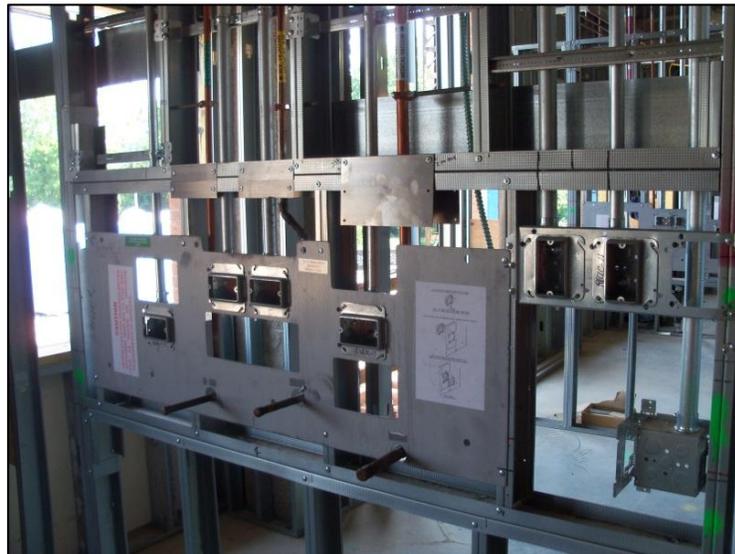
Figure 61 - Headwall template can be seen in place with medical gas and conduit rough-ins. Personal photograph taken by Chris Pozza.

Each headwall used on the project is shipped with its own specific template to be used during construction before drywall is installed, as seen in Figure 61. Prior to installing the template, stud walls need to be built and framed to house and support the headwall unit. The template shown here spans three spaces between studs, but the actual headwall extends well past this width to be either 96" or 102" wide.

Medical air, vacuum, and oxygen pipes can be seen in Figure 61. Each pipe needs to protrude several inches beyond the template and be capped for pressure testing. Once the pressure tests take place, each pipe needs to be measured and cut to specific lengths that are indicated on the template. After all rough-ins are complete and all dimensions are adjusted and correct, the modular unit can be installed when drywall is hung and painting is complete.

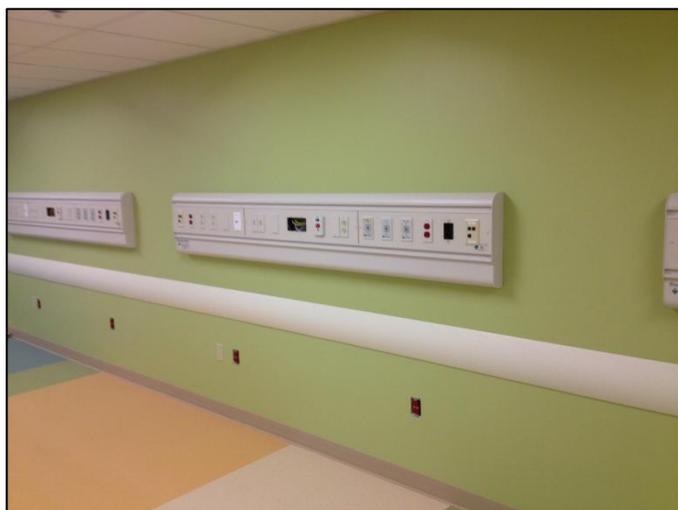
Figure 62 - Modular headwall units used on the project. This image was taken on the third floor of the KP Medical Office Building. Personal photograph taken by Chris Pozza.

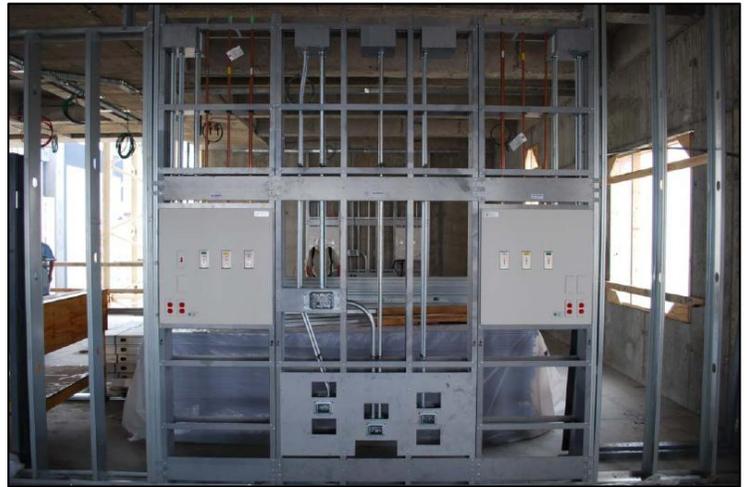
Figure 63 - Proposed headwall module. The entire unit consists of piping, conduit, wiring, framing, and other necessary components. Connections are made above the finished ceiling for a convenient means of installation as no vertical drops are necessary to be roughed in. Image from Modular Services.

An image of the proposed modules can be seen in Figure 63. Notice junction boxes and medical gases are already installed to the top of the unit, even though no conduit or piping can be seen anywhere else in the photograph. This provides for significant labor savings opportunities and quality is guaranteed due to prefabricating the panels off site in a controlled environment.
