Kaiser Permanente Largo Medical Office Building – Largo, MD

Technical Assignment 3

November 12, 2012

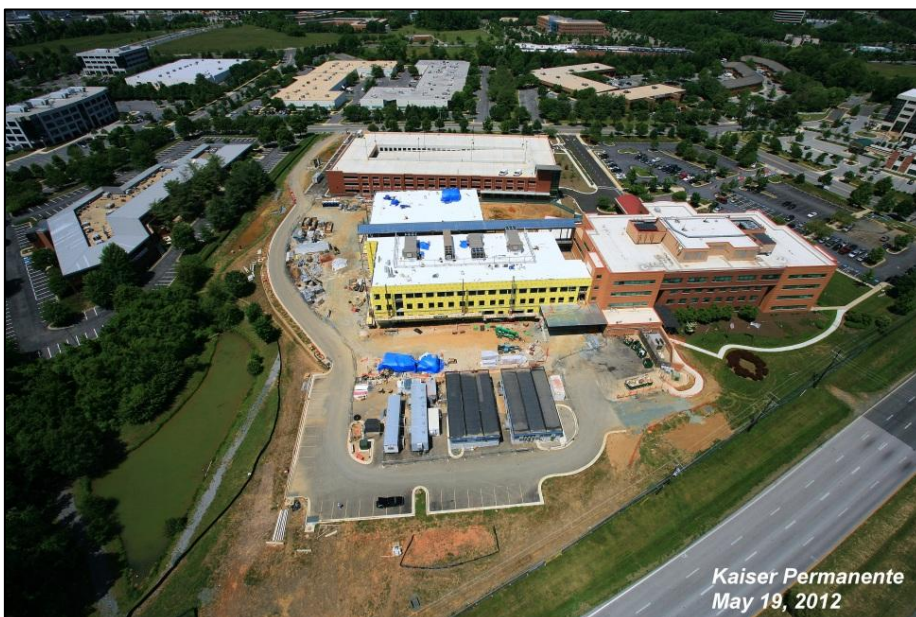
Figure 1 - The stormwater management pond protection can be seen in the lower left of the image. This area has been protected throughout construction and the pond will be completely restored upon completion of the project. Image courtesy of DPR Construction.

Credit 5.1 and 5.2 are both addressed as the stormwater management pond (SWM) will be protected during construction and restored fully after completion. This pond and its protection can be seen to the right in Figure 1. The

black fencing put in place cuts off access to this area and prevents any debris from falling down the bank and into the pond. Stormwater design has been taken into account as there are several bio-retention areas located on site, but whether or not related credit requirements will be achieved is undetermined.

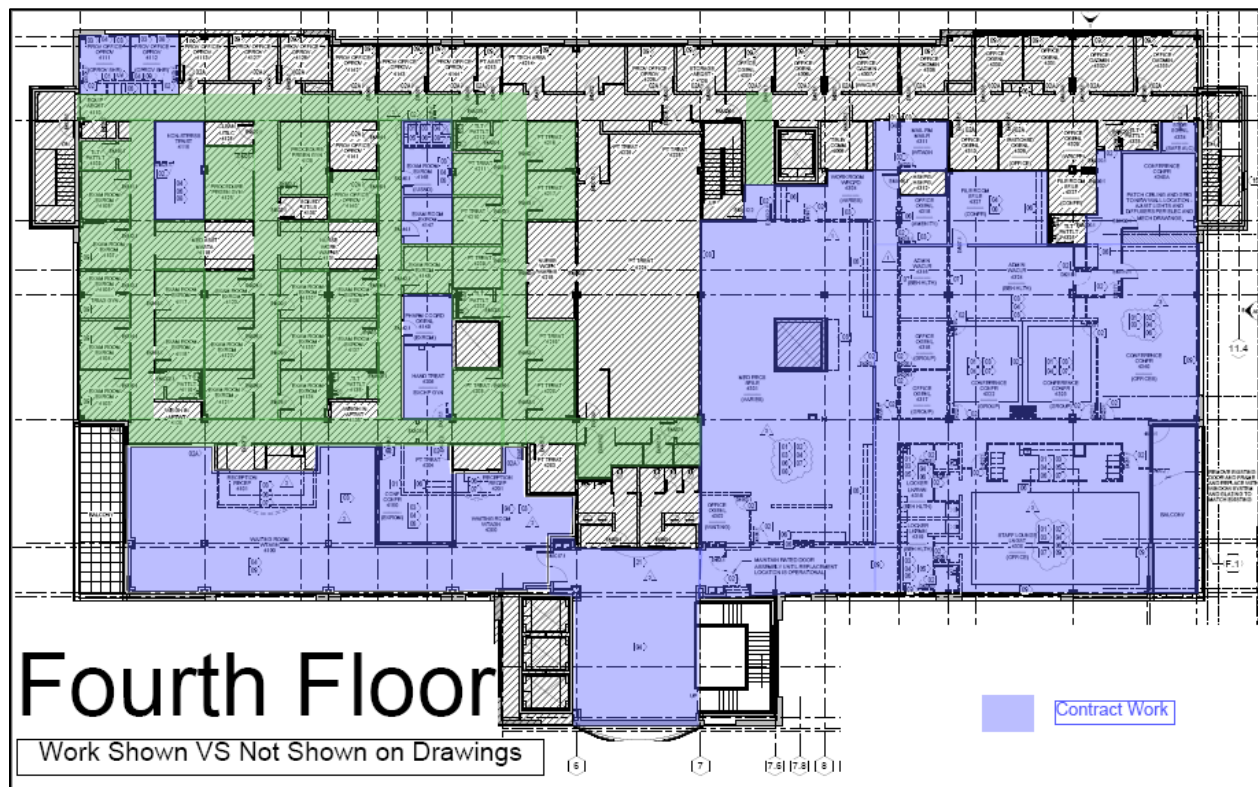
Figure 2 - Image of the existing building's fourth floor. Renovation areas in purple represent work to be done included in the original contract. Green areas represent spaces where work has been deemed necessary, but are not included in the original contract scope and are subject to change possibly altering the Materials & Reuse section of the LEED evaluation drastically.

Building Reuse, Material Reuse, and Recycled Content were the most difficult items to determine. For the renovation, it is best assumed that there are at least 75% of the existing walls, floors, and roof that will be maintained; therefore, credit 1.1 is achieved. It is also estimated that reuse of 50% of interior non-structural elements are going to remain in place. These credits are subject to change, however, as there are major scope amends expected for the renovation. Figure 2 is a prime example why Materials & Resources are difficult credits to determine. In the image below, the color purple represents areas where contract work is specified. Renovation areas highlighted green are places where work has been determined necessary, but are not included in the original scope. Renovation was expected to affect roughly a third of the 129,000 SF existing building, however that is expected to significantly increase.

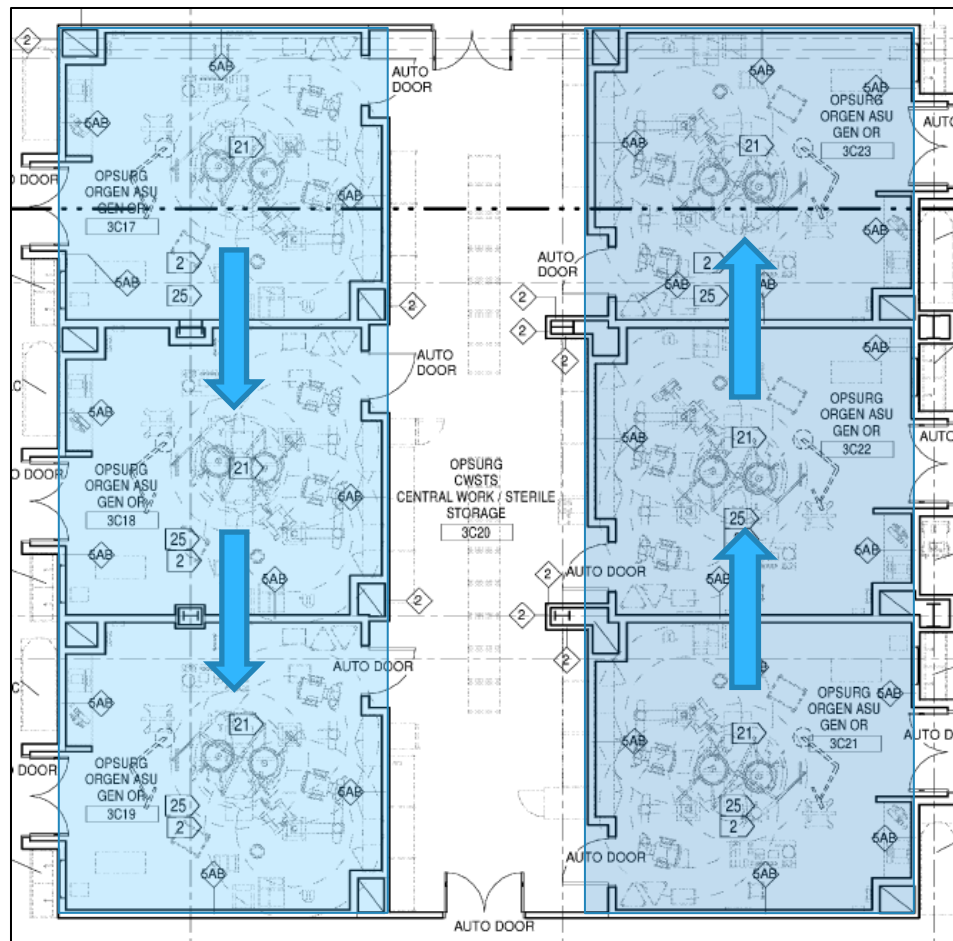
Figure 4 - Operating rooms on the third floor of Area C. It can be seen two colors represent separate crews have been established in order to save time and improve efficiency of work in this critical area. Image courtesy of Ellerbe Becket.

One of the biggest risks currently on the critical path includes the ConMed conduit and operating rooms (OR's). 2" ConMed conduit is used throughout each of the six major operating rooms on the third floor of Area C, shown in Figure 4. Each surgical room has roughly 20 outlets requiring this 2" conduit. ConMed conduit is necessary for the communication system. Systems are closely monitored by the nursing staff during surgeries and can be checked at nurse stations in this area of the building. A major issue putting the schedule at risk is the lack of detailed responses to past requests for information (RFI's). Due to insufficient coordination information involving the ConMed conduit details, rough-ins are behind schedule because outlet locations are not detailed or coordinated with other systems.

Plenty of other work is required in these OR rooms. Because they're on the critical path and each room requires such a large amount of work, the decision has been made to change from having one crew in these rooms to having two separate crews as shown in Figure 4. Time to complete the OR rooms is expected to be half of what was originally anticipated.

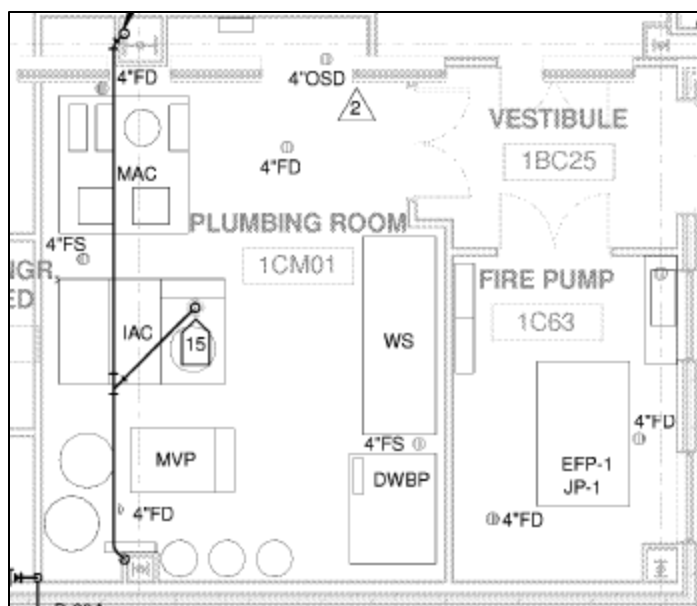
Figure 5 - Mechanical and plumbing room located in the southwest corner of the building in Area C. These spaces have been laid out slightly different than on the drawing shown above, due to the necessary space requirements between equipment. The exact savings cannot be known for sure, but eliminating the need of a change order, rework, and lost time was agreed to be saved by both DPR and the subcontractor. Image courtesy of Ellerbe Becket.

Another value engineering decision made by the project team was to change the layout of the mechanical and fire pump rooms, seen in Figure 5. These rooms are located in the southwest of Area C on the first floor. Specific spacing is required between different pieces of equipment, which is not adequate as shown on these drawings. With this layout, both rooms would have to have an increase in square footage. Adjustments were made as necessary between the general contractor and subcontractor. This required some extra time, but no extra cost and was a definite benefit to the project. Instead of stopping work in these rooms, a logical solution to relocate equipment was found that didn't require the stagnant time that is typically associated with design questions, redesigning, and change orders. All spacing requirements were met and maintenance access is easier than it would have been if laid out as shown in Figure 5, while no walls needed to be moved to provide extra space.

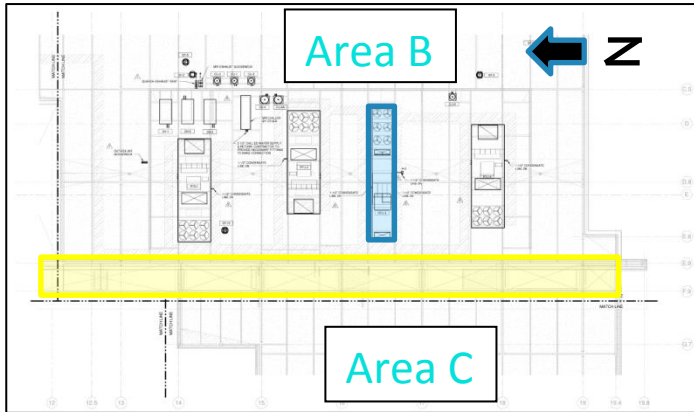
Figure 6 - Roof plan of Area B showing each of the building's rooftop mechanical units. Highlighted in blue is RTU-3, which serves only the third floor operating rooms in Area C, requiring mechanical ductwork to cross a clerestory space, highlighted yellow, separating Area B and Area C. Image courtesy of Ellerbe Becket.

An example of value engineering that was desired, but not implemented, can be seen in Figure 6. Rooftop Unit 3 (RTU-3) was brought to the project team's attention by the mechanical engineer. RTU-3 serves only the operating rooms (OR's) on the third floor of Area C.

Significant ductwork was required to travel the extra distance compared to being directly above the areas that it serves. Because the ductwork had to cross between Area B (where RTU-3 is located) and Area C (where operating rooms RTU-3 serves are located), ductwork had to pass through

the clerestory corridor space, highlighted yellow above in Figure 6.

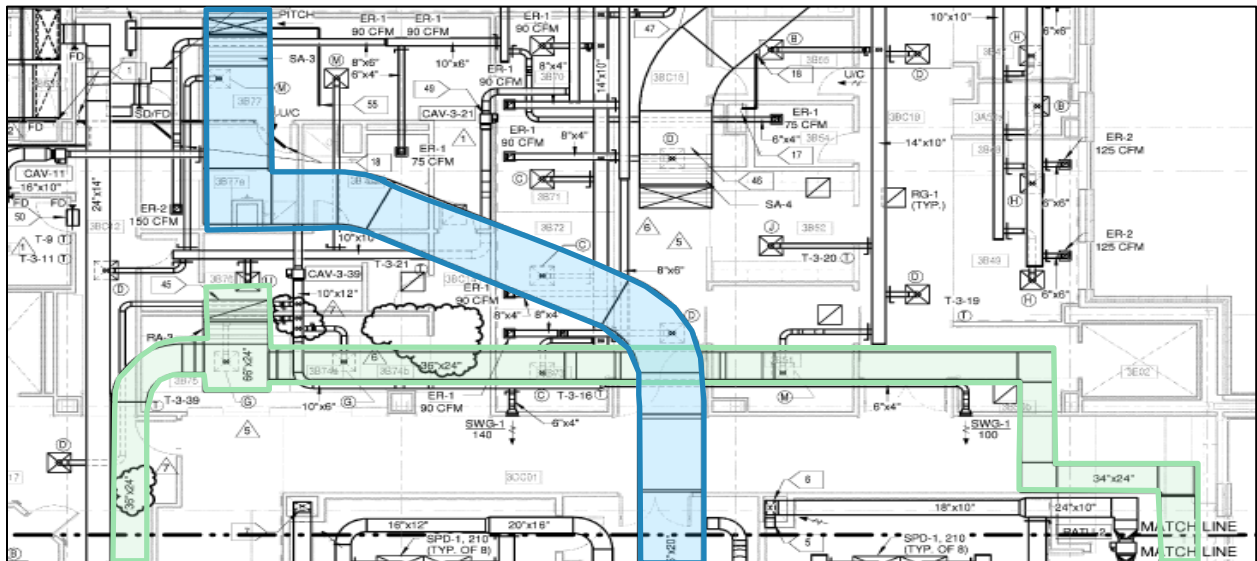
Figure 7 - Ductwork from RTU-3 is shown passing through clerestory corridor spaces are shown. Supply duct is highlighted blue and return duct is highlighted green. Image courtesy of Ellerbe Becket.

Figure 7 shows the amount of ductwork that is necessary to run from Area B to Area C and how much open space is protruded by crossing supply and return duct. This ductwork could have been eliminated had RTU-3 been placed above the OR's in Area C.

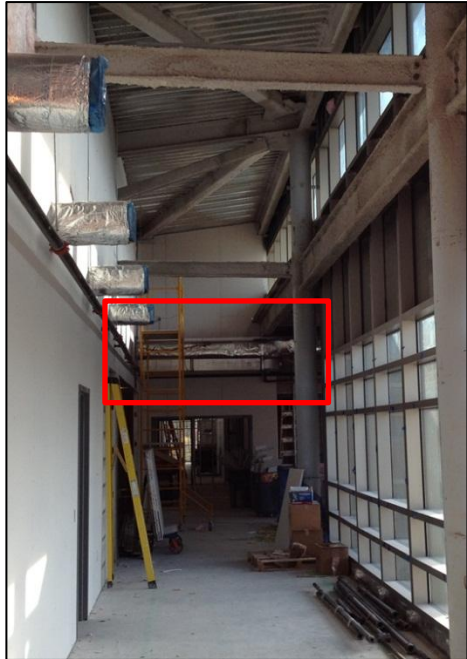
Figure 8 - View of corridor space in Area B on the third floor looking south. Ductwork can be seen crossing this space running from Area B to Area C along with the clerestory window in the upper right of the image. Personal photograph taken by Chris Pozza.

A big reason this idea was proposed, other than to save a large amount of ductwork, was for aesthetic reasons. As shown in Figure 8, ductwork can be seen crossing through open space. This is not ideal, especially with the clerestory windows above, which will create shadows in the corridor space.

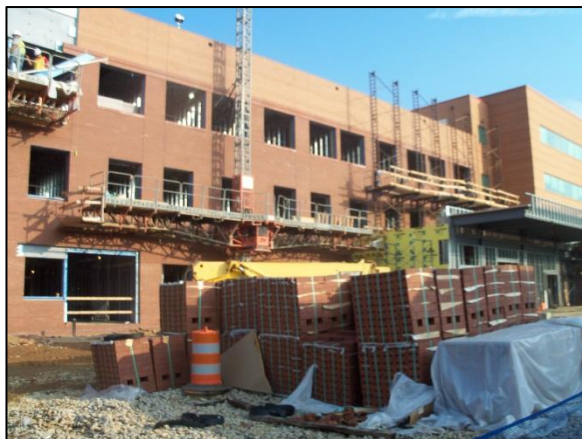
Figure 9 - Fraco Lifts which didn't allow work to be done underneath along with large amounts of brick taking up valuable laydown space for an extended period of time can be seen here. Personal photo taken by Chris Pozza.

up by brick, as shown in Figure 9. This problem could have possibly been eliminated with just-in-time delivery of precast or brick panels. Full understanding of the installation process, lead/lag time involved, associated costs to use for comparison, and manufacturers local to the Maryland/DC Metro area are all necessary to learn more about these types of systems. Alternative systems can also be investigated. For instance, Thin Brick is a type of façade system that uses bricks that are the same length and width as traditional bricks, but much thinner and weigh about 1/6th of traditional bricks. It might not have been possible to use a Thin Brick system here, but that can't be determined without further investigation.
