# Research Facility Core and Shell

## Technical Report 1

Construction Management

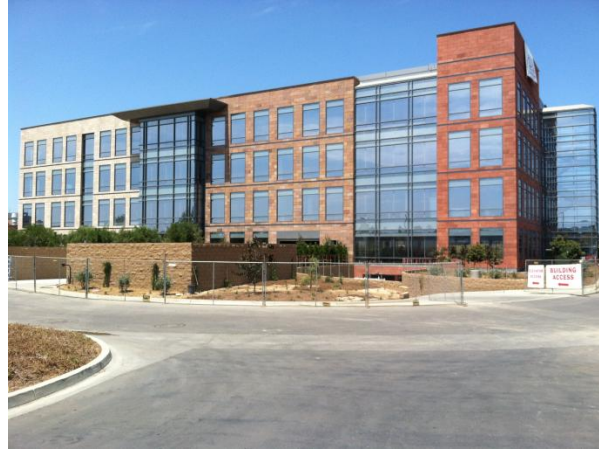
Figure 5 Masonry Walls

RFCS is heavily characterized by its masonry components. Concrete Masonry Units are used to support the soil loads in the basement and run the perimeter of the building below grade. Various types of masonry veneer were used on the enclosure of the building which can be seen in the figure below. All of which were about 6"x12"x 1" pieces of stone attached one by one to the metal stud wall assembly. Stick built scaffolding was used and all four sides of the building went up simultaneously.

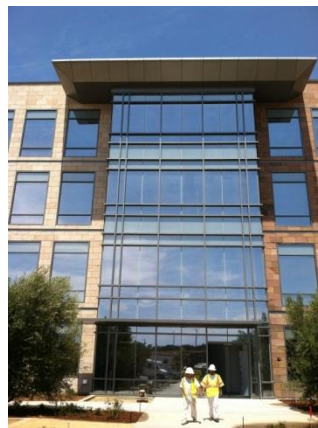
Figure 6 Curtain Wall

Aside from the masonry that was used for the enclosure, curtain walls constituted a large portion as well. These curtain walls consisted of steel mullions that supported windows that were mainly 4'x8' and were composed of clear blue "vision" glass. The curtain walls were built on the ground and raised as panels. Once raised, they were tied into the structure at connection points on each floor.
