Memorial Vista

A North Virginia Office Building

Technical Assignment III

William J. Gamble | 5th Year – Construction Option | November 15th, 2013

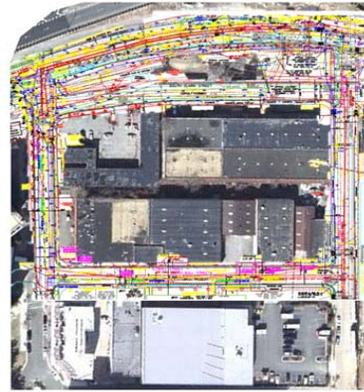
Original Site with the Existing Utility Overlay

One of the first problems that the team on this job came across was the fact that there were more underground utilities than shown in the drawings and most of which were mislabeled or not even marked at all. As relocation of the utilities that ran through the site began, a large sewer main was discovered. It was determined that this was the primary sewer main for this area, with no redundancy elsewhere. Since these were significant pipes for the county, the team needed to perform a complicated tie-in and swap process to allow the systems to be relocated. This process was not accounted for in the schedule and took a large amount of time to perform. Because of the delay, the scheduled completion date had to be adjusted.

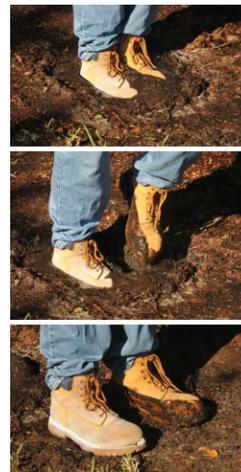
MUD TEST: Untreated boot (R) and boot sprayed with Ultra-Ever Dry (L).

To solve this problem, a different product by the name of Ultra-Ever Dry could have been used. This product is a super hydrophobic coating that repels water, oil, and other liquids. This means that instead of being a vapor retarder, where some water vapor does make it through the barrier like the bentonite fabric, the Ultra-Ever Dry substance would prevent the flow of any water through the building if applied properly. Along with its qualities to repel liquids, it also has superior abrasive resistance to materials surrounding it. This is important because the spray would be easily applied in two coats to the foundation of the building in the same places that the bentonite fabric was applied, but would be done quicker, more efficient, and would allow for the backfill process to be done with ease. The original installation of the bentonite fabric calls for an adhesive to be applied to the wall and then the sheets to be pressed against the wall with an overlap of the edges being at least four inches. This allows for a lot of human error to take place. The Ultra-Ever Dry is applied in a base coat and a top coat, where the installation time can be significantly reduced with the use of an industrial heat gun. The backfill process could also be looked at. The soil being used to backfill would not have to be checked for sharp objects that could have damaged the previous water retardant, therefore allowing the process to be completed quicker. In the end, the Ultra-Ever Dry could result in being cheaper to install, and allow for a quickened schedule due to its easy install and tougher qualities.
