Final Thesis Report

Jeremy Drummond
Construction Management
Anumba
The Duffy School
Florence, NJ
04/08/2015

THE DUFFY SCHOOL

210 WEST SECOND STREET, FLORENCE TOWNSHIP, NJ

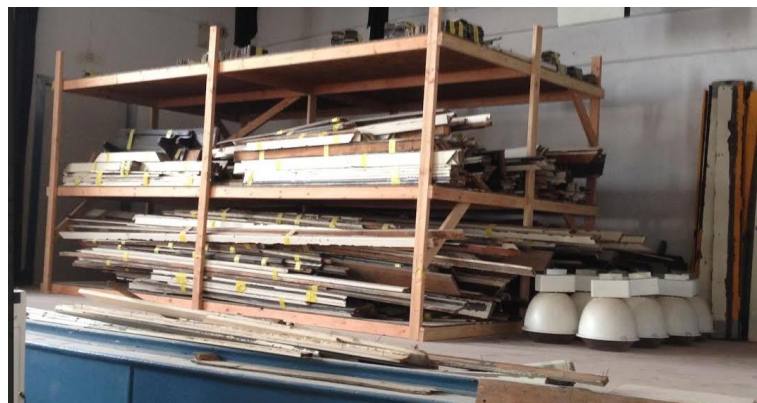
Figure 12-Current Material Storage

⁹I first discussed the schedule delays associated with the storage of the historical items to Mrs. Lizzy. One of the issues being that the items are all originally stored in the old gymnasium on the stage and the floor surrounding, as seen in Figure 12 on the right. Once the gymnasium starts to get worked on, the items are moved from that area and placed in one of the apartments that is close to be completed, which for this project is room 101 or a room to the west side of the school building. This room is not that far from the gym, but the walk from the stage to room 101 takes around 3 minutes. There are a lot of historical pieces in storage, so the moving from one room to another takes valuable time.

Mrs. Lizzy suggested the project should invest in an on-site container to hold the historical pieces from the start of the project until the pieces are reinstalled in the building. The on-site container will take away the need to place and then move the items. Instead the pieces can be taken down and put instantly into the container. Once in the container, the piece can remain untouched until it is needed, towards the end of the project schedule.

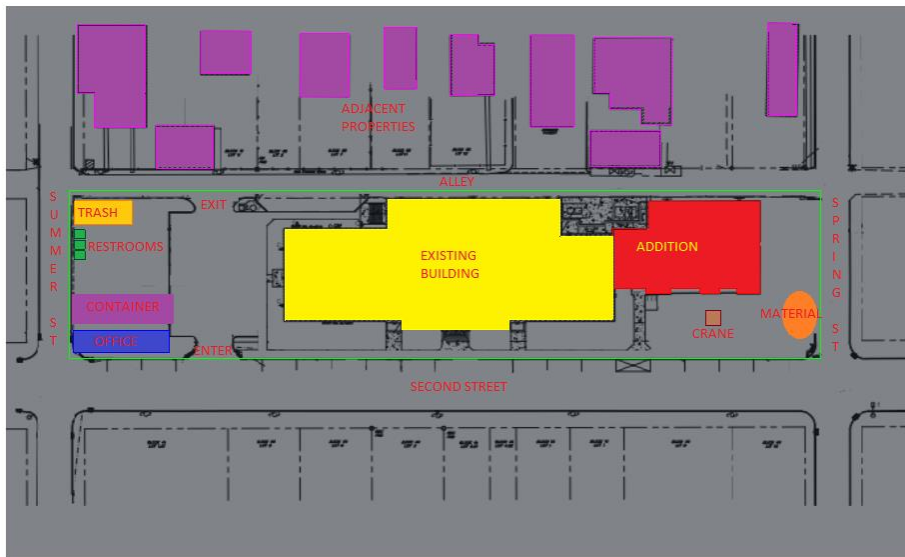
Figure 13-Site Logistics Plan

¹⁰The other issue with the container is if there is enough space. It is estimated that to deliver a container, double the length is needed to get the container in its final location. After doing some investigating of the site conditions and space, I found that there is adequate room for the container on the west side of the site, next to the mobile office. There is plenty of room to get the delivery truck onto the site and this space does not get utilized during construction, so having the container there for the project does not affect any other parts of the project. The location of the on-site material storage container can be seen below in Figure 13.

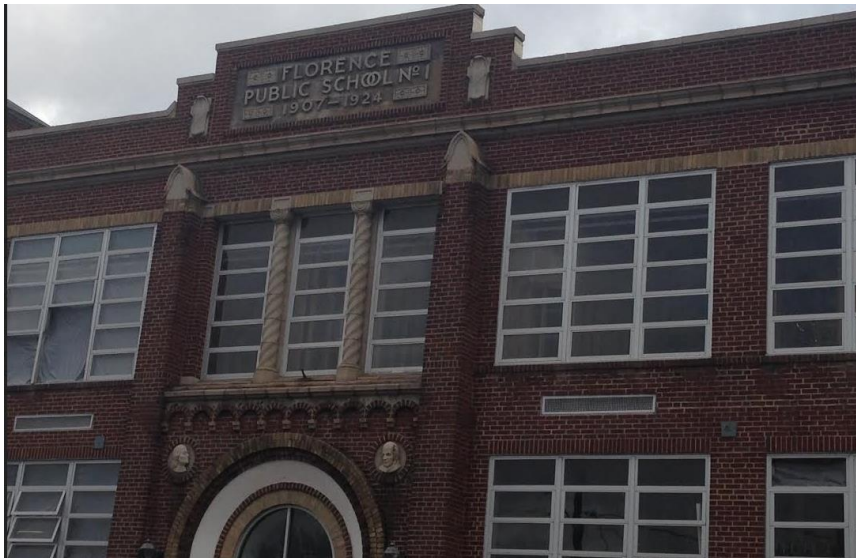
Figure 14-Current View of School

¹¹The next issue I discussed with Mrs. Lizzy is the delays the project is incurring due to problems with the window delivery. The project called for the existing windows to remain in the gym/auditorium. These windows needed to be protected during construction and any broken glass panels needed to be replaced. There are many windows on the existing and some can be seen below in Figure 14. When talking with Mr. DeSantis he informed me that in total 16 windows needed to be replaced due to them be already broken and 5 more were needed due to improper care during construction. These windows are a very rare size and only select distributors sell the panels. The original 16 were ordered and the panels were delivered to the site with enough time to not cause any delays. The last 5 panels that got broken during construction are the issue. The original windows did not take long to get delivered because the company was slow at that time. These last 5 windows were forgot about until they needed to be installed. The windows took an extra month to come in, then the original ones. This month caused many delays with getting the building water tight.

Mrs. Lizzy discussed how if the Keystone Group was hired on from the beginning this would not have been an issue. I initially thought the solution would just be to order more windows in the start of the project with the notion that more windows might get broken. Mrs. Lizzy said that is always an option, but for the Duffy case she said the main problem was the last 5 windows was that they were forgotten about until it was too

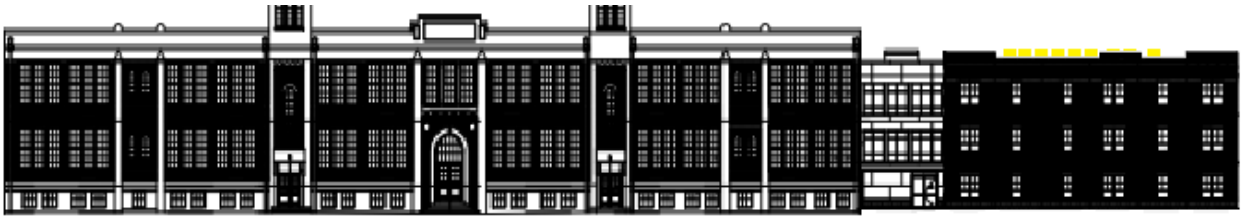
Figure 18-South Elevation with Solar Panels

Figure 19-West Elevation (No Panels Visible)

Figure 20-East Elevation with Solar Panels

From the elevations shown above, the visibility of the solar panels is minimal (yellow). The panels are less than 3 feet tall, which makes them hard to see from any angle or view. Standing across West Second Street, pedestrians will be able to see the very top of the panels that stand a little taller than the roof. Due to the small alley and adjacent homes to the north of the sight, there is no place for a pedestrian to stand where they

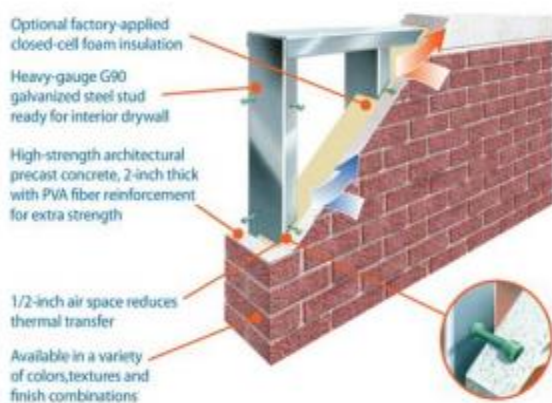
Figure 22-SlenderWall

For the Duffy School Addition and Renovation SlenderWall Architectural Precast Concrete Brick Panels will be investigated. SlenderWall is a light architectural precast concrete system. The precast system consists of a two inch reinforced architectural precast concrete exterior layer, with the inside is composed of sixteen gauge, six inch galvanized steel studs that are spaced vertically at two foot off center.

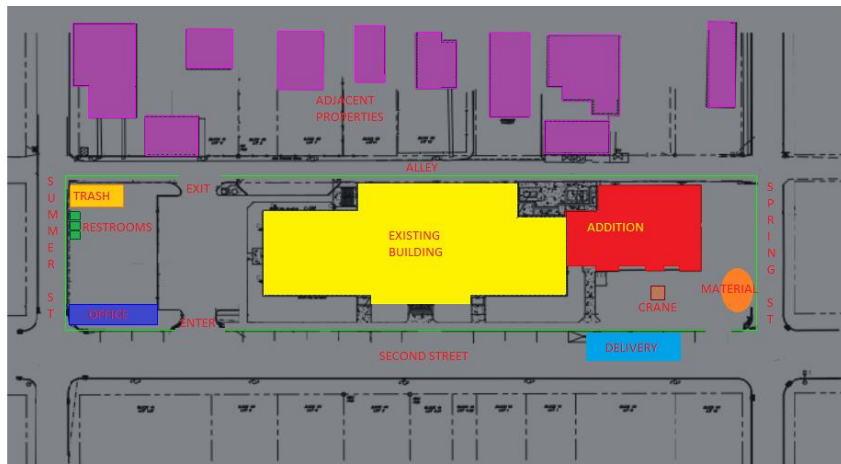
Figure 26-Delivery Site Logistic Plan

¹⁹The site logistics is a concern on any construction project. It takes planning upfront to make sure everything on the site will be able to run smoothly and not affect the flow of construction for other trades and tasks. The current site layout for the Duffy School Addition and Renovation will be able to accommodate the delivery and installation of the prefabricated wall panels. The panels will not affect the site logistics if they get delivered right when needed. There is not space to store the panels, so they must get delivered and erected in a close time period. The delivery trucks will park on West Second Street on the south side of the building. The wall panels will be picked up directly from the truck bed and hoisted into place by the crane. It is
