Mueller Laboratory Renovation: Final Report

By
Mark Jackson
Construction Management Option
4/22/15

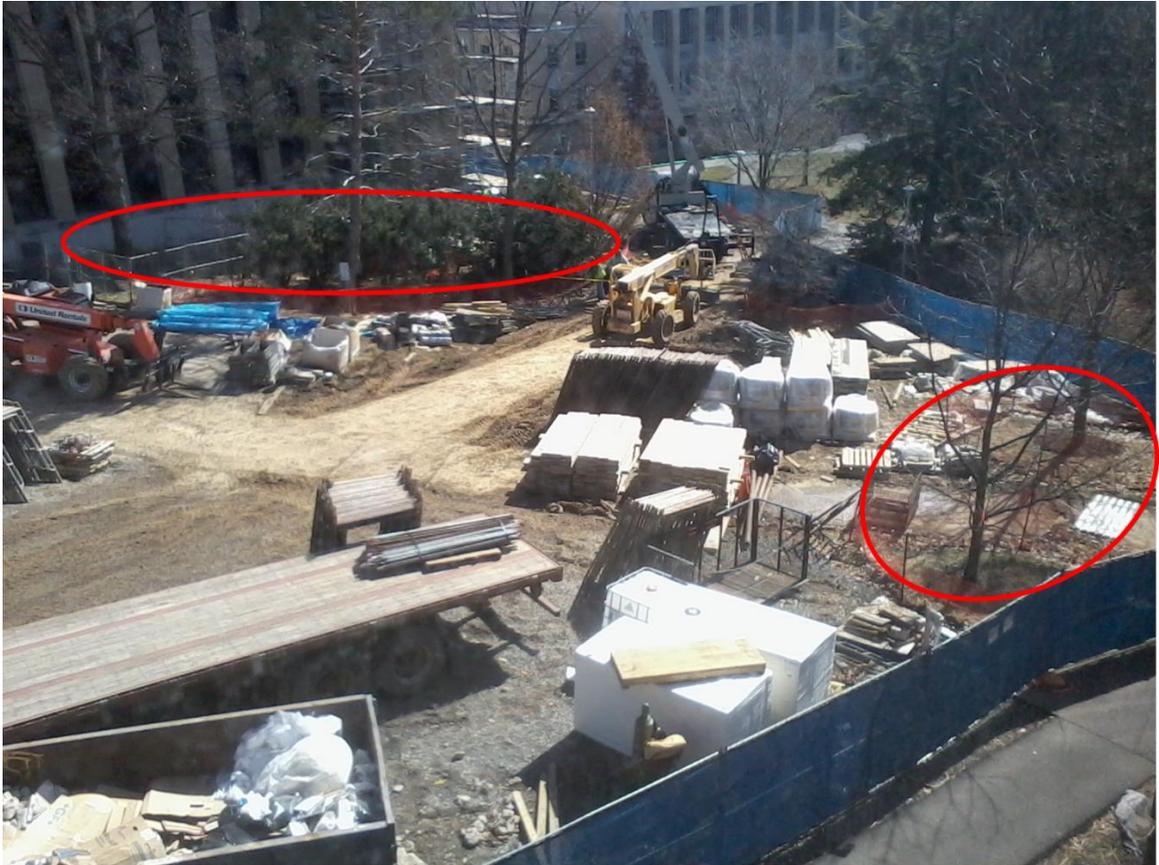
While the site fencing encompasses a generous work area, several factors cut down on the amount of usable space. First is the presence of three islands of trees that must be protected, as seen in the picture below.

Figure 9: Fenced in areas with trees to be protected.

Since the Penn State University Park campus functions as an arboretum, all significant trees must be protected throughout the construction process. This requires fencing around these trees within the project perimeter fencing. These tree islands are fenced off for the duration of the project, constricting the worksite and reducing what area can be used for material staging and contractor parking.

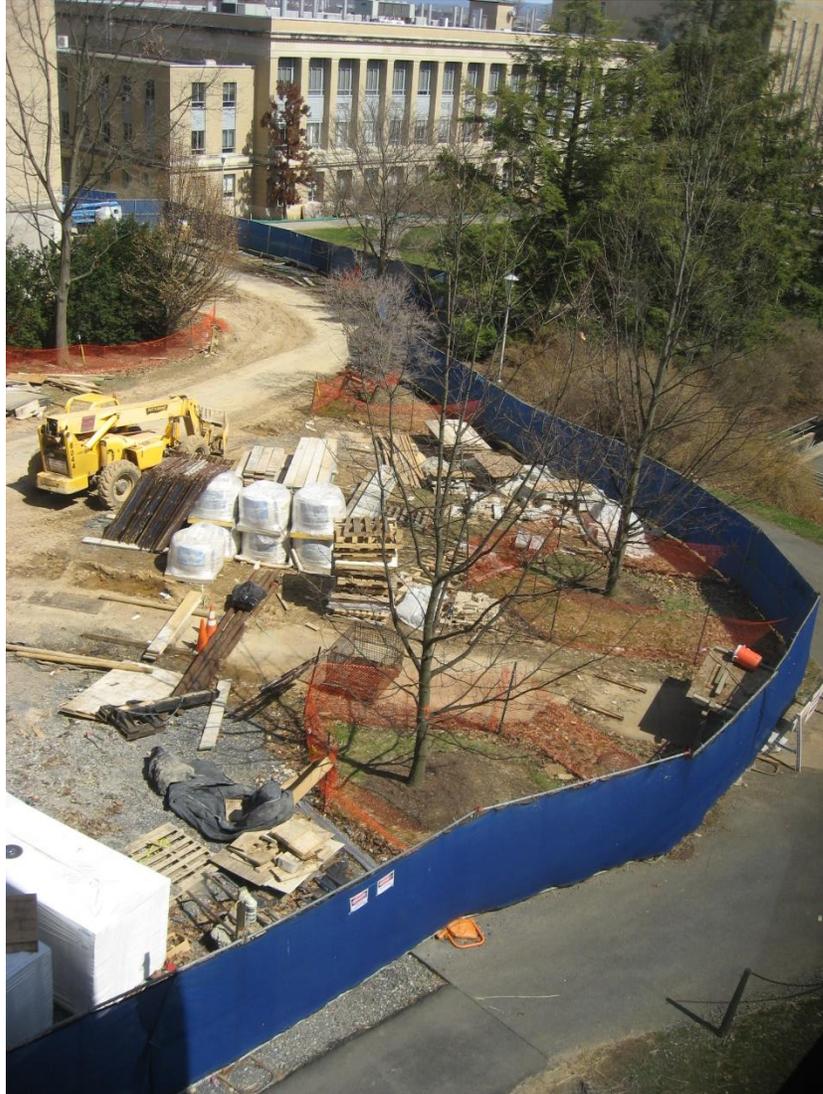
A second factor is the lack of suitable material staging area. The purple triangular region in the site plan, shown above, is a material staging that is on a considerable slope, as seen below.

Figure 10: Material storage on slope.

Any tall items, such as stored mechanical equipment, would be in danger of falling over or sliding if placed on this slope. Thus, this area is delegated to lengths of pipe and other short items. This wastes valuable staging space. Furthermore, this necessitates storing the large mechanical equipment in the only open, flat space on the site, by the front gate. These pieces of stored equipment in turn displace contractor parking, creating a bottleneck at the site entrance gate, as shown in the picture below.

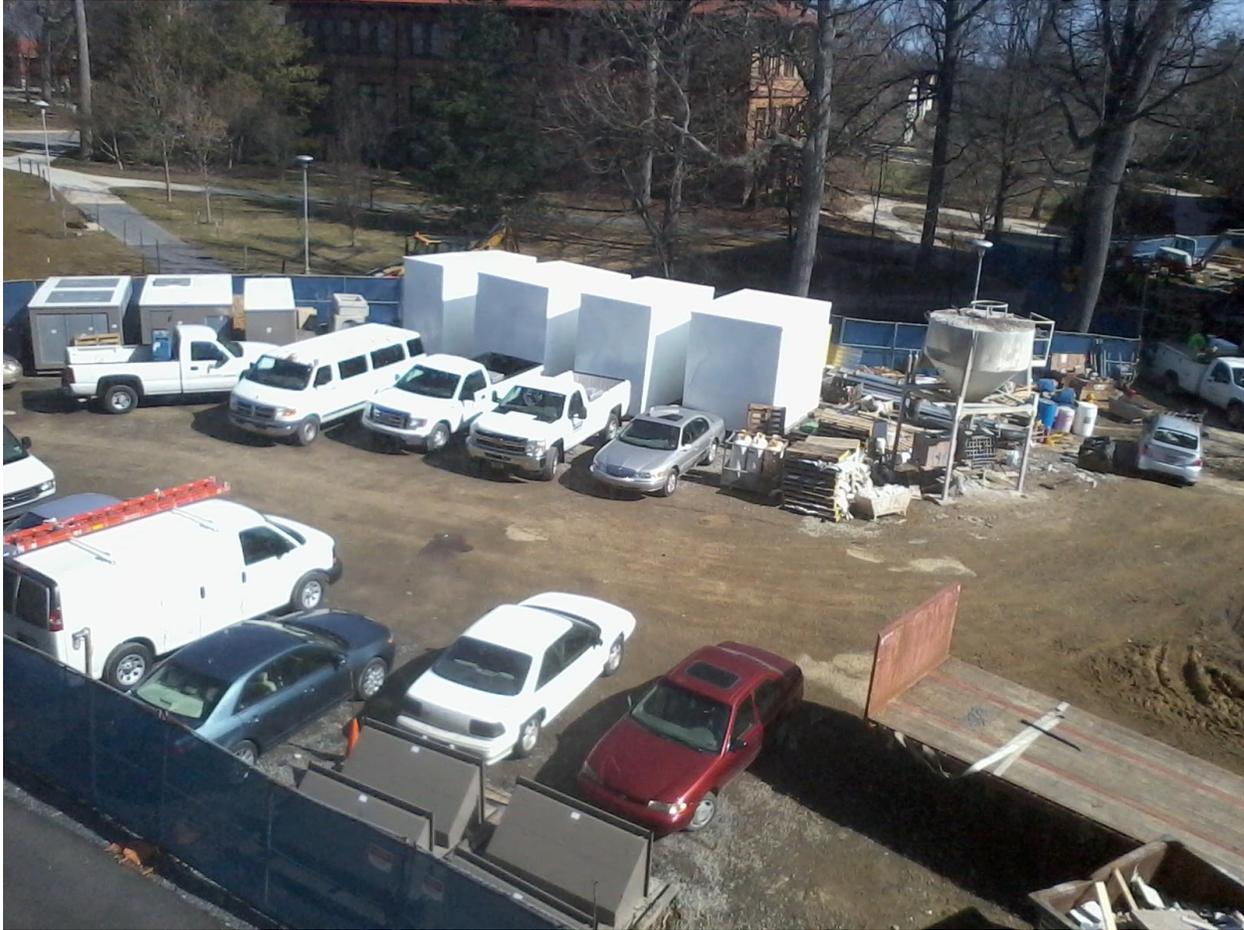
Figure 11: Stored mechanical equipment displacing contractor parking.

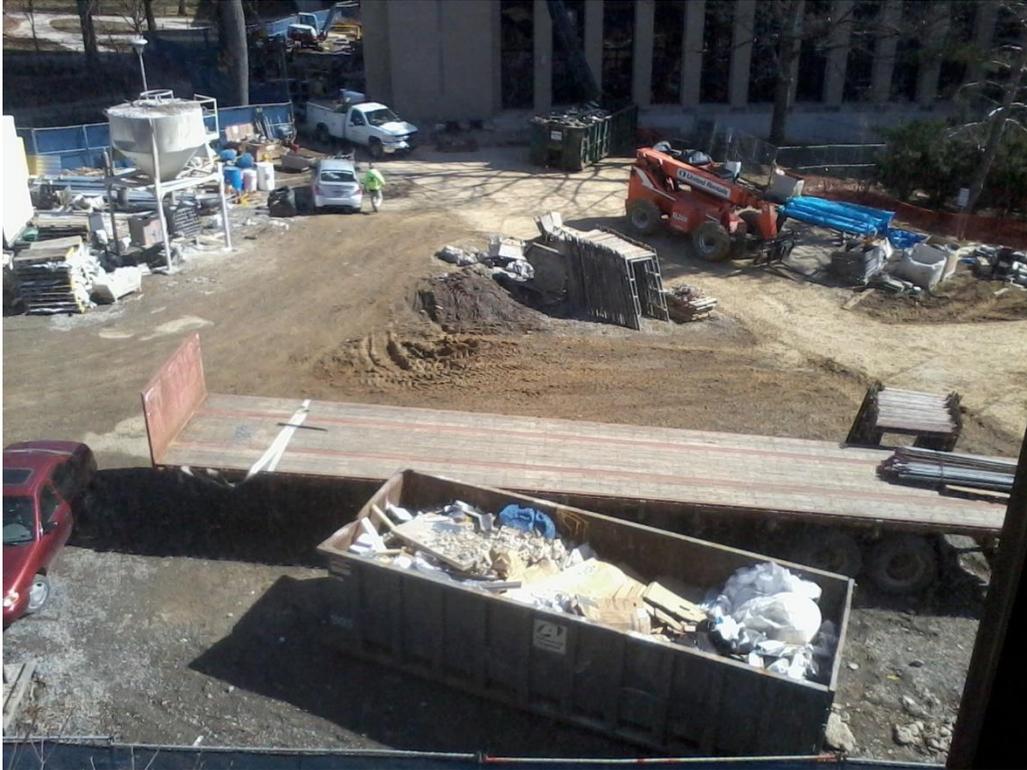
Storing the mechanical equipment also displaced other equipment as well, meaning the mortar mixer and stored scaffolding get placed in the only remaining open space, the center of the jobsite. This further hinders the movement of JLG lifts and other equipment. Additionally, semi-trailers have no place to be unloaded without blocking either some of the 14 contractor park spaces or the dumpster, as shown below.

Figure 12: Stack of scaffolding and mortar mixer forced to center of site. Semi-trailer blocks the dumpster.

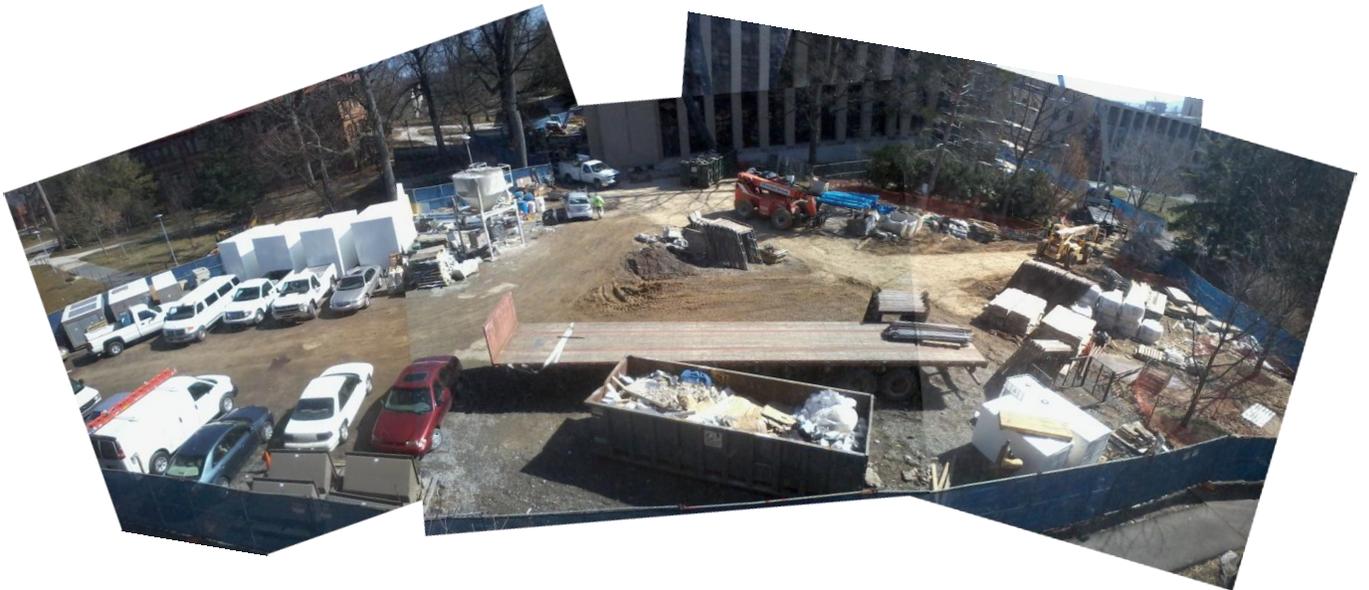
In all, the jobsite is congested and disorganized, as seen in the panorama below.

Figure 13: Panorama of existing job site.

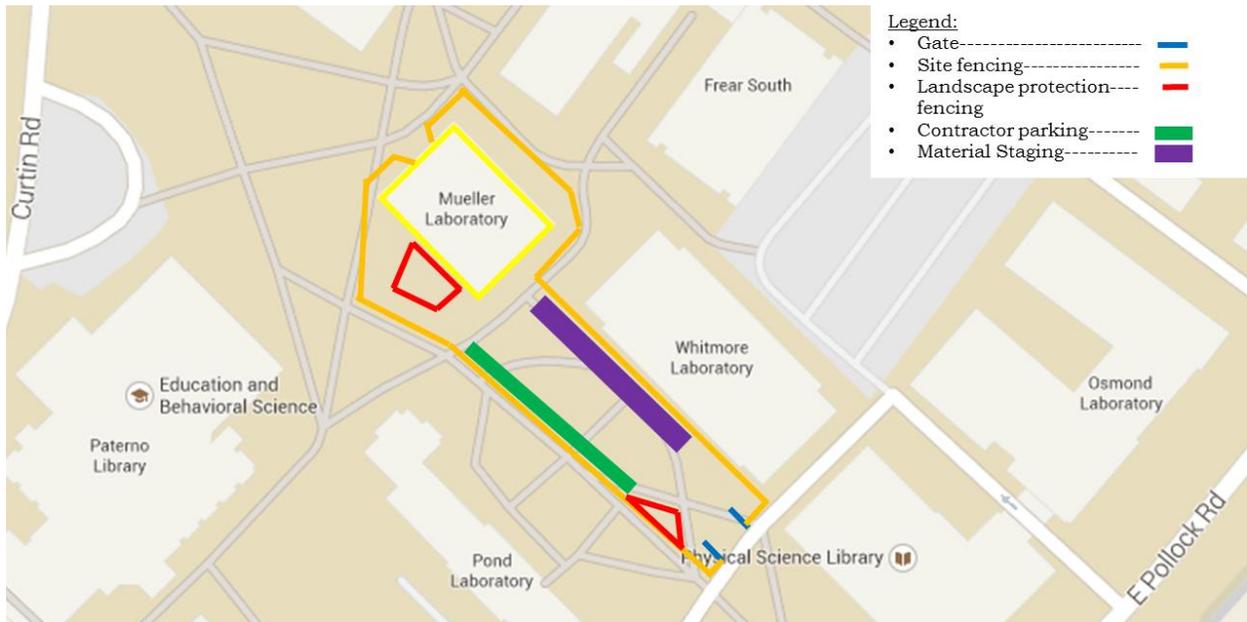
Figure 16: Proposed site plan. (Map from Google Maps)

My proposal is to move contractor parking and material staging to the south of Mueller Laboratory, as shown in the diagram below.

In this plan the site is accessed from the south, using the laboratory access road that runs between Whitmore and Davey Laboratories. The front entrance of Whitmore Laboratory, adjacent to the proposed work site, would be blocked, but the north, east, and south entrances would all remain open, allowing ample access for Whitmore's occupants.

There are a number of advantages to moving the work site to the south. First is the minimization of protected tree islands. The three fenced-in areas from the original plan has been reduced to two, and only one that greatly impacts the work space. Then new tree island in the space to the south of Mueller would include only two sizeable trees, as shown in the picture below looking toward Mueller from the proposed new entrance gate.

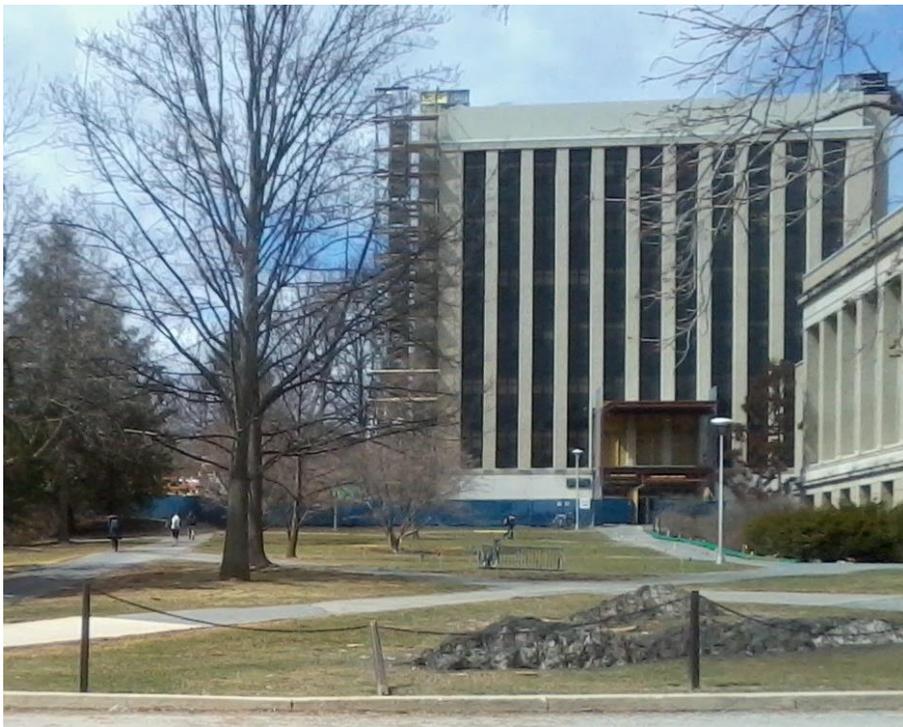
Figure 17: Area for proposed work site.

Fortunately these trees are at the edge of the proposed site, and will not greatly limit usable area. These two trees can be protected with fencing just as the trees next to Mueller Laboratory are, with site fencing. The few small ornamental trees closer to Mueller can be temporarily transplanted to another location, as occurred on the current plan.

The current material staging area drops nearly 14 feet in over a distance of 140 feet, averaging a 10% grade. The proposed staging area drops only 8 feet over a distance of 200 feet, for an average 4% grade, less than half of the current staging area. This flatter grade allows for more efficient storage of material, easier access to material and equipment, and safer conditions for workers on the site.

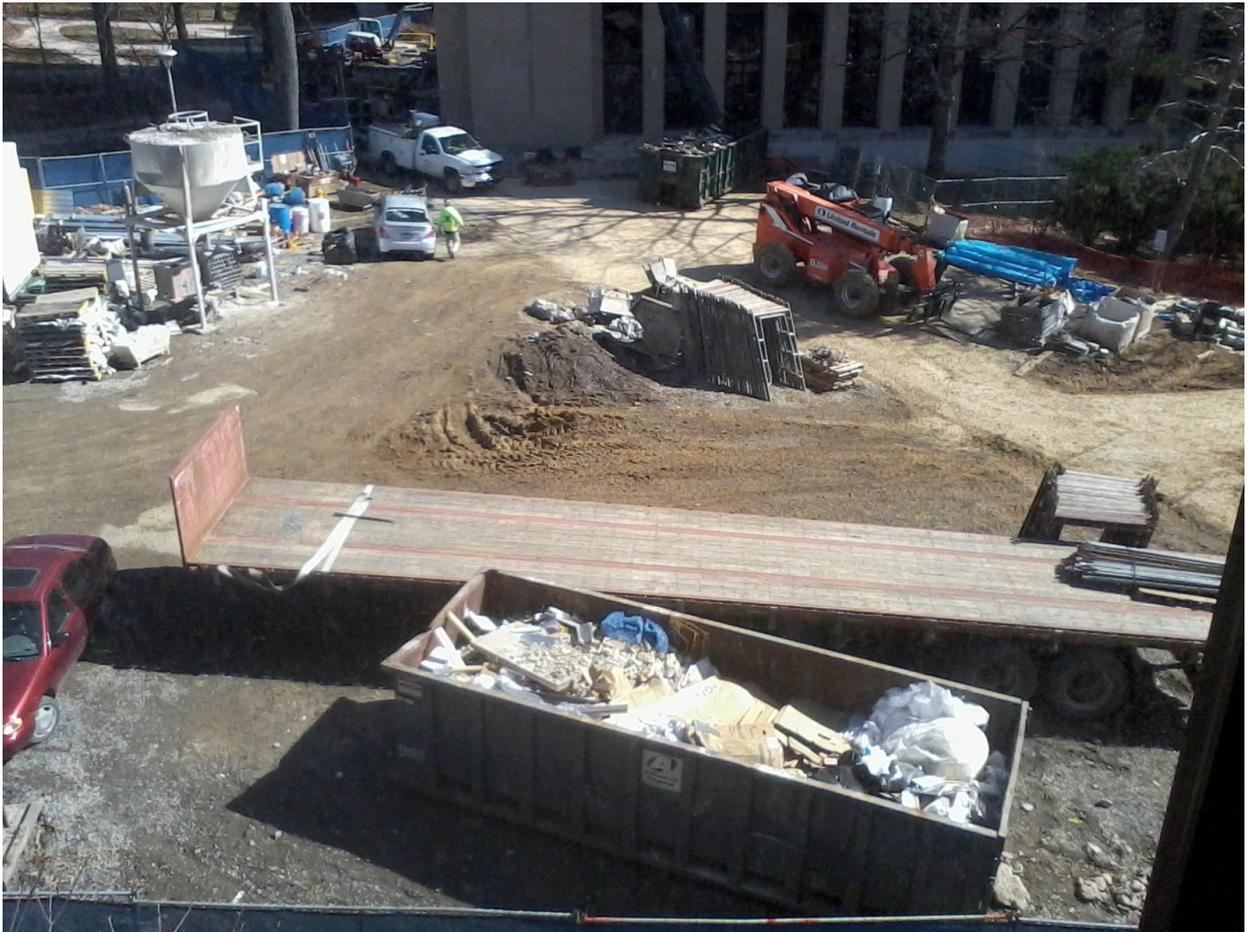
Figure 21: Dumpsters on the worksite.

The dumpster in the foreground is not easily accessible, and far from the building. If two smaller dumpsters were put in this location, one for landfill waste and

one for scrap metal, the scrap dumpster might go unused. Putting the dumpster this far from the demolition work means that workers have to pre-sort their waste before bringing it to the dumpster, or sort it at the dumpster. This takes time, and thorough sorting would not be assured.

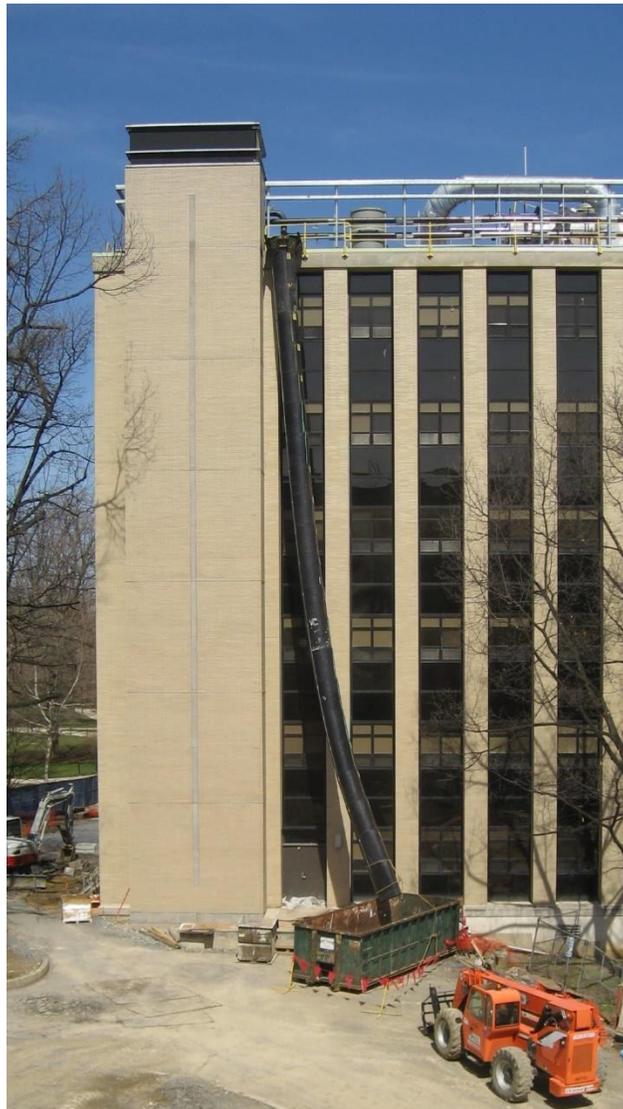
The picture below demonstrates another difficulty. A demolition debris chute can be seen running to a single dumpster. This means that none of the waste from the upper floors can be sorted into landfill waste and recyclable categories.

Figure 22: Second dumpster with trash chute.

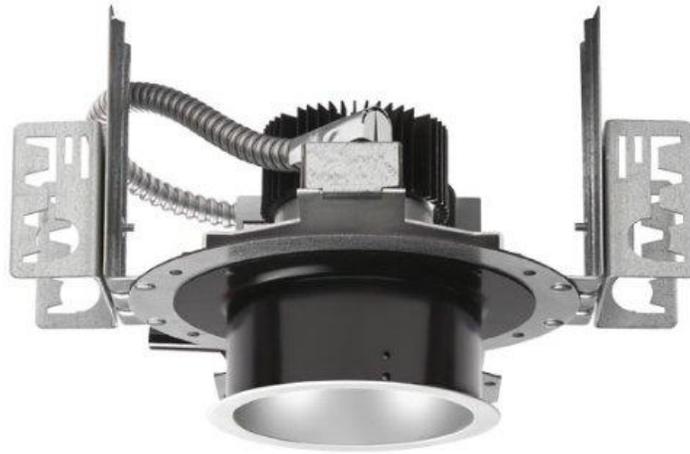
Figure 25: The 4" CREE fixture. (Picture from Amazon.com)

Comparing the 4" CREE to LED bulb 1, both run at the same wattage. The bare LED bulb has 6.4% higher lumen output, and has a higher CRI. It also has a lower CRT, meaning its light will appear warmer.

So the performance of the fixtures and bulbs is very similar, with only 6” CREE fixture 2 possibly edging out LED bulb 3 because of the bulb’s poor CRI. But a cost comparison will help the cause of the bare LED bulbs. The CREE downlights specified for the project cost from \$157 to \$204. In contrast, a recessed downlight fixture with an Edison-base socket costs \$9, and a bare LED bulb costs \$23 to \$59, for a maximum total cost of \$68.

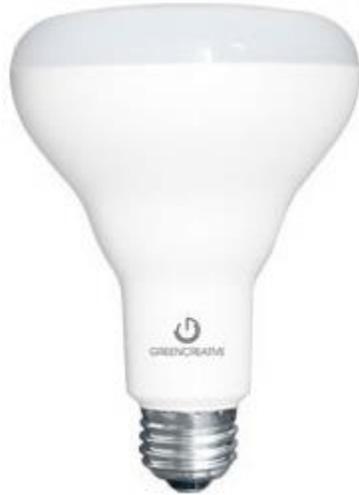
Figure 27: LED bulb 1. (Picture from Amazon.com)

Performance Specifications	
Replacement for:	BR30
Brightness (Lumens):	700
Color Temperature:	2700K
Color Accuracy (CRI):	92
Traditional Wattage Equivalent:	65 Watts
Power Consumption:	13 Watts
Voltage:	120 Volts
Dimmable:	Yes (See Compatibility List)
Moisture Rating:	Dry
Fixture Rating:	Open / Not Fully Enclosed
Base Type:	E26
EnergyStar Qualified	Yes - (See Rebates Page)
Dimensions / Additional Data	
Bulb Diameter:	3.74 in
Maximum Overall Length:	5.31 in
Product Weight:	8.32 ounces
Certifications:	UL
Product/Order Code:	13BR30G3DIM/927
Lifespan / Cost To Run	
Projected Life: @3 hrs/Day	40,000 Hrs
Yearly Energy Cost: 3 hrs/Day @ .11 kWh	\$1.57

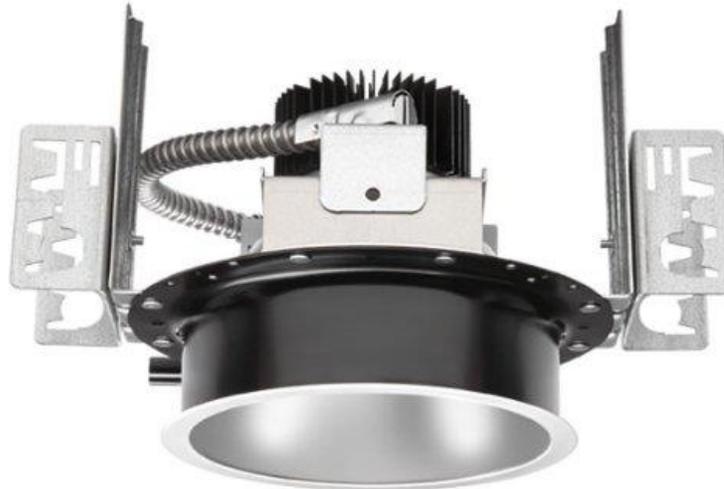
Figure 28: The 6" CREE fixture. (Picture from Amazon.com)

The first 6" CREE fixture and LED bulb 2 are also similar. The bare bulb runs at 1.5% higher wattage for the same lumen output, but has a CRI 4 points higher than that of the CREE fixture. This bulb also has a lower CRT, a good quality for the lobby and bathroom spaces.

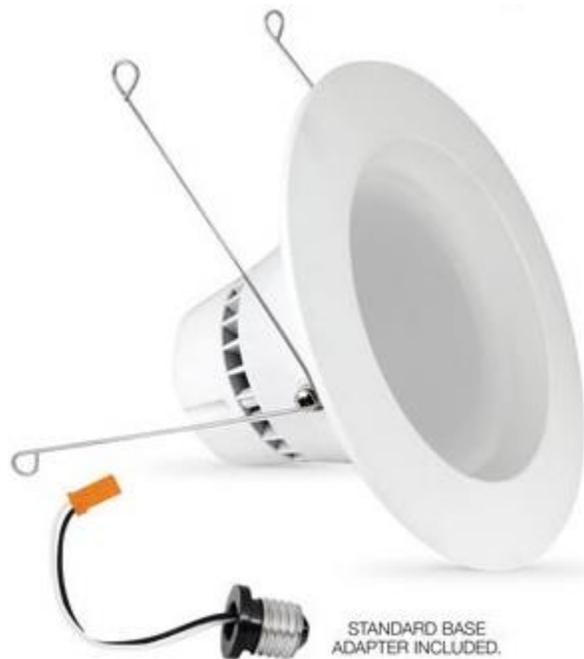
Figure 30: LED bulb 2. (Picture from Amazon.com)

Performance Specifications	
Replacement for:	5" or 6" Downlight
Brightness (Lumens):	1250
Color Temperature:	2700K
Color Accuracy (CRI):	94
Traditional Wattage Equivalent:	120 Watts
Power Consumption:	20.8 Watts
Voltage:	120 Volts
Dimmable:	Yes (See Compatibility List)
Moisture Rating:	Damp
Fixture Rating:	Suitable for type IC, type Non-IC and Air Tight Housings
Base Type:	E26
EnergyStar Qualified	Yes (See Rebates Page)
Dimensions / Additional Data	
Bulb Diameter:	5.15 in
Maximum Overall Length:	4.2 in
Certifications:	UL
Product/Order Code:	LEDRT56/927
Lifespan / Cost To Run	
Projected Life: @3 hrs/Day	50,000 Hrs
Yearly Energy Cost: 3 hrs/Day @ .11 kWh	\$2.47

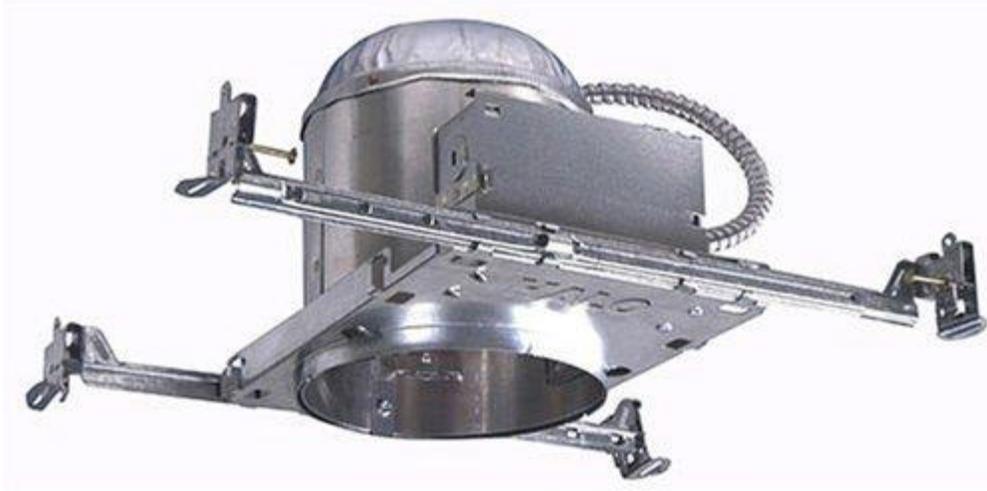
Figure 31: The Edison-socket fixture. (Picture from Amazon.com)

The second 6" CREE fixture nearly beats the selected LED bulb 3. Both have identical CRTs and run at within .8% lumen output of each other. However, the bare

LED bulb has a CRI of only 82, far worse than the CREE's 90. But the bare bulb partially redeems itself by running at only 26 watts instead of 30, a savings of 13%.

Screw-in LED bulbs should be used instead of hard-wired LED fixtures. Screw in bulbs are cheaper to purchase than hard-wired fixtures. Once installed, any defective units are easier to repair or replace than hard-wired fixtures. And when upgrades are desired, screw-in fixtures are easier and cheaper to upgrade, and generate less waste.
