# 8621 Georgia Avenue Silver Spring, MD

Nick Dastalfo | Structural Option  
Advisor: Dr. Thomas Boothby  
April 13, 2015

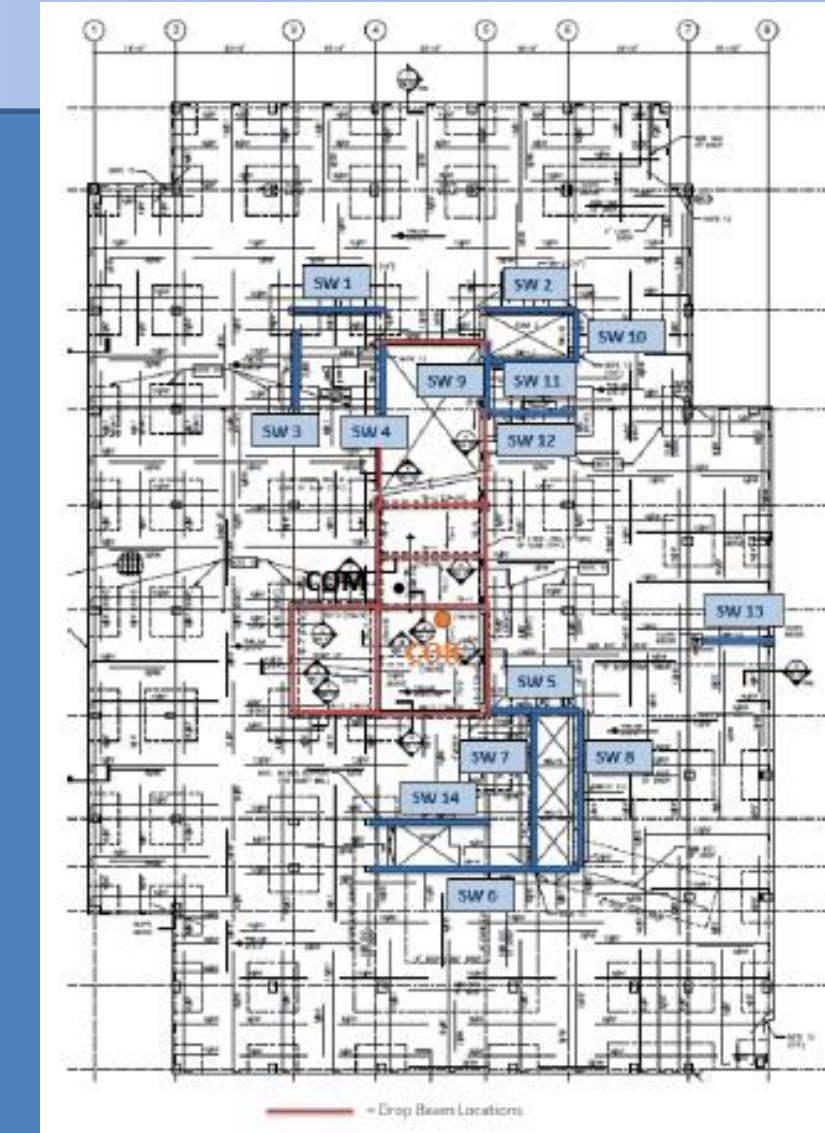
- Ordinary Reinforced Concrete Shear Walls
  - 12" or 14" thick
  - located near stair and elevator cores
- Additional beams added in parking garage

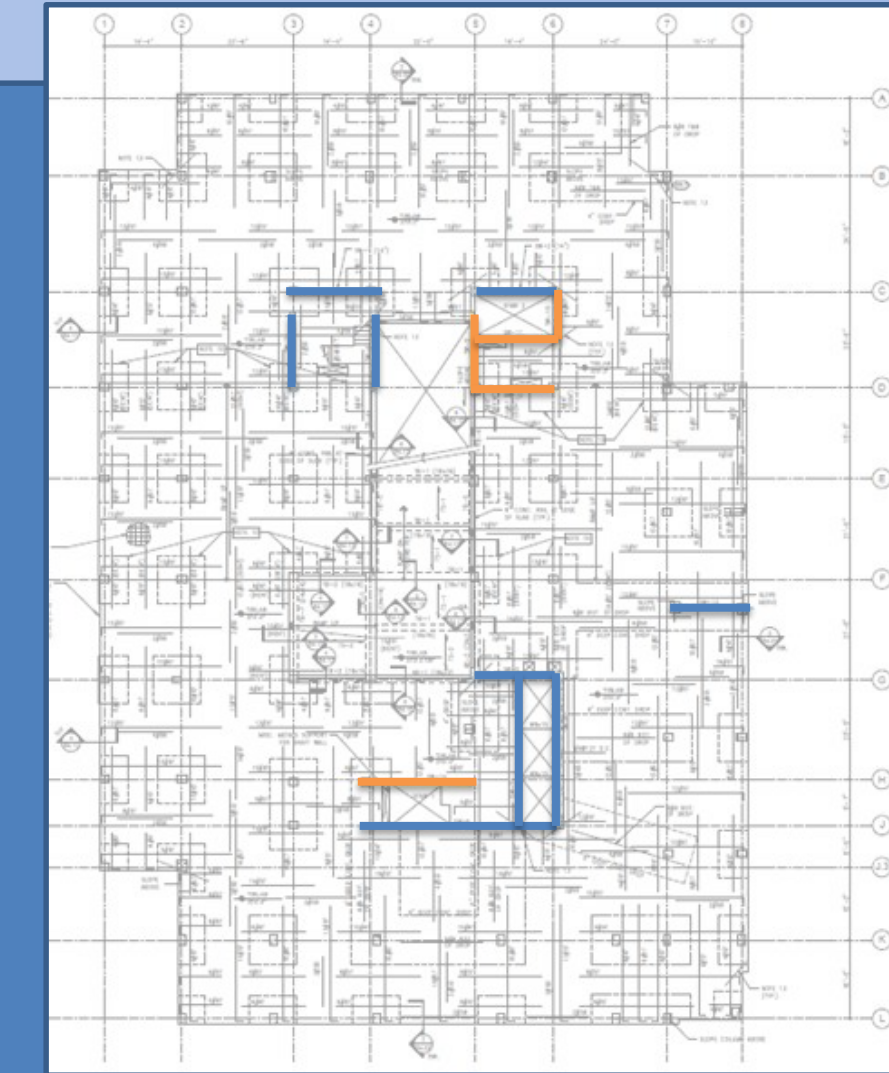
- Ordinary Reinforced Concrete Shear Walls
  - 12" or 14" thick
  - located near stair and elevator cores
- Additional beams added in parking garage
- Shear Walls vary in height

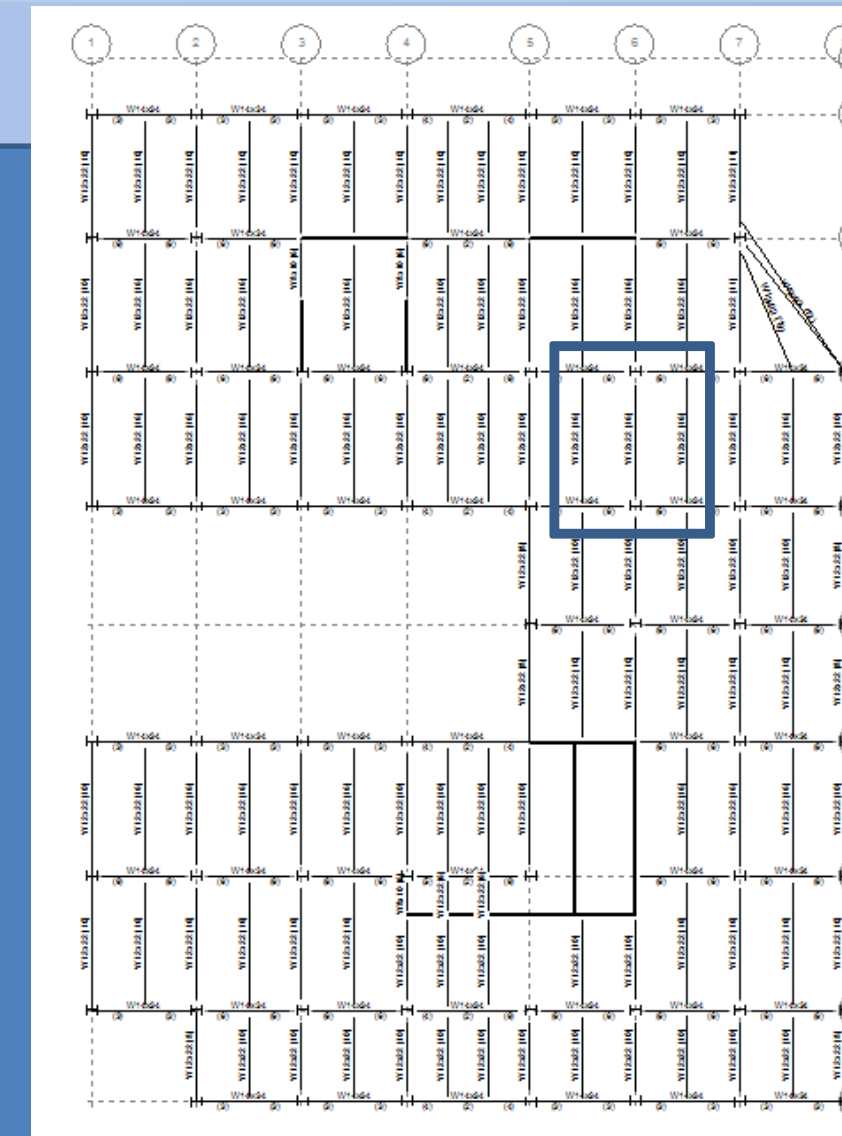
- Long Direction selected

Beam Orientation			
	Steel Weight (tons)	# of Members	# of studs
Long	590.9	2,220	25,093
Short	627.3	2,577	28,387

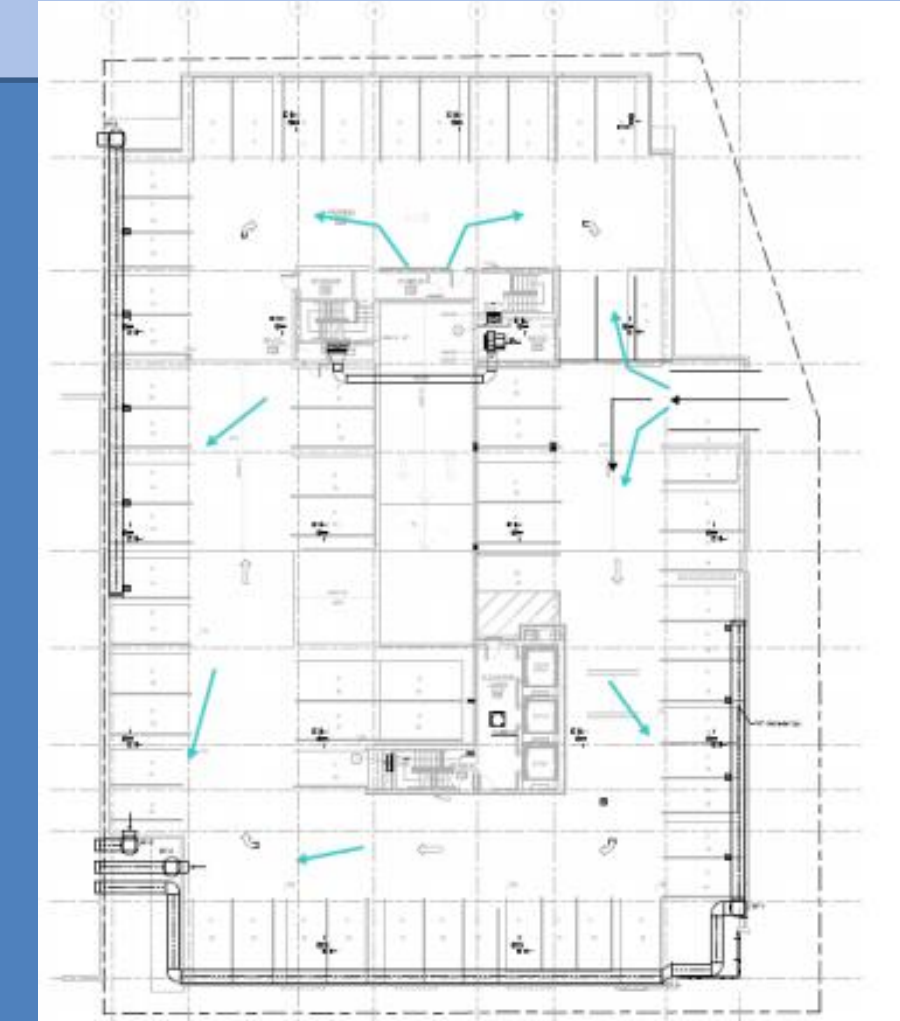
- Underground parking → Need to exhaust air
- 4 Exhaust fans
- Rely on air pressure to move clean air
- Air exhausted safely away from pedestrian area.
