11141 Georgia Avenue

Located in Wheaton, MD

Technical Report 1
Samantha deVries

Structural Option
Advisor: Ali Said
September 12, 2014

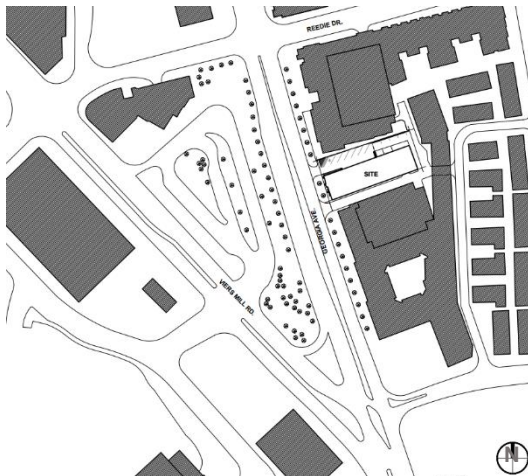
Figure 1: Building Location on Site, Courtesy of Bonstra Haresign Architects

The residential units are one and two-bedroom studio apartments. There is a rooftop terrace with a small wading pool, nice views, and a penthouse lounge for residents of the building, which includes dining areas, kitchen space for events, a fitness center, and a game room. There is a location to store and repair bikes in the building, and the site is closely located to the Wheaton Metro Station. The building is located near the corner of Reedie Drive and Georgia Avenue in Wheaton, MD, as shown in figure 1.
