# TECHNICAL REPORT 2

## HFS WAREHOUSE AND BAKERY EXPANSION

University Park, PA

CONSTRUCTION MANAGMENT

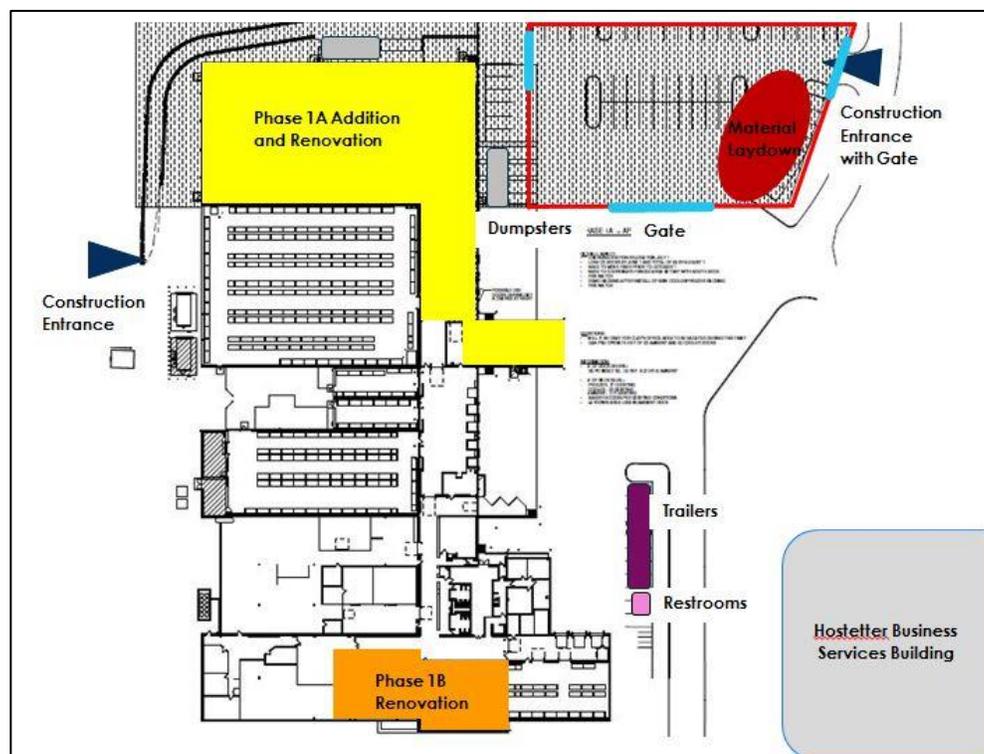
Figure 2

Starting with phase 1A, the addition to the warehouse will be erected. The renovation of the south side will make the start of phase 1B. The material laydown is surrounded by a gate on the northern most parking lot. This is also where one of two construction entrances is located. This can be seen in Figure 2.

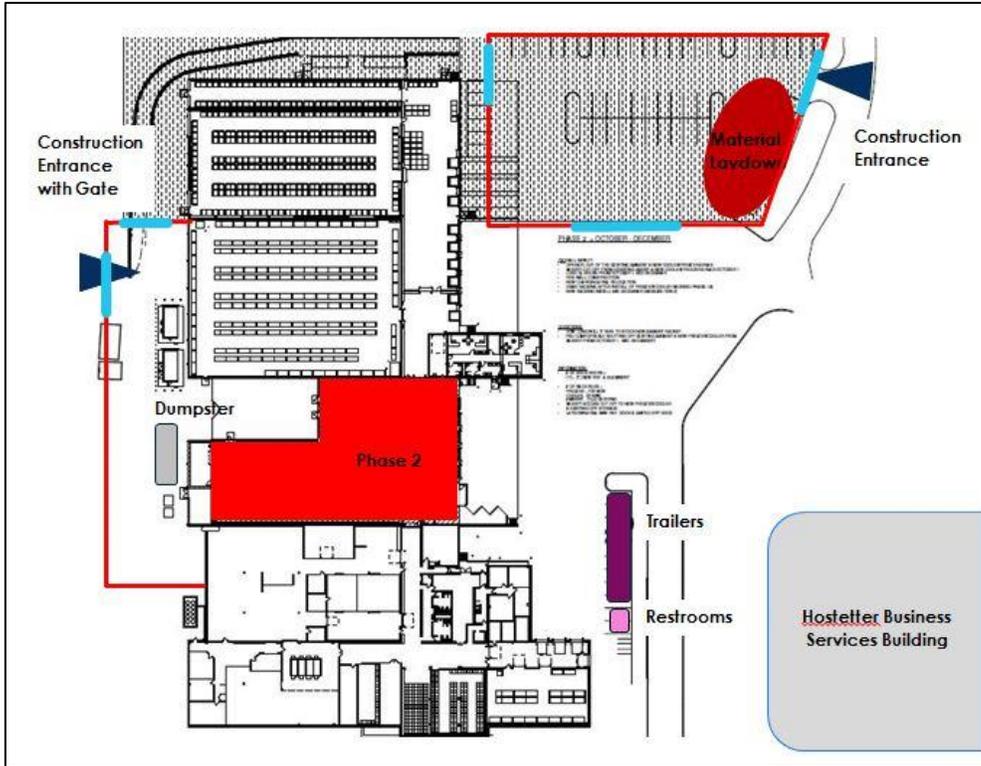
Figure 3

Phase 2 marks the start of the existing cooler and freezer renovation. A new fence is place around the west side of the building, along with dumpsters. The second of two construction entrances will need a gate to allow passage through the fencing as seen in Figure 3. This fence will be used later in phase 3.

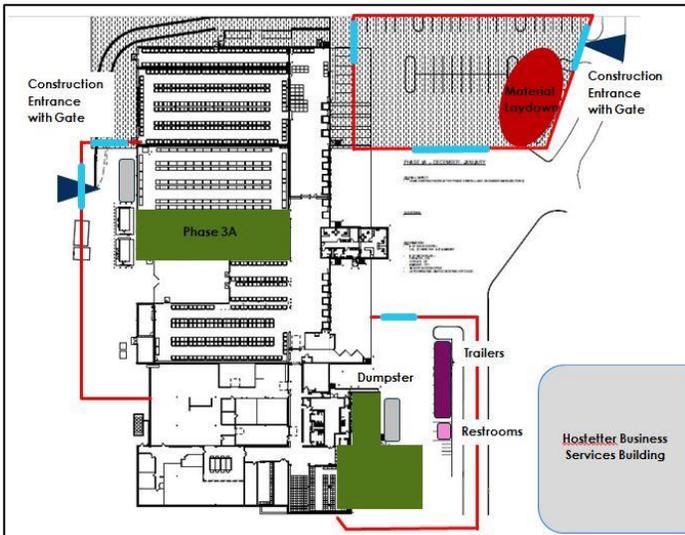
Figure 5

Phase 3 starts with the existing freezer. This will be renovated into more dry storage. The first part of phase 3 will start with the southern part of the dry storage area and the offices as seen in Figure 4. As the offices continue to be renovated, the northern part of the dry storage area will start renovations. This can be seen in Figure 5. Additional fencing will be set up around the trailers and south east side of the building.

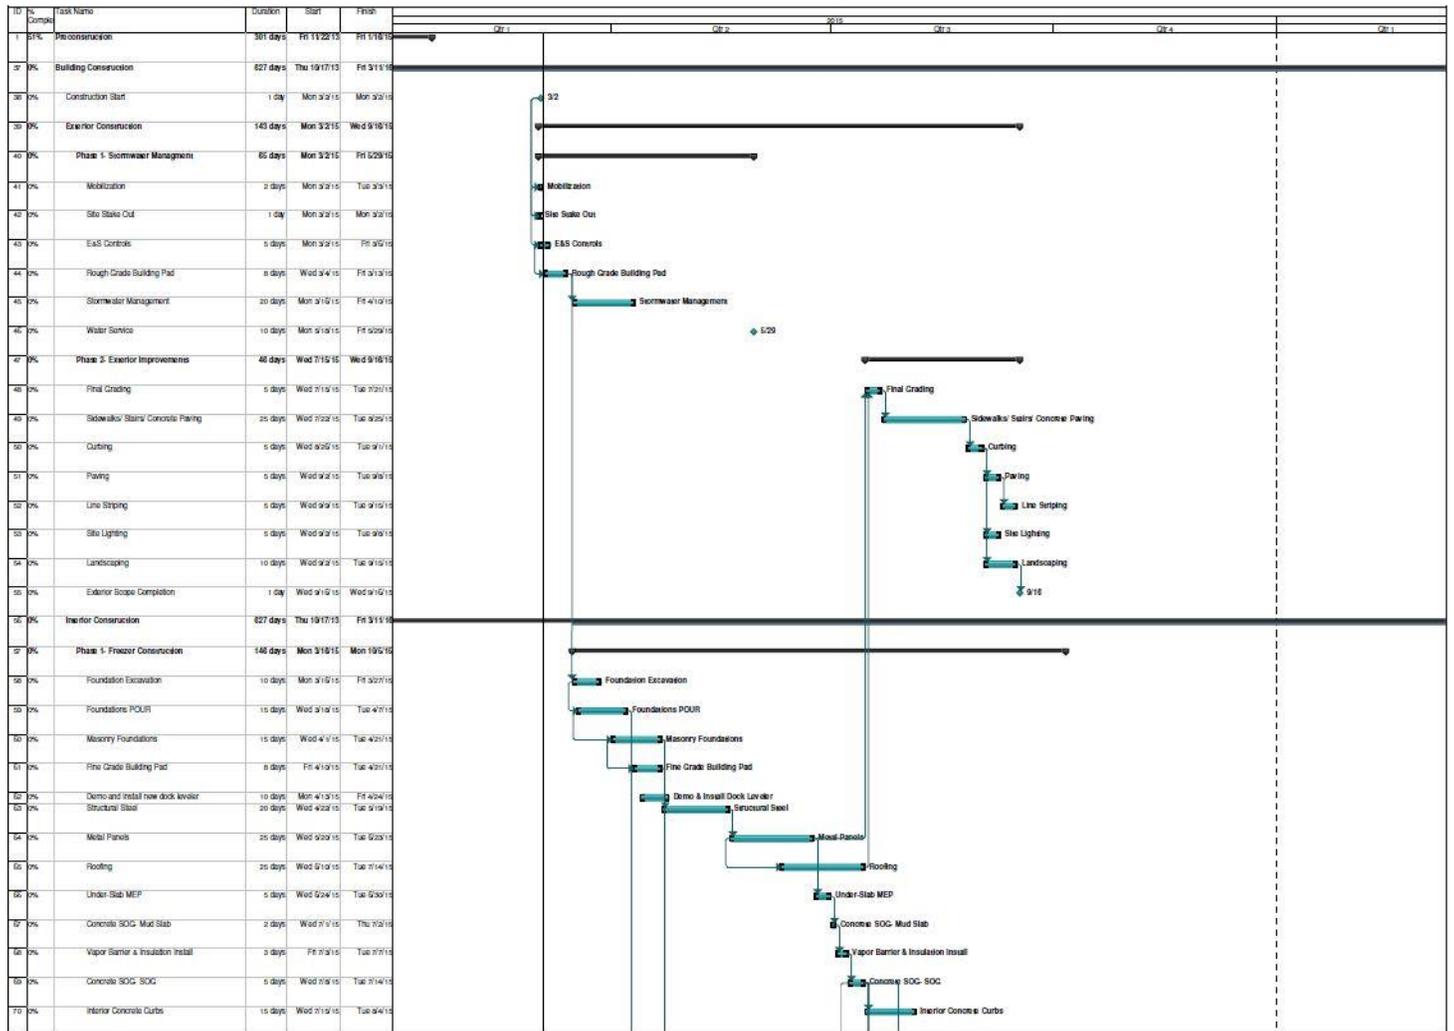
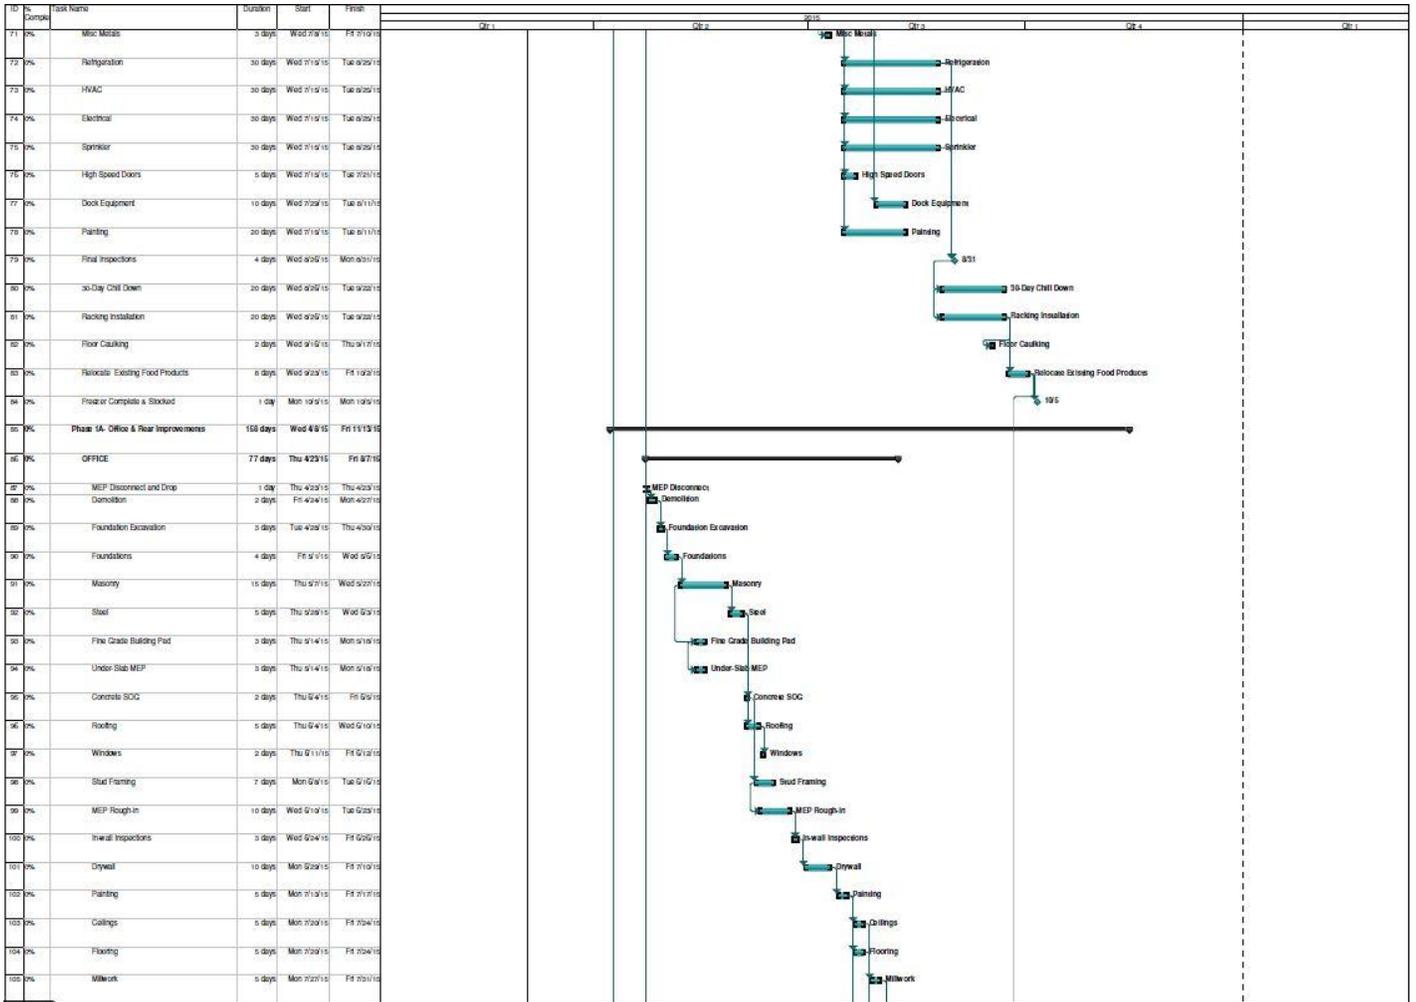
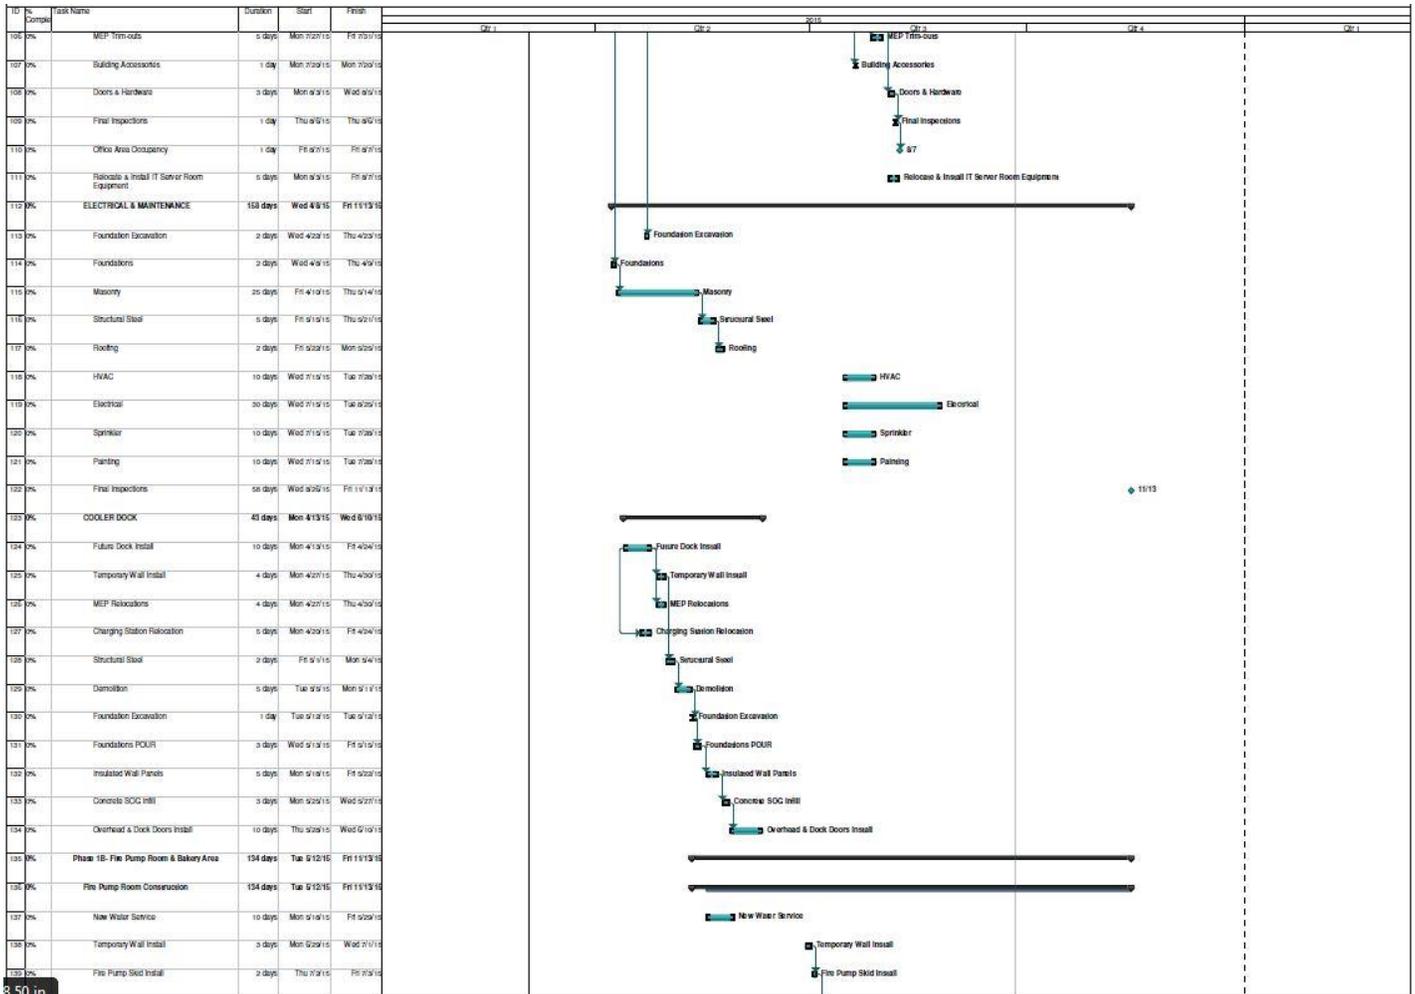
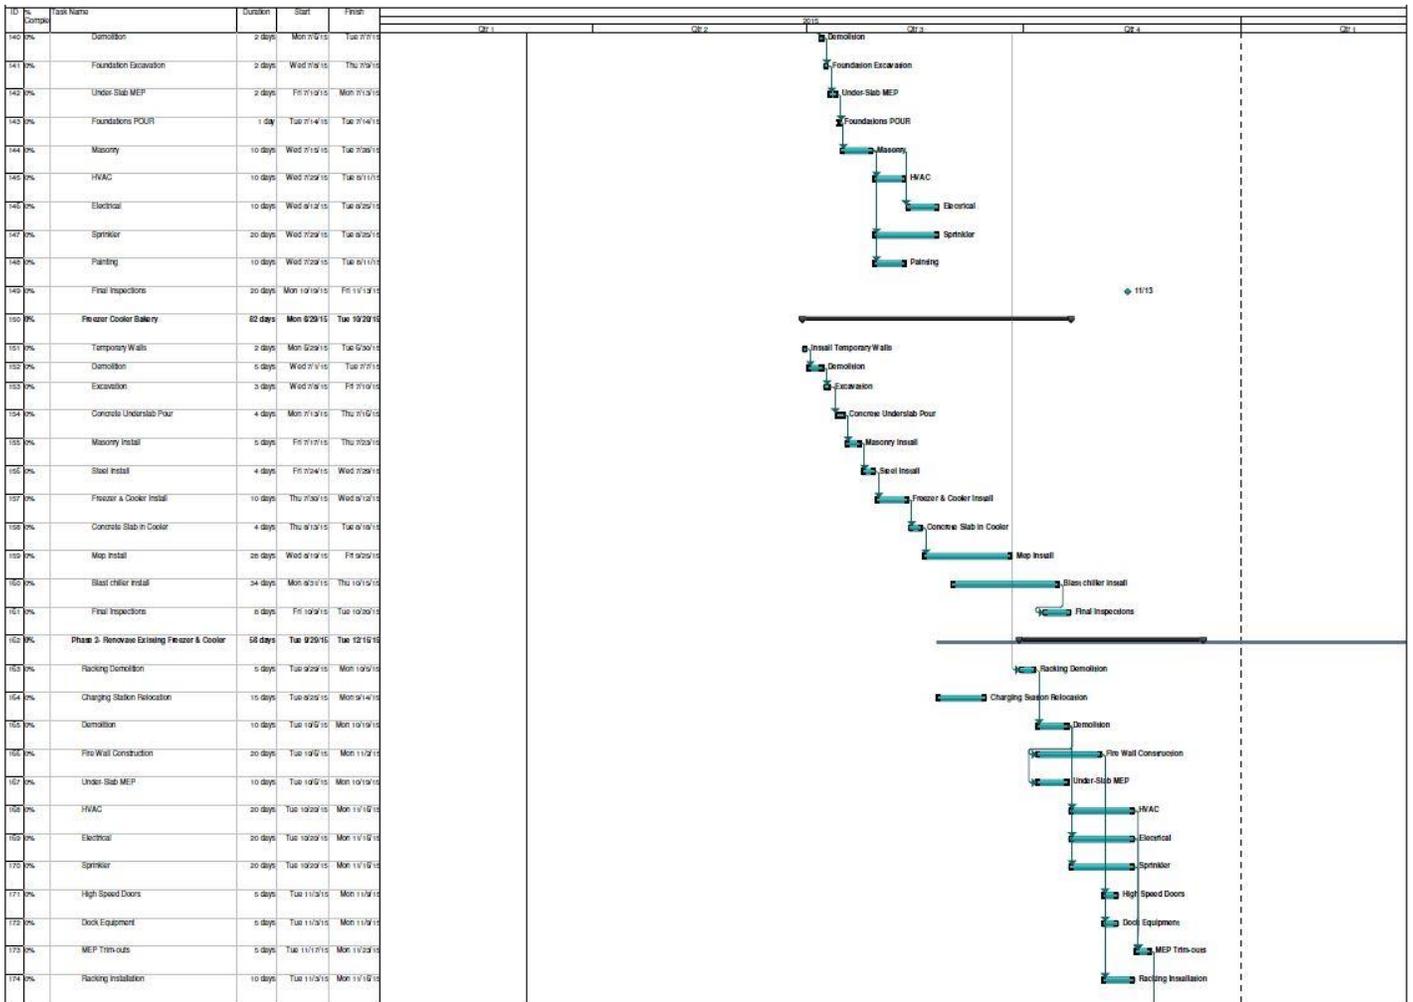
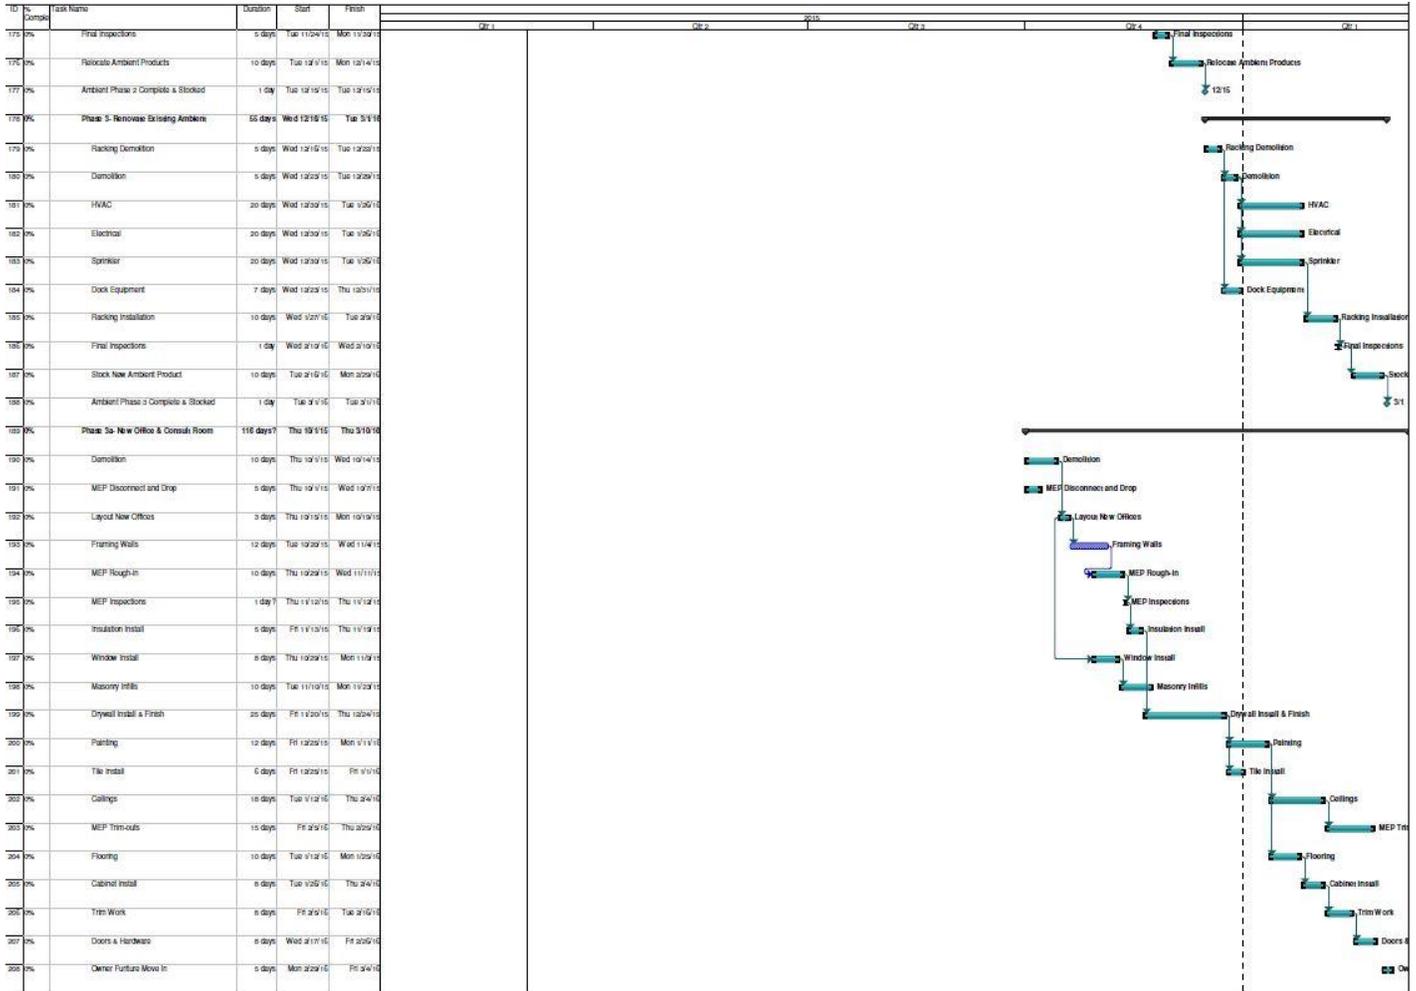
# APPENDIX A: SCHEDULE

The existing HFS Warehouse and Bakery Expansion will undergo three phases from the construction start date, March 2<sup>nd</sup>, 2015, and will be completed for owner occupancy one year later, March 2016. The design phase started in November of 2013. Phase one starts with the excavation and foundation of the warehouse addition located on the north side. The freezer construction is also a part of phase one starting on March 16<sup>th</sup>, 2015 and continuing for 146 days until October 5<sup>th</sup>, 2015. New freezer and refrigeration units will be installed to replace the aging and inefficient system currently in place. The office and rear improvements will undergo MEP rough-in for ten days from June 6<sup>th</sup>, 2015 to June 23<sup>rd</sup>, 2015. The MEP trim-outs will take about 5 days starting July 27<sup>th</sup>, 2015. The MEP for the freezer and cooler in the bakery will take 28 days and will start on August 28<sup>th</sup>, 2015. Renovations of the existing ambient storage area will be included in the third phase starting on December 12<sup>th</sup>, 2015. The final MEP installation will be located in the new office and consulting room. This will start October 1<sup>st</sup>, 2015 and end in February 25<sup>th</sup>, 2016. A full construction schedule can be found in Appendix A.
