## 7.0 Analysis 3: Case Study - Concrete Over-pour on Decks Due to Steel Deflection (Structural Breath)

### 7.1 Background

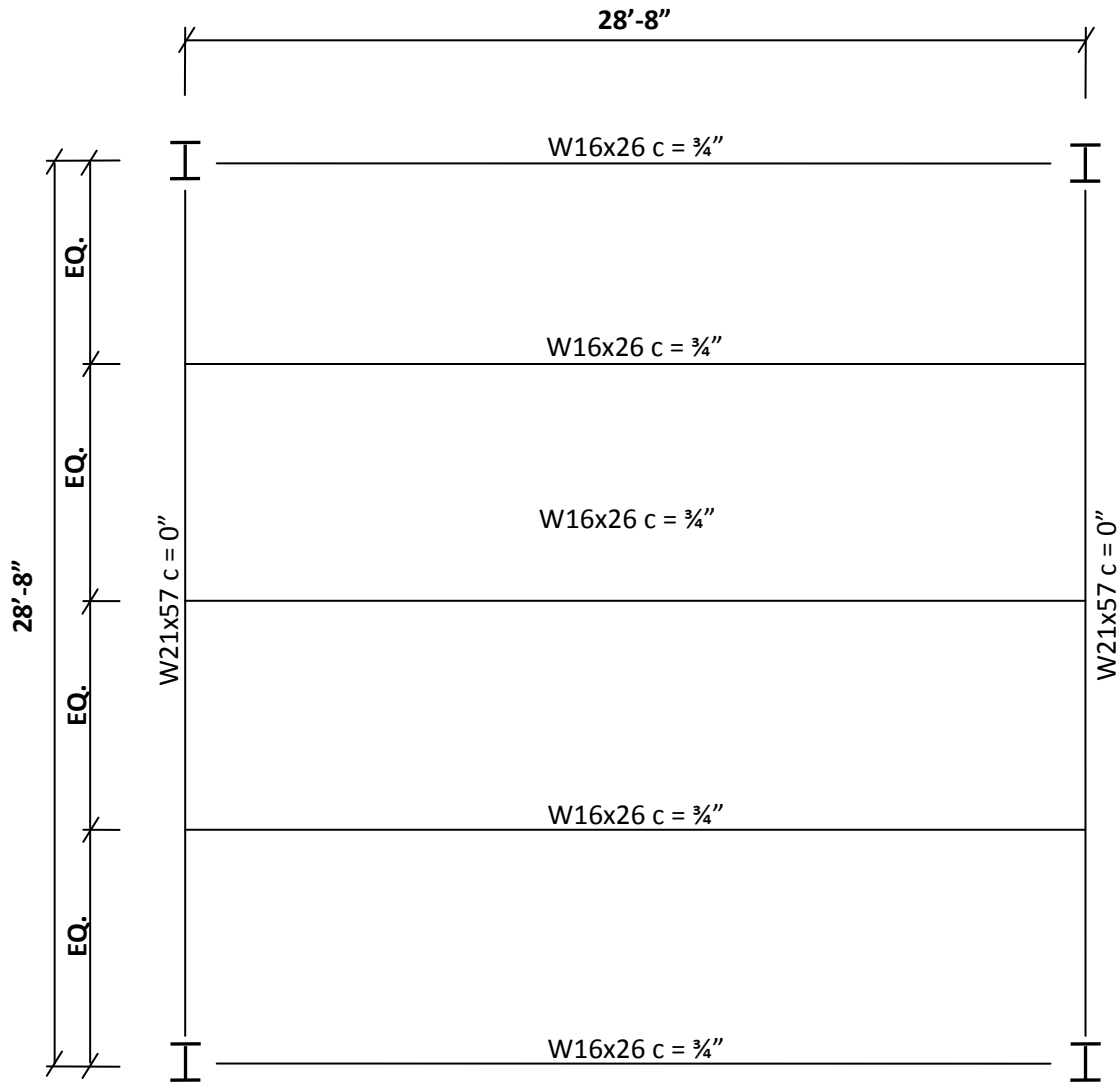
Figure 27: Typical Bay Plan

The typical bay is 28'-8" by 28'-8" with W21x57 (c=0") girders and W16x26 (c=3/4") beams with 3 equal spaces (see Figure 27 below).

After the decks were poured out the structural engineer conducted a survey of the concrete decks. They found that the typical bay deflected on average 1 ½” as predicted by the deflection calculations. The engineer ran the calculations and determined that the structure was capable of supporting the over-pour concrete.

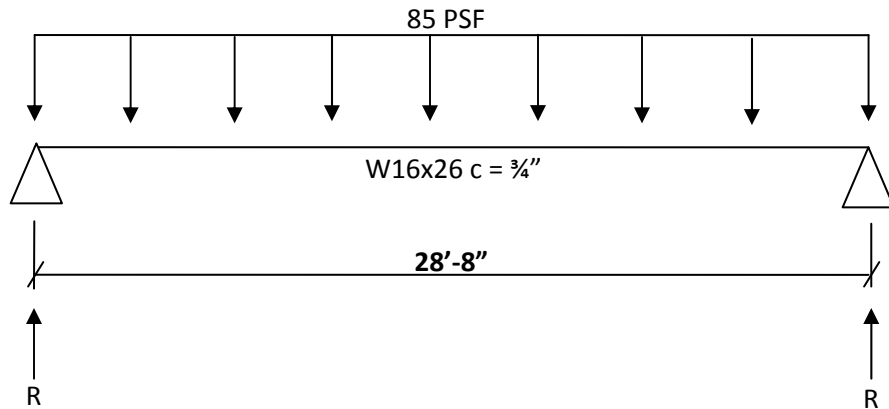
Simply Supported Beam – Uniformly Distributed Load

$$w = 85 \text{ PSF} \times (28'-8''/3) = 812.2 \text{ plf}$$

$$R = wl/2 = (812.2 \text{ plf} \times 28'-8'')/2 = 23.3 \text{ k}$$

$$\text{Deflection Max (midspan)} = 5wl^4/384EI = [5 \times 812.2 \text{ plf} \times (28.67' \times 12''/')]^4 / (384 \times 29 \times 10^6 \times 301 \text{ in}^4 \times 12) = 1.41''$$

$$\text{Deflection Max (midspan)} = 0.83''$$

$$\text{Difference} = 0.58''$$

Since this is the most common steel member in the building it would not be feasible to upsize the beam because it will weight 9 plf more which is the driving force in steel material cost.

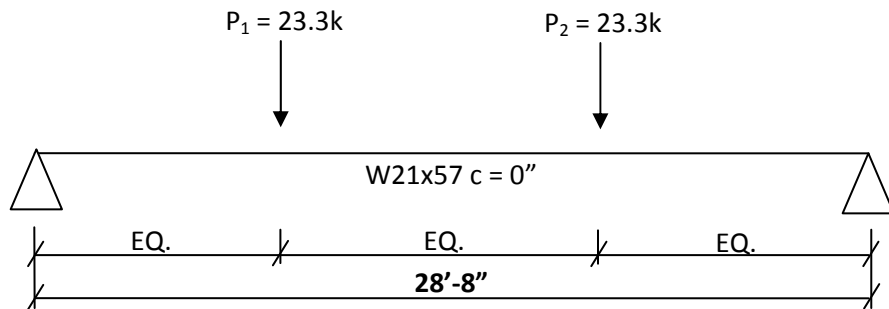
### Simply Supported Girder – 2 Equal Concentrated Loads Symmetrically Placed

$$R = P_1 = P_2 = 23.3 \text{ k}$$

$$\text{Deflection Max (midspan)} = (Pa/24EI) \times (3l^2 - 4a^2)$$
