STRUCTURAL BREADTH

The new river rejection system to be installed on the unoccupied first floor will contain new equipments and add tremendous new weight to the floor slab. The structural breadth will study and analyze the impact of the equipments on the beam and girder of the first floor.

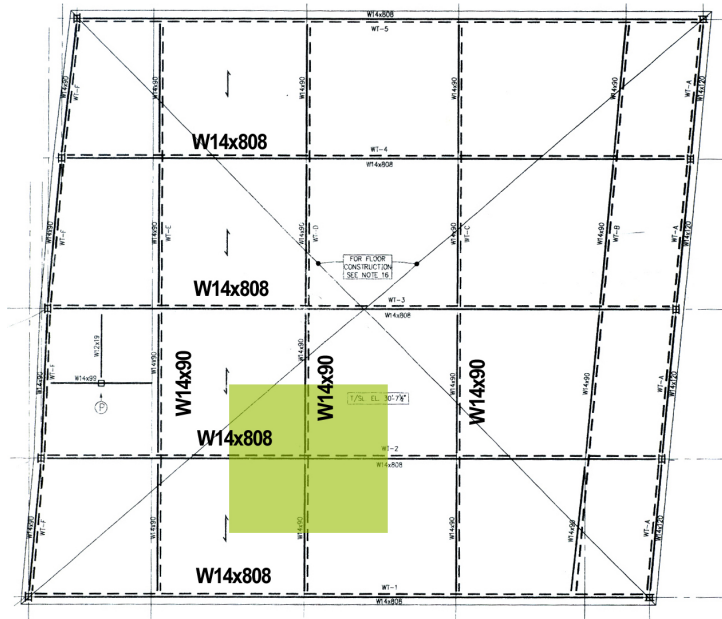
Figure 17. First floor structural plan.

To figure out how to load will affect the floor members; the location of the mechanical system needs to be laid out in order to determine which members will be affected. Figure 16 shows the sizes of beams and girders in question and also the space where the mechanical equipments will be placed.
