Project Introduction

Crystal Plaza II is a renovation and expansion of an existing 12 story building at 220 South 20th Street Arlington, VA, effectively adding eight additional stories, a rooftop pool and work out complex, and a street level commercial space to a once commercial office building, now turned multi-unit, high-end residential complex.

Christopher R. Stultz | Construction Management
Dr. David Riley | Advisor

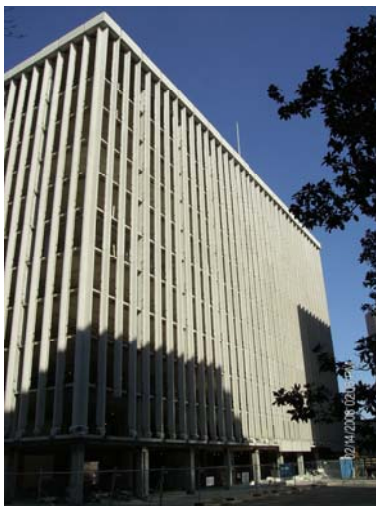
Figure 4 Exterior precast façade, south, to be removed

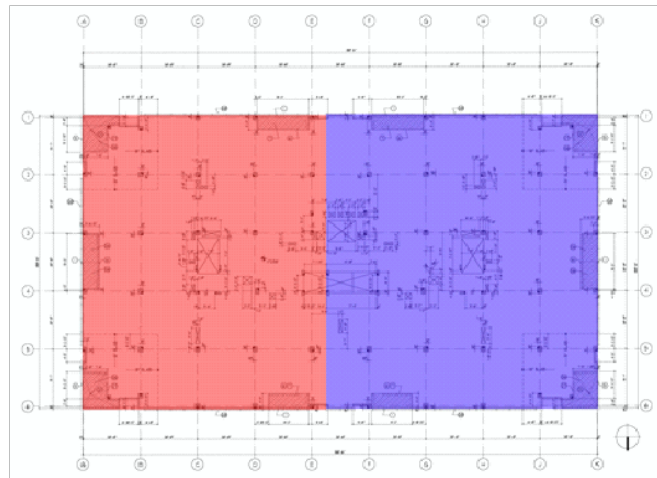
Figure 5 Typical slab pour sequence with area/pour 1 in red and area/pour 2 in blue

Floors 13-20 feature a cast in place, post tensioned slab. Concrete was placed on the reusable plywood formwork, supported by aluminum I-beams, using a 3 yard concrete bucket hoisted by the tower crane. About a floor a week was constructed in a two pour per floor sequence to allow material staging and forming. Each pour was approximately 200 CY and required a day to place and finish the concrete. Two different mixes, 5000 psi and 8000 psi, were used on each floor and required coordination between the concrete sub contractor, the supplier, and the general contractor. A “puddling” method was also used over critical columns that required 8000 psi concrete.

After the concrete was placed and work began on the second area, bracing, shoring, and formwork began erection over area one, typically within 24 hours, allowing a quicker floor sequence and a decreased schedule. The formwork for the pour was left in place until the concrete reached 75% of its 28 day strength. Re-shores were also used three floors below the active pour for four total levels of shoring to provide support of the construction loads, and the post tension cables were stressed when the concrete strength reached 3000 psi.

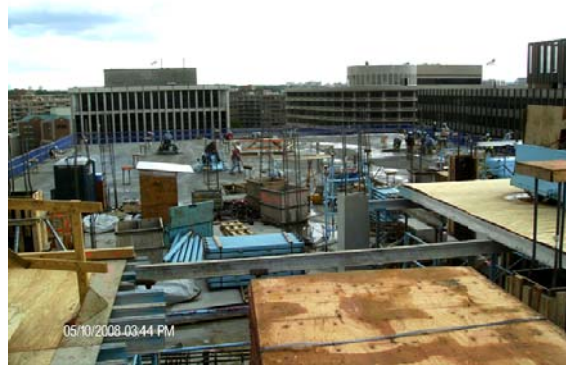
Figure 6 View of 13th floor west pour (area 2) from 14th floor east framing, 2 days after 13th floor east pour (area 1)

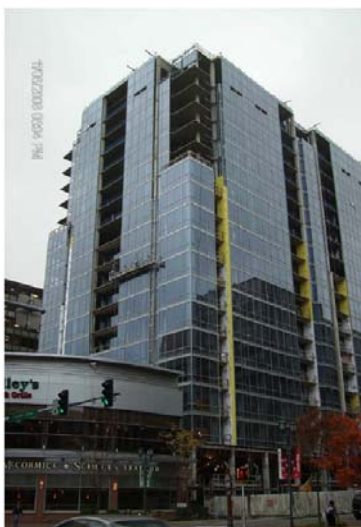
Figure 7 Installed curtain wall, northeast

The curtain wall is a unitized system which features an operable window panel for the apartments. The curtain wall is an aluminum frame, low-e glass system that attaches to the slab via concrete imbeds. For the existing slab, a plate was attached to the slab to provide a connection point. The design of the system was the responsibility of a separate architect, and testing/quality control is performed by an independent consultant. To keep the project on schedule, the curtain wall was released for manufacture before construction began. The specialized pieces, such as corners, terrace walls, and come backs will be constructed after the given section of unitized pieces are in place. This provides a large risk to the project as it strives towards water tightness, especially with the limited capacity and location of the supplier/sub contractor in Buffalo, NY.

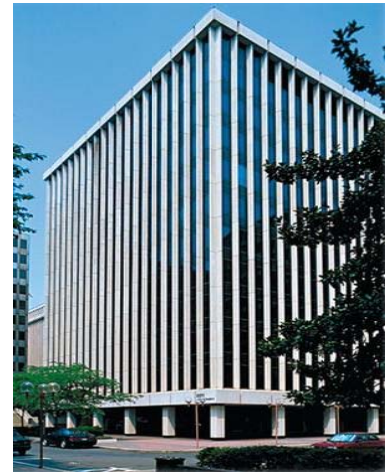
Figure 9 Existing precast façade to be removed

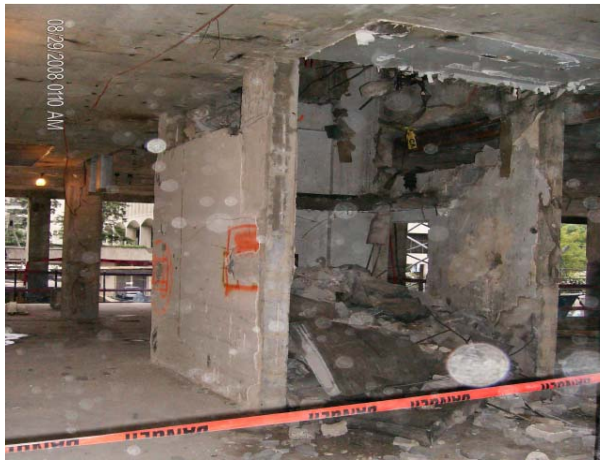
Figure 14 Demo of existing stair tower

The other large openings posing issues were the new stairs and elevator shafts. After demolition of the existing stairs, the opening was enlarged and shifted to center the stair towers. The demolition included removal of upturned and regular concrete beams, thus requiring the need for additional structural support by means of W steel shapes, as seen below. The steel needed to be placed prior to the demolition and thus the need for proper sequencing becomes vital. The necessary process for installation of steel, inspections, demolition, and reconstruction needed to be detailed so as to not create a possible hazard or delay. A similar process was required for the elevator shafts.

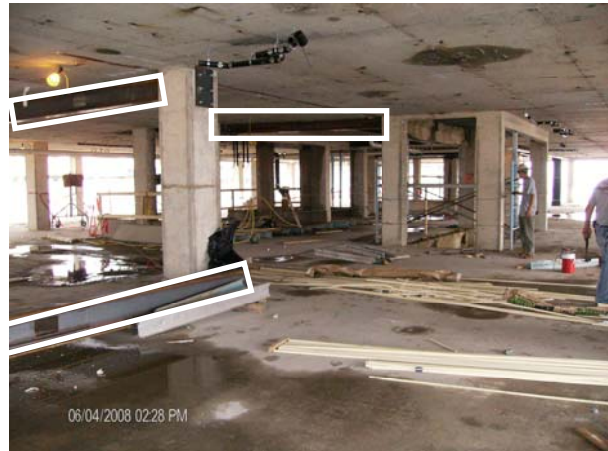
Figure 15 Structural steel reinforcing around stairs and elevators. Piece on lower left to be installed

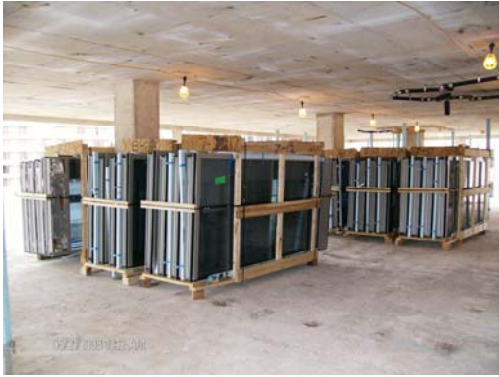
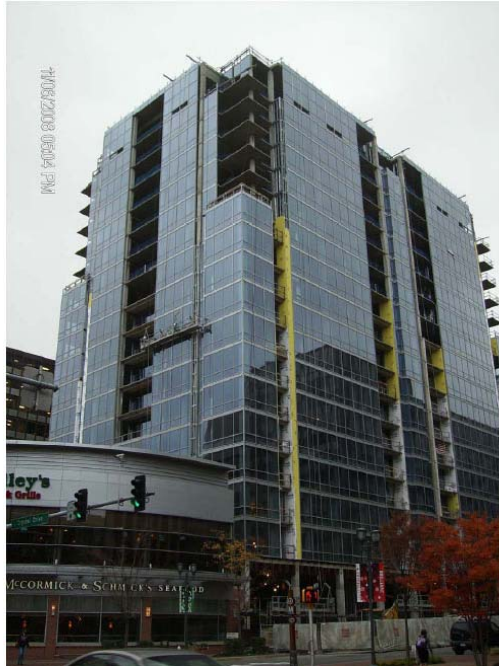
Figure 16 Stored and installed curtain wall panels

The curtain wall for Crystal Plaza II is custom designed to include operable windows and spandrel panels to cover exterior bay columns. Also included is the need to integrate doors for use of the designed balconies. These details create issues of interface and weatherproofing and must be taken care of in the submittal review process. The long lead time for the curtain wall, especially due to its custom nature and the location of the manufacture not only present an issue, but put the curtain wall on the critical path. Also, as part of a renovation, the lower levels required field measurements of the structure to ensure a proper fit of the curtain wall panels.

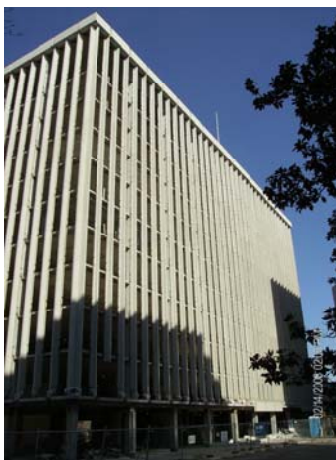
Figure 17 Exterior pre-cast facade to be removed

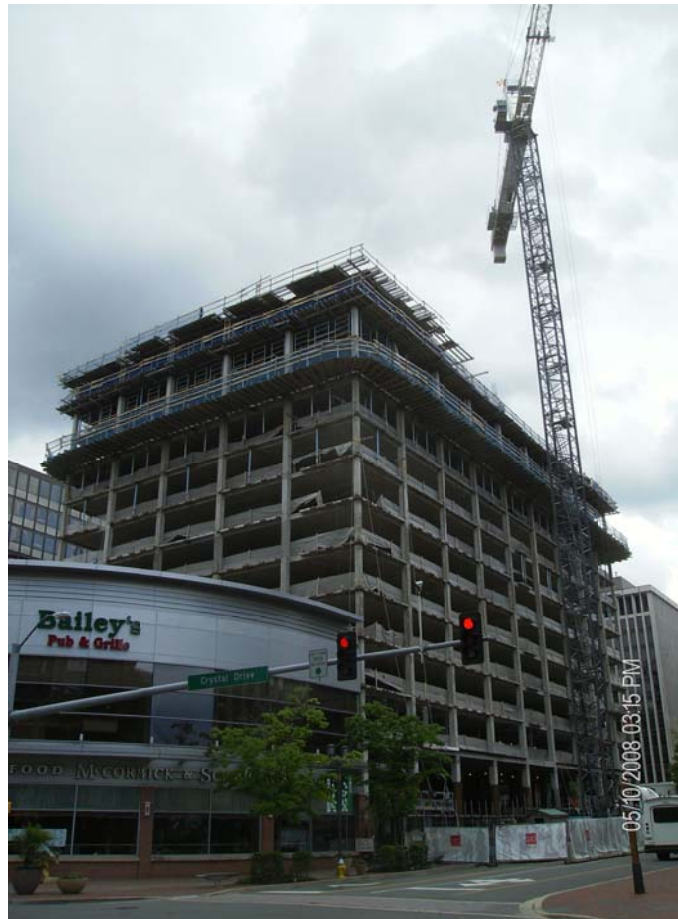
Figure 20 Superstructure and facade phase beginning
