# La Jolla Commons Phase II Office Tower

San Diego, California

Alyssa Stangl | Structural Option  
Faculty Advisor | Dr. Hanagan

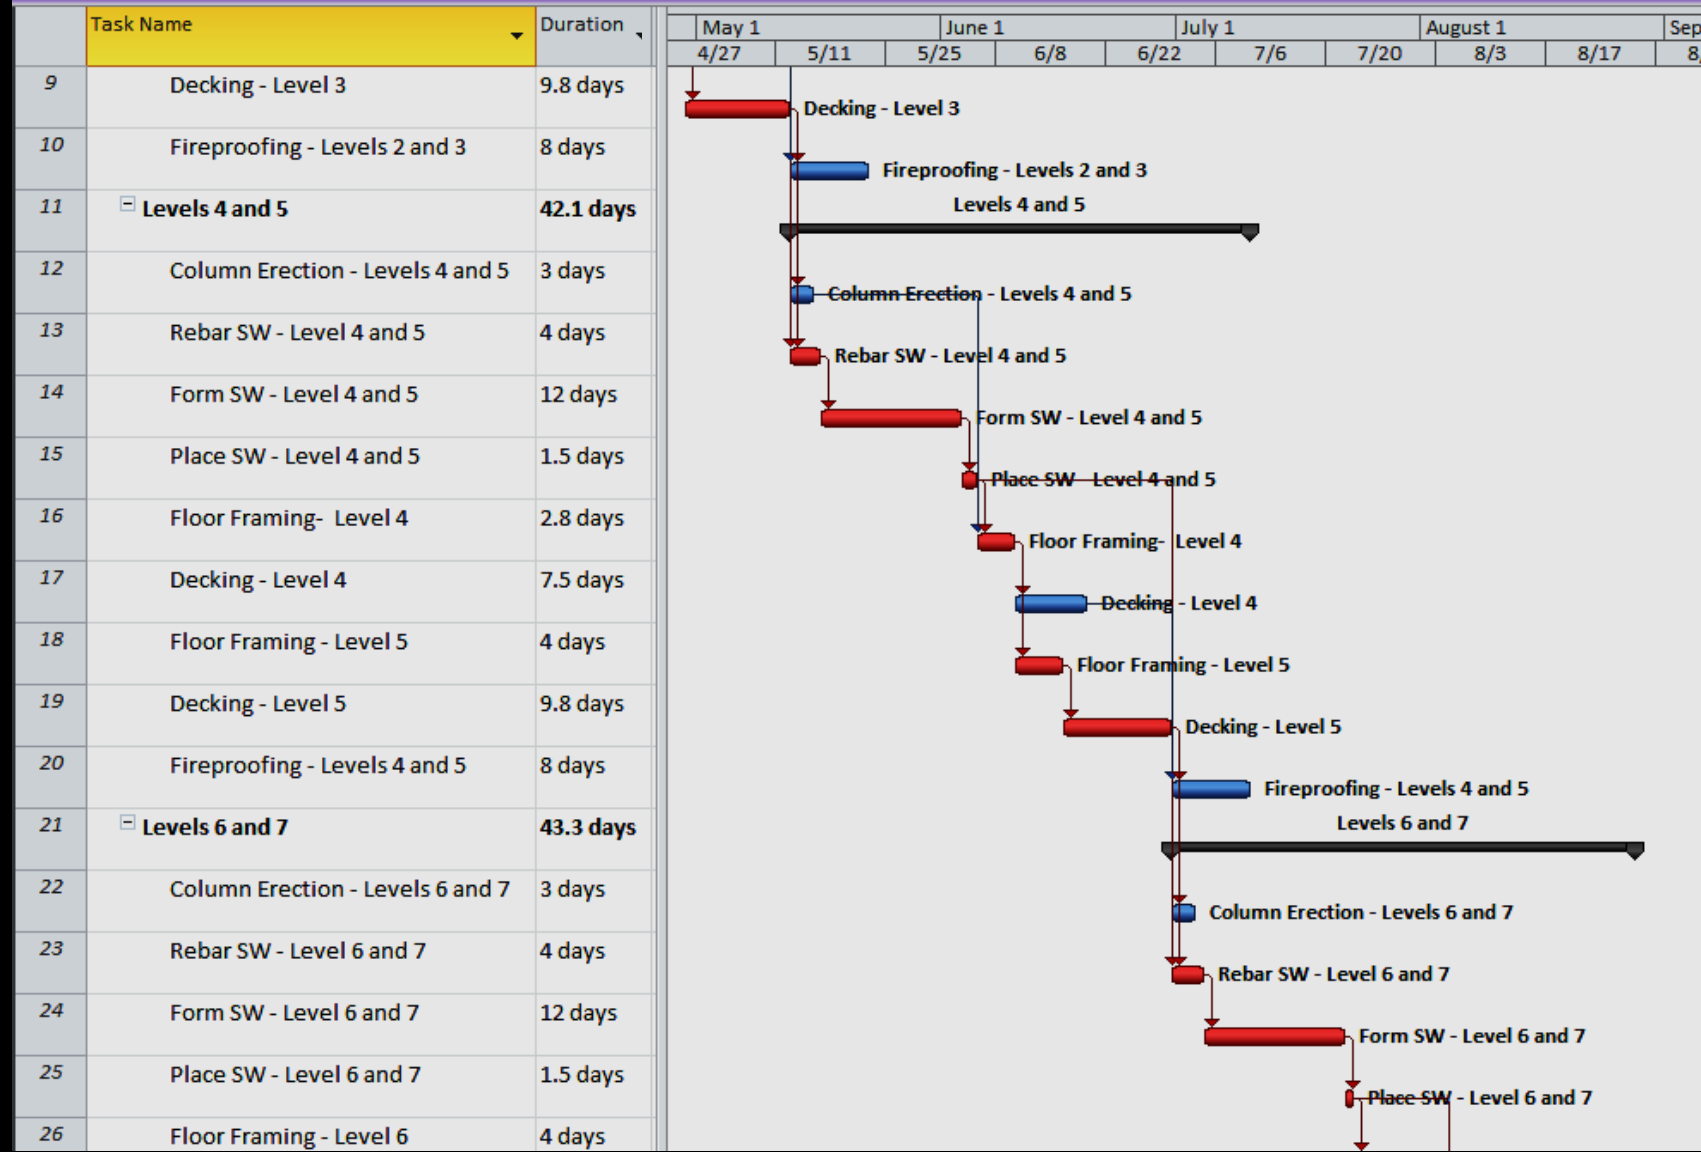
# Steel System Schedule

- Schedule produced in Microsoft Project
- Durations from RS Means 2009
- Superstructure duration | 230 days

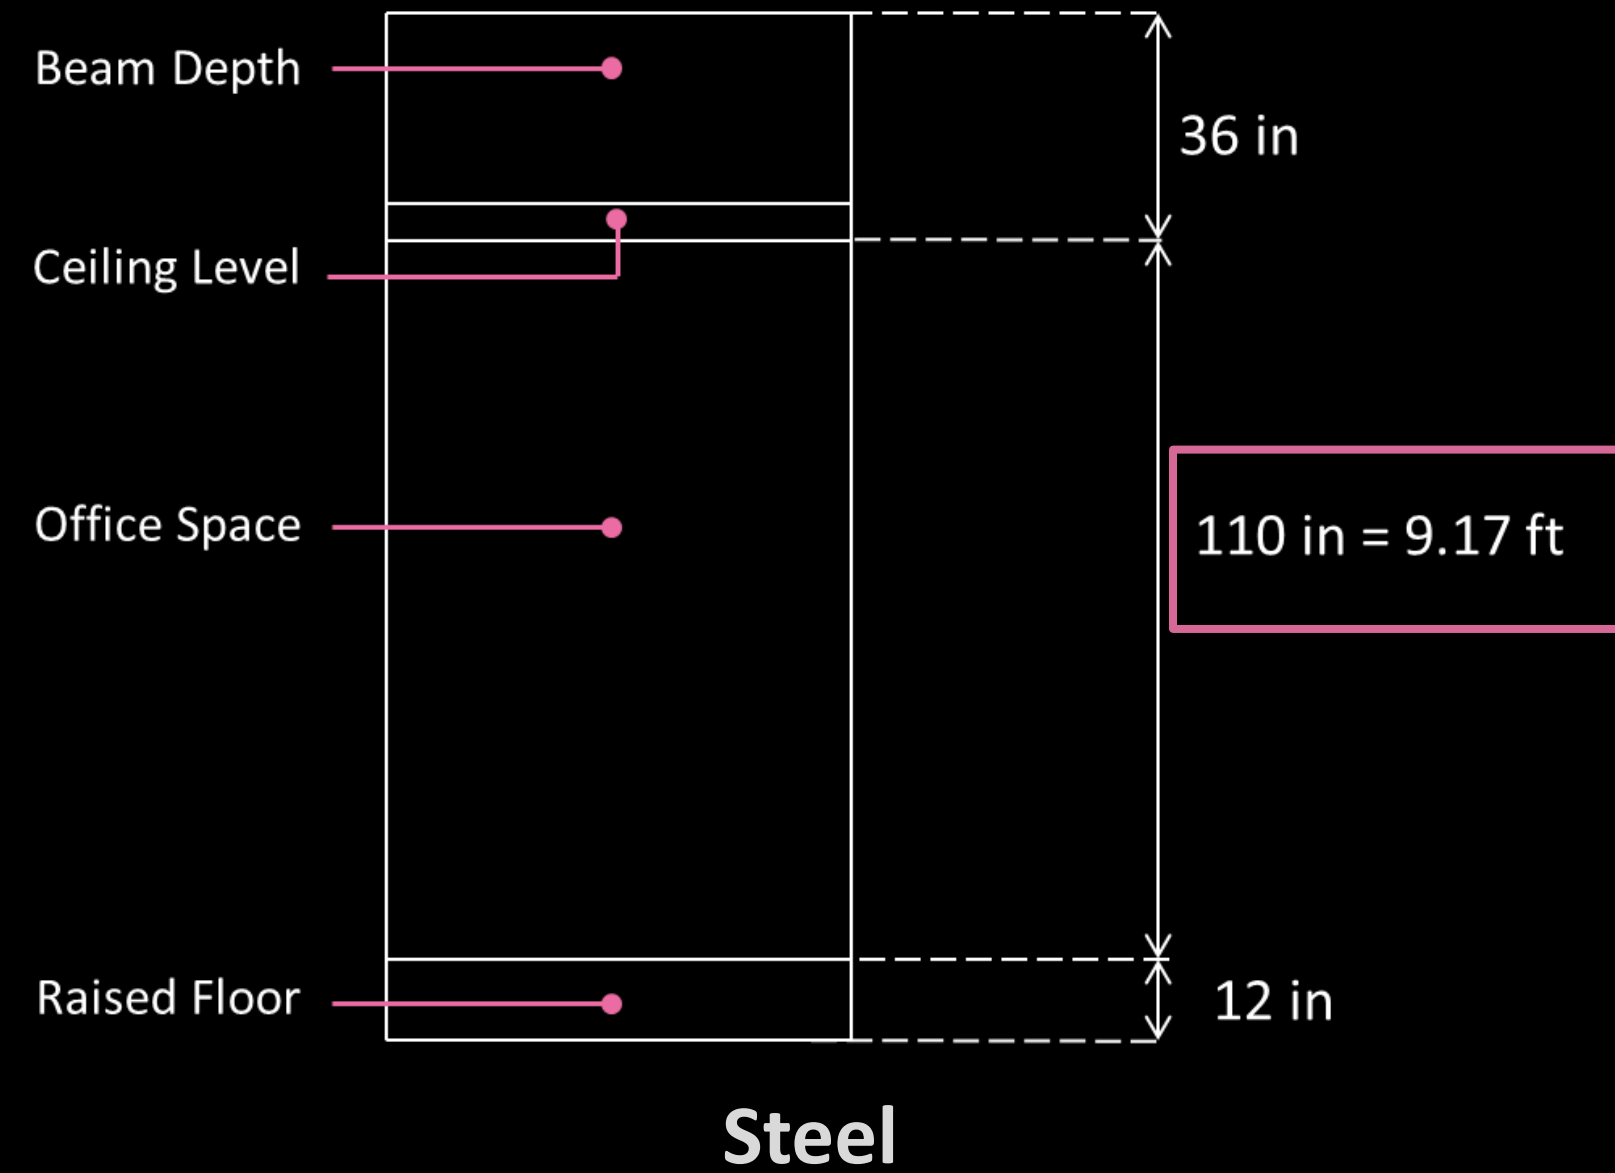
## Floor-to-Ceiling Height

**1'-6" Decrease in floor-to-ceiling height**

- Building height limited to 198'-8" by FAA
- Steel creates a deeper structural system than concrete
- Loss of floor-to-ceiling space

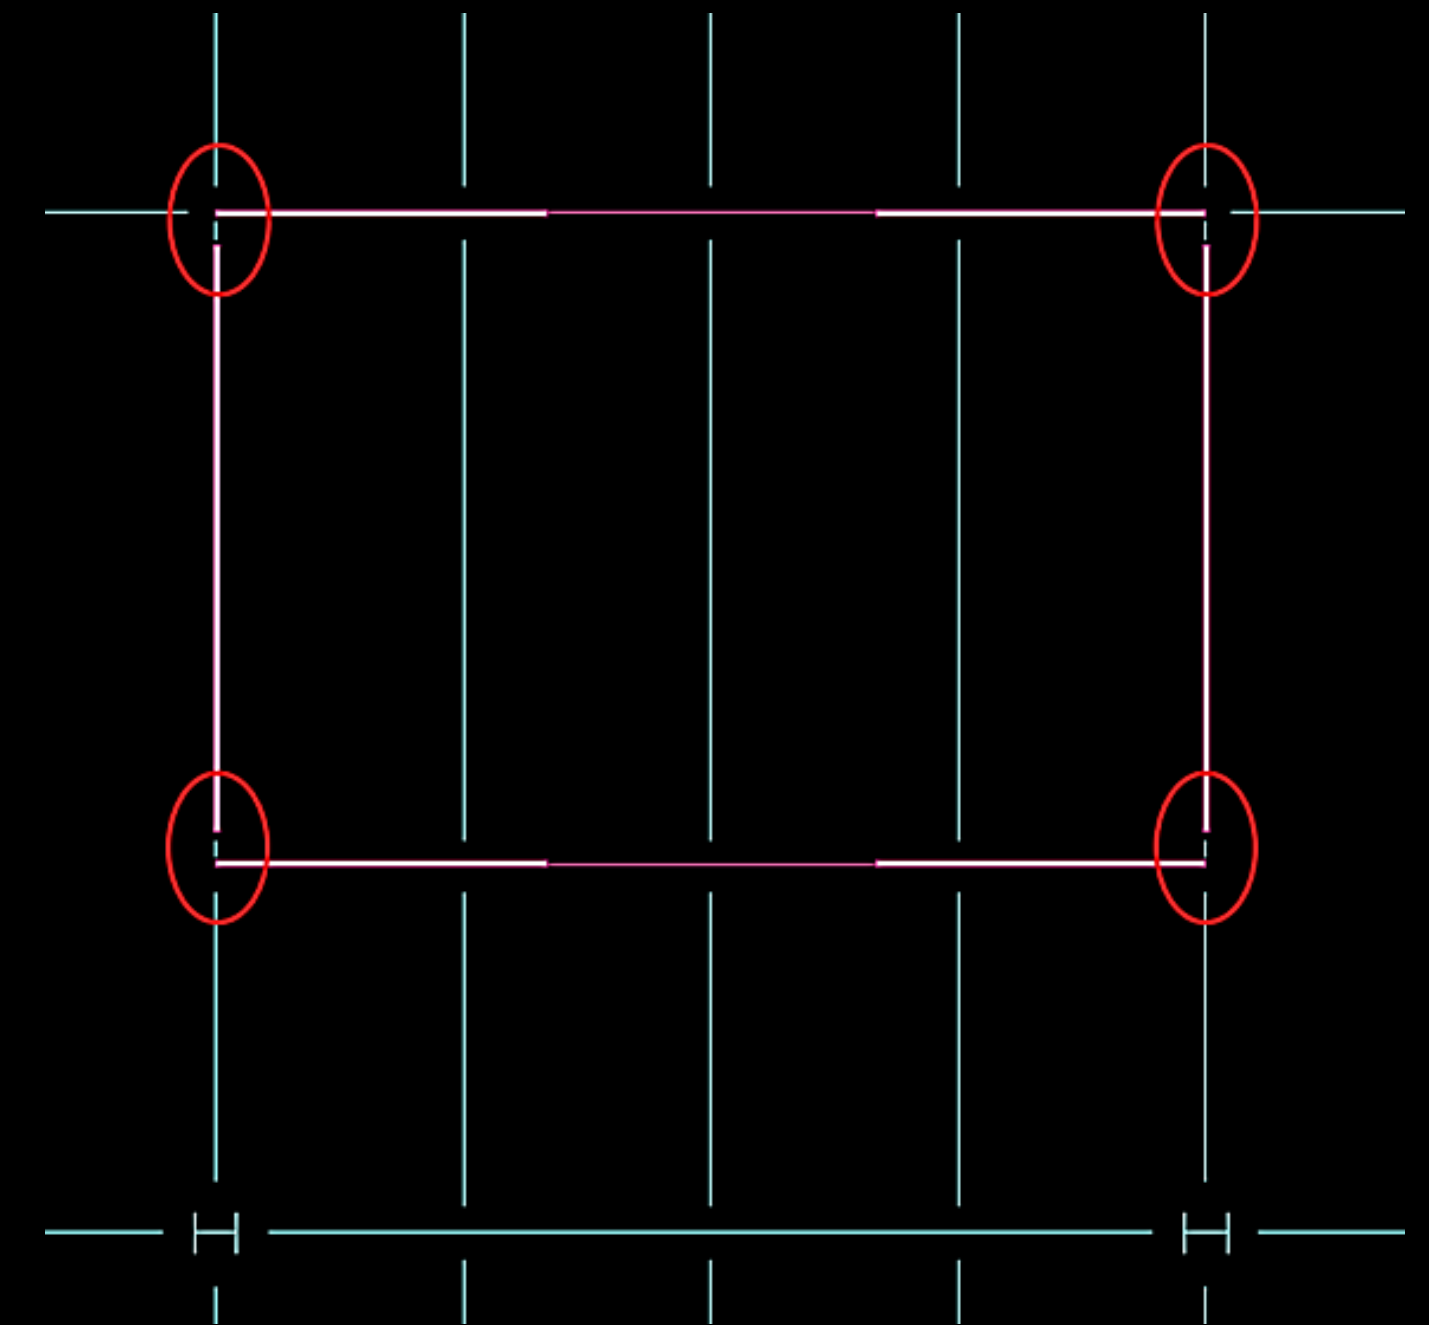
## Shear Wall Modeling Method

- Shell elements connected at nodes caused an irregular distribution of torsional forces within the wall core
- Bentley suggested disconnecting the shear walls and adding gravity framing elements to eliminate a “framing tables” error
- Does not count on flanged walls to take out of plane loads or to help in flexure
- Eliminated odd torsionally anomaly
