# Memorial Vista

A North Virginia Office Building

## Technical Assignment II

William J. Gamble | 5<sup>th</sup> Year – Construction Option | October 16<sup>th</sup>, 2013

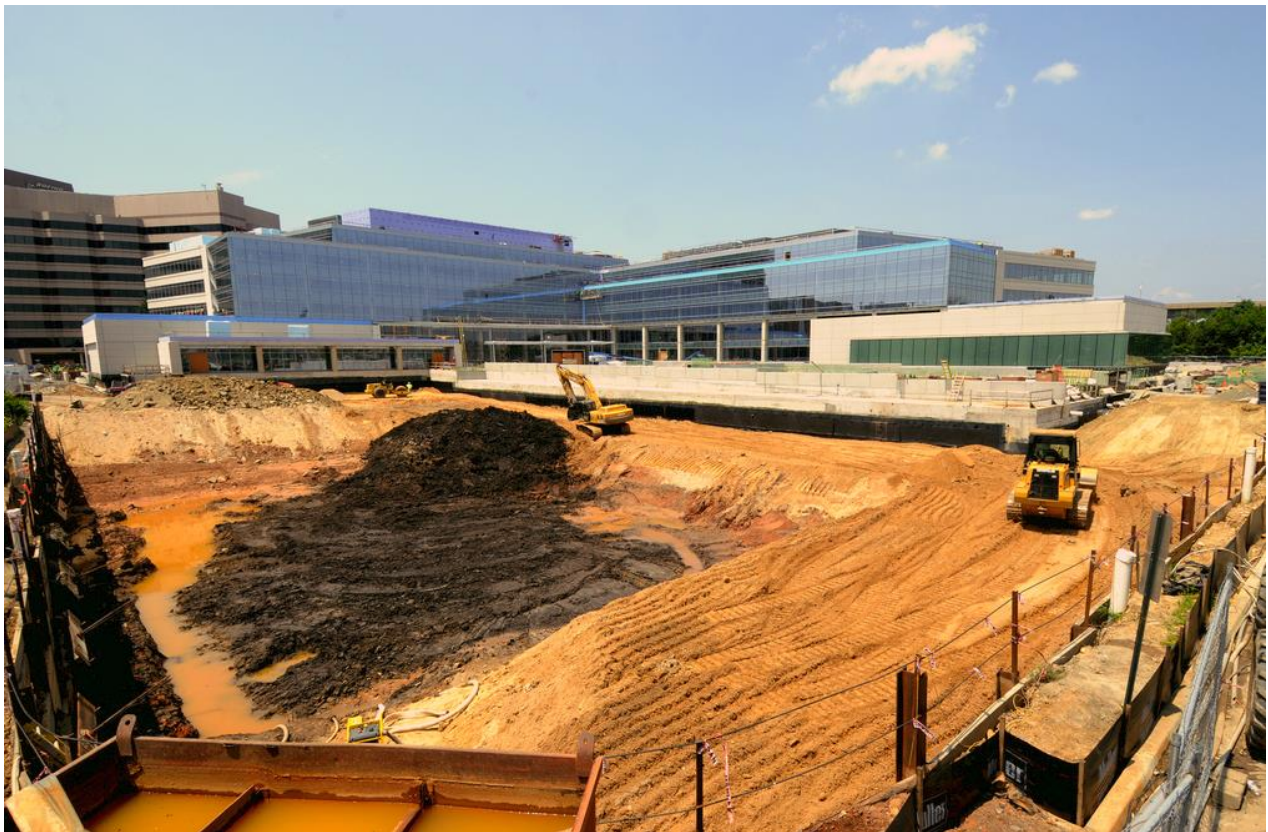
Figure 2 – Excavation for Future Addition (Courtesy of Davis)

An aspect that also must be kept in mind is that the majority of the buildings that originally accompanied the site at one time had an industrial use to them. This being said, each location and surrounding location would need to be checked for contaminated soil. The owner requested that the entire site be excavated for this purpose to eliminate the possibility of contaminated soil in the chance that further renovations or additions take place. Figure 2, below, shows the excavation of the future foundation for an addition on to the building. This was to be filled in after the excavation takes place and any contaminated soils are removed. To complete the entire excavation of the site, Davis decided the best tactic would be to excavate each wing of the building (North and South) and then the remaining land. This can be seen in the site layout plane, during the excavation phases later in the report.

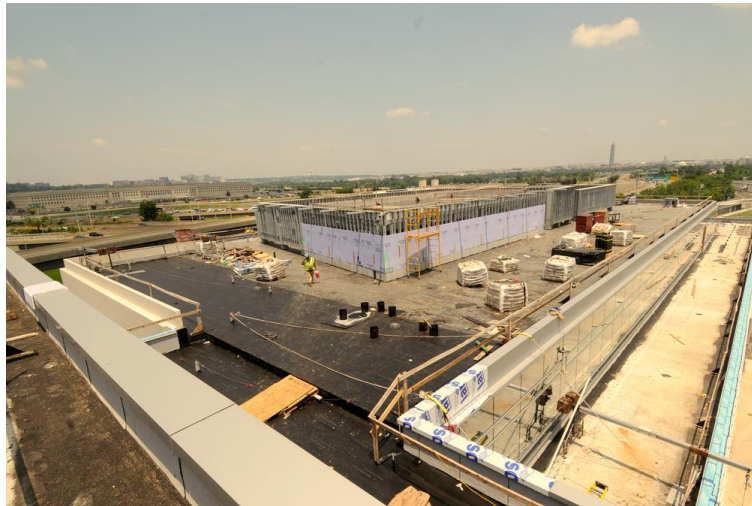
Figure 4 – View of Penthouse from Roof (Courtesy of Davis)

On the top of the building is the penthouse, this space contains two cooling towers, 2 chillers, and a single heat exchanger. Surrounding this space is various types of roofing, ranging from roof pavers to a fluid applied protective membrane with gravel on top. The pavers were used where balconies are located to allow for the safety of the occupant and prevent them from tripping. There are also raised planters on the roof where the balconies are located to allow small gardens to be a part of the roof and to cut down on the heat island effect. The most important aspect when scheduling the construction sequence of the roof is not necessarily the roof materials, but rather the mechanical equipment that will be housed in the penthouse space. These items have long lead times, and drive the schedule for when the roof can be completed. Figure 4, below, shows the framing of the mechanical room penthouse. It can be seen that the completion of this penthouse is holding up the roofing phase of the project.
