# Wellington Condominiums

Exton PA

### **Technical Analysis in Existing Construction Conditions and Project Management**

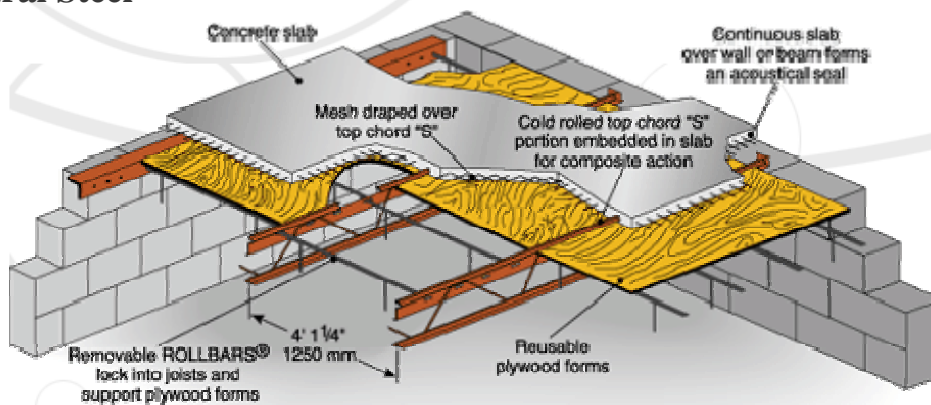
**Figure 2:** Typical Usage of Hambros Joist System Prescribed by Manufacturer – Reference: [www.swirnow.com](http://www.swirnow.com)

The Wellington Condominiums project did not make use of large structural steel components but is using a very innovative system called the Hambro's joist 3" slab on deck composite system. The second, third, and penthouse floor make use of this system. This floor's bearing and shear wall components were designed into the Wellington Condominiums project by the stud engineer and made use of 4" and 6" metal stud walls at 16" o.c. These walls are capable of carrying the loads directly and therefore make it very easy to lay up this composite system. The general steps with advantages to this system are laid out as prescribed by the manufacturer Swirnow Structures.

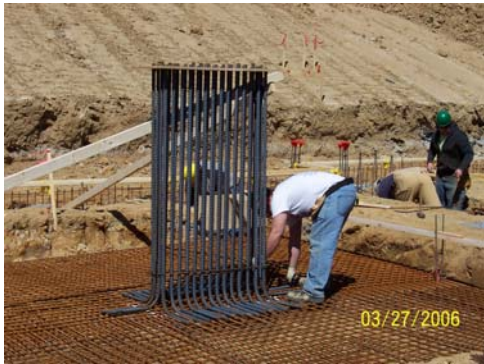
**Picture 1:** Column Footings being erected

Since the soil at the time had enough cohesion to stay in place, the foundation strip and column footings did not require any horizontal or vertical formwork. The only task left was to situate the footing rebar and place the concrete with a concrete pump at the locations required. Once the footings were to the strength required, the foundation's exterior walls and columns took form with large gang forms. These large forms took shape very quickly with a 120 ton AmQuip crane tipping up each one into position. The formwork was connected and reinforced into place with lateral bracing. After the formwork was set and properly supported, the rebar was placed in the foundation walls

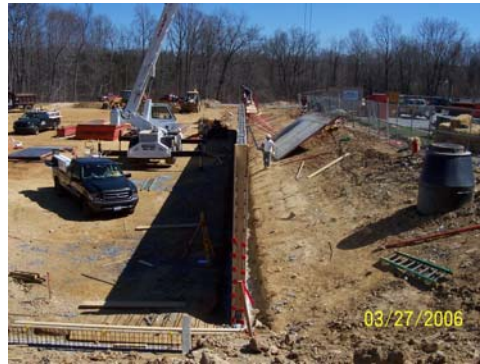
**Picture 2:** Vertical Formwork being used for Foundation walls

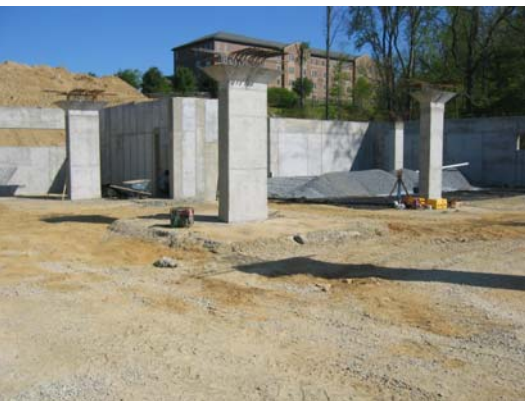
**Picture 3:** Foundation Columns and Footings installed prior to slab on grade

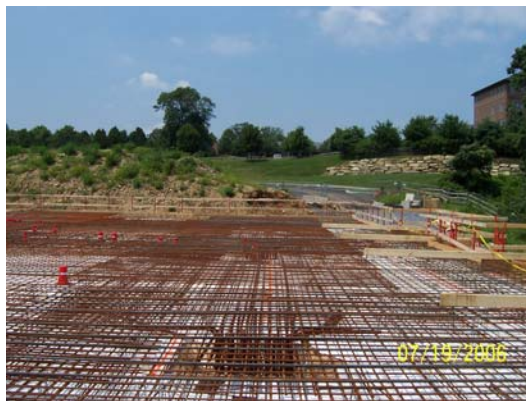
**Picture 4:** 12" transfer slab on first floor before pour

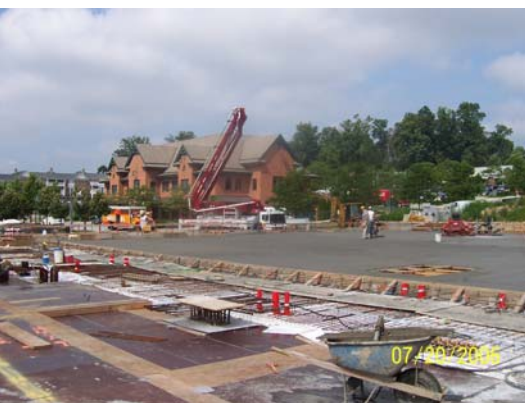
**Picture 5:** First of three pours on first floor with concrete pumps utilized

After pouring the slab on grade with the concrete pump the next focus was on the first floor. The first floor would be the first encounter and need for horizontal formwork. The formwork consisted of setting up metal shores, stringers, and joists with plywood as the sheathing. The first floor's vertical formwork would also make use of plywood as the ease of handling and construction. The rebar and roughins were situated and the concrete was placed using the concrete pump truck. For pictures of the horizontal and vertical formwork used on the Wellington Condominiums project see Appendix A.

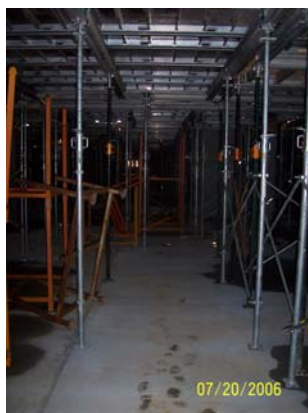
**Picture 6:** Horizontal Formwork being utilized for the first floor pour
