50 Connell Drive

Technical Report #3
Alternate Methods Analysis

50 Connell Drive Office Building
Berkeley Heights, NJ

Submitted 11/21/08
Submitted by: Jason Salyer
Option: Construction Management
Thesis Advisor: Dr. Messner

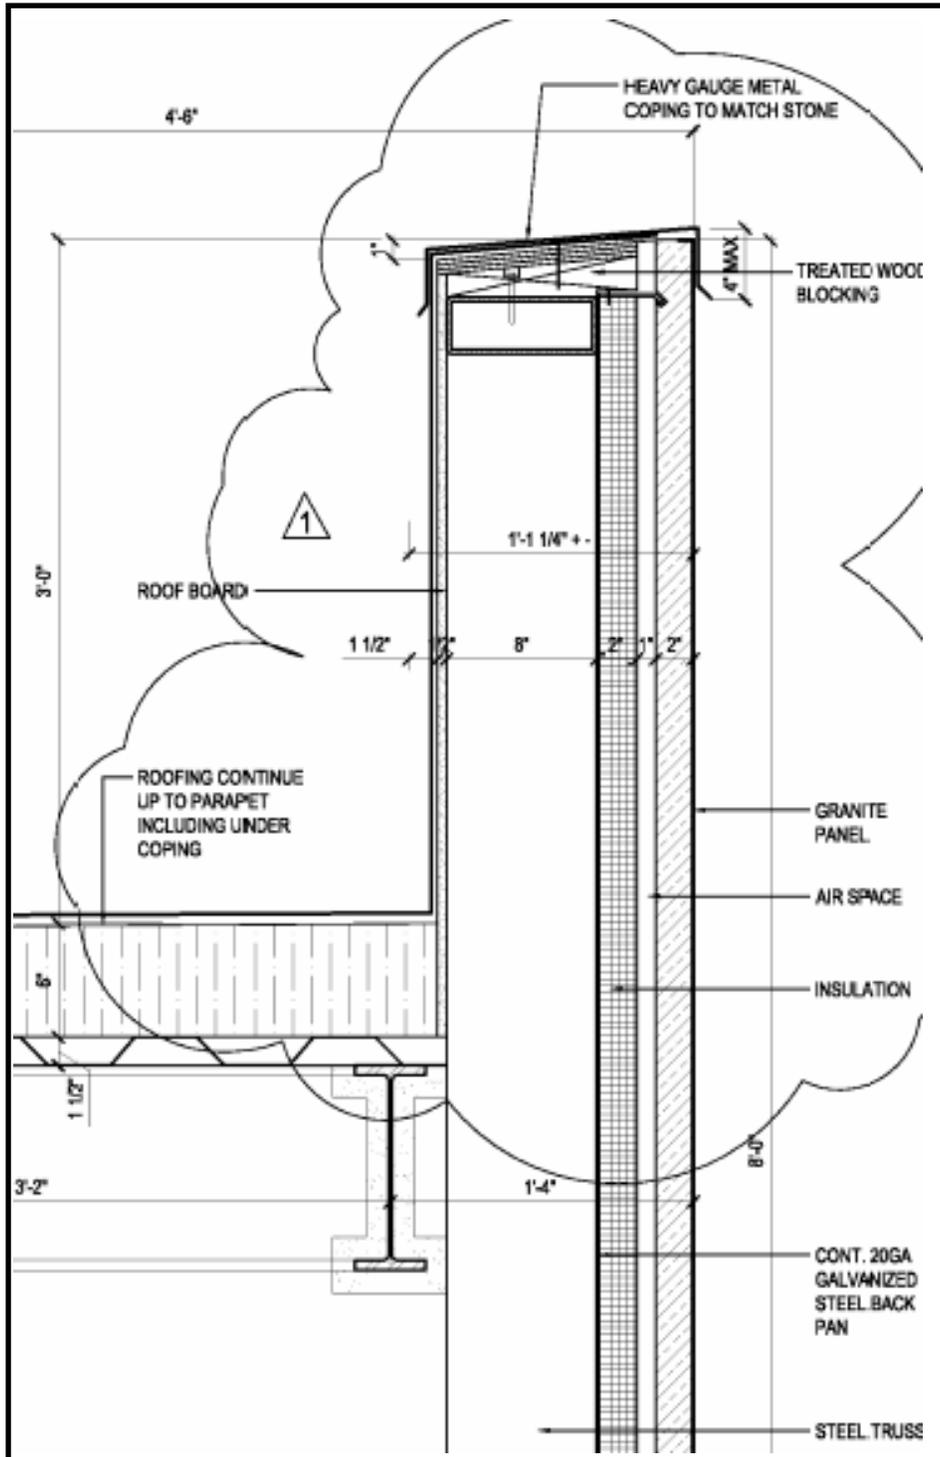
Figure 2 – Parapet Detail Showing Rubber Roofing Under Coping

Turner was able to save the Connell Company about \$30,000 by altering the design of the roof parapet. The original design had aluminum panels on the inside of the parapet to provide a layer of weather protection. These panels extended along the entire 900 foot perimeter of the building. The construction team suggested that an alternate design be implemented. They determined that the aluminum panels were not necessary and eliminated them from the design. Instead of using the metal panels the new design simply extended the EPDM rubber roofing membrane up through the parapet and under the coping. Refer to **Figure 2** to see the re-designed parapet details. This resulted in a design that functioned just as well as the original design. The membrane has certain characteristics that make it desirable for this application. EPDM rubber has excellent

resistance to weathering, low temperature flexibility, low electrical conductivity and satisfactory resistance to polar chemicals.

There are several advantages to this system. The cost to extend the rubber membrane the extra distance was negligible compared to the cost of buying and installing the aluminum panels. Less labor was required since the same crew that installed the roof was now weather guarding the parapet. This reduced the schedule time to complete the parapet. The owner was very pleased with the re-design. Neither the quality nor the aesthetics were sacrificed to cut costs. This was an excellent implementation of value engineering.

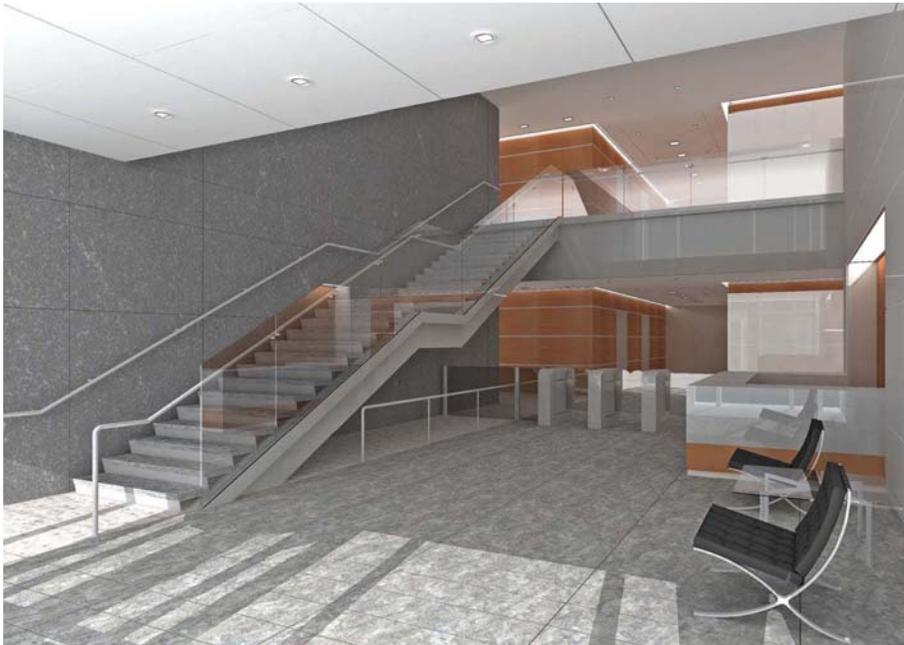
Figure 3 – Rendering of Lobby

As mentioned in an earlier section the lobby staircase was an item that implemented value engineering. Refer to **Figure 3** for a rendering of the lobby. The original design called for stainless steel. Stainless steel is a very expensive product and as a result Turner began looking for ways to reduce the cost. This was a challenge because the owner did not want to compromise the aesthetics of the final product. Turner's solution was to use regular steel with a stainless steel cladding. Since the cladding is a very thin layer the material cost was lower than the original design. A cladding would have the same exact appearance as the original design.

This correlated very well with the goals of the owner. They were able to save money by changing the design of the stairs while retaining the desired final appearance. Nobody would ever be able to distinguish the cladding from solid stainless steel. The owner was able to reinvest this money into other areas of their business.

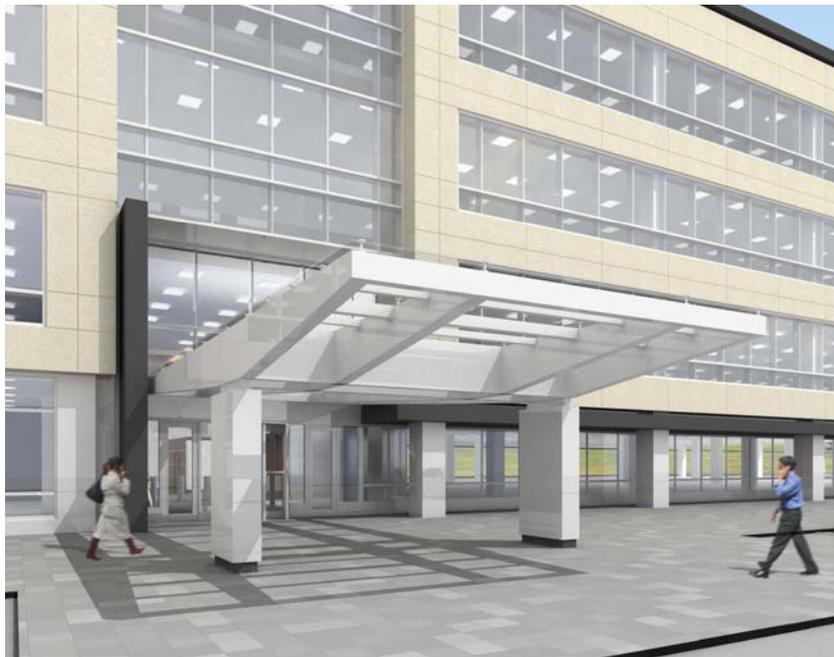
Figure 4 – Rendering of Exterior Canopy

The outside of the building has a canopy covered walkway built from steel and glass. Refer to **Figure 4** below for a rendering of the canopy. Similar to the lobby stair design, the original design of the canopy specified stainless steel. The architect and the owner both desired the finish that a stainless steel would provide. However the owner was not happy with the cost that would be required to install stainless steel. Turner suggested changing the design to an aluminum frame. This would have reduced cost but the owner rejected the idea because it did not provide the desired finish. The solution that the team implemented was to use regular steel with a painted finish that closely matches that of a stainless steel. The owner was pleased with the affect that the paint provided. However there are concerns that a painted finish will require maintenance in the future. This is a reality that the Connell Company is willing to accept because of the immediate savings. Value engineering on the canopy along with value engineering on the lobby stairs saved the owner a total of \$550,000.
