DENNIS V. WALTER JR. | CONSTRUCTION MANAGEMENT

# PHASE 2 NEW BUILDING, JOHN TYLER COMMUNITY COLLEGE

## TECH ASSIGNMENT #3

# Phase 2 New Building

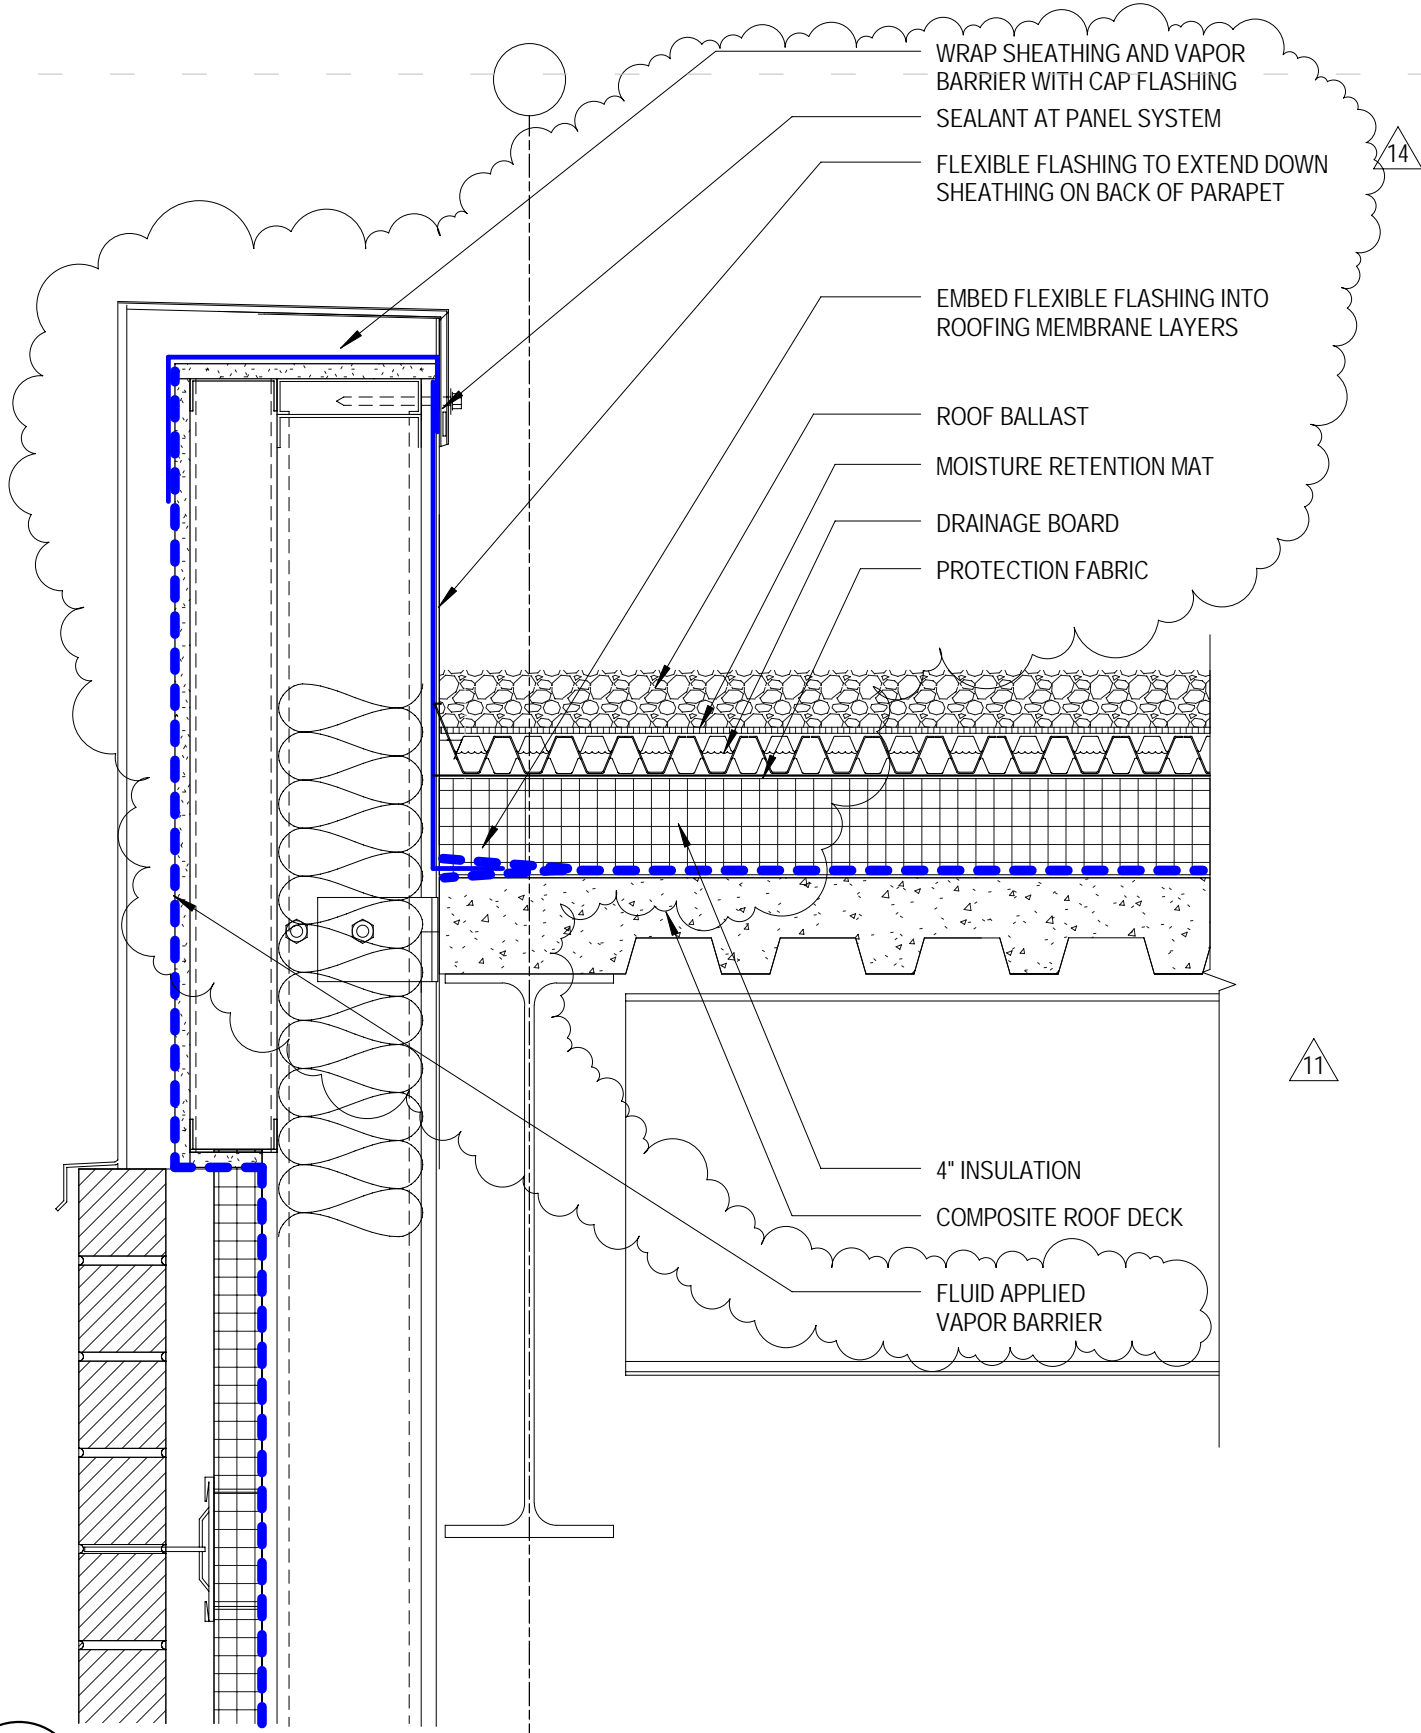
WRAP SHEATHING AND VAPOR BARRIER WITH CAP FLASHING  
 SEALANT AT PANEL SYSTEM  
 FLEXIBLE FLASHING TO EXTEND DOWN SHEATHING ON BACK OF PARAPET

EMBED FLEXIBLE FLASHING INTO ROOFING MEMBRANE LAYERS

ROOF BALLAST  
 MOISTURE RETENTION MAT  
 DRAINAGE BOARD  
 PROTECTION FABRIC
