Pearland Recreation Center and Natatorium Pearland, Texas

Technical Report #3

**Prepared By: Matt Smiddy
Faculty Consultant: Dr. Magent**

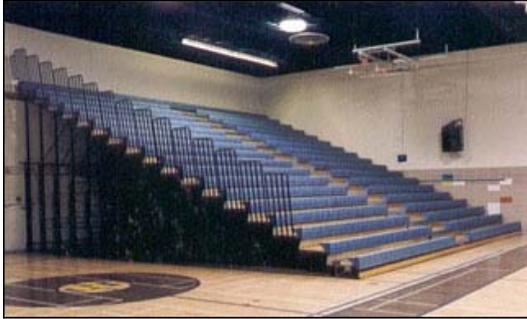
Pool deck space in the natatorium was very important to the swimming and diving coaches because it gave them an area to do dry land training. In order to maximize available deck area, the owner requested using telescoping bleachers around the pool. Due to the humid atmosphere in natatoriums, bleacher manufacturers would not warranty the bleachers in the natatorium because the mechanical system of the telescoping bleachers would corrode within 5 years. Since this would require significant maintenance the owner certainly did not want to install the telescoping bleachers without a warranty. Upon the designer's suggestion, a fixed bleacher system was chosen for this area.

Figure 4-1: Telescoping bleachers. Courtesy of Hahn Enterprises

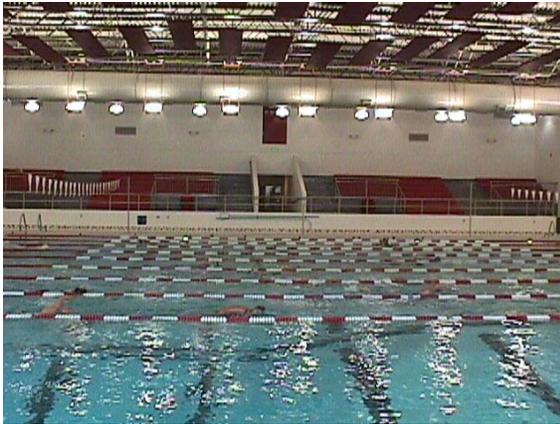
Figure 4-2: Fixed bleachers. Courtesy of Polymer Services.

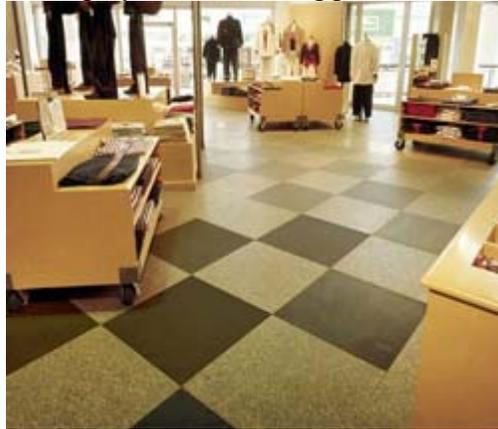
Recreational manager for the Pearland Recreation Center and Natatorium had worked at a university that had a roll-out flooring system and suggested similar flooring for the weight room in the Recreation Center. The roll-out flooring system consisted of 6' wide rolls of flooring that were rolled out like carpet and chemically welded together. The designer's past experience with this type of flooring, was that the material tends to delaminate from the concrete floor due to expansion. To investigate this issue, a number of gyms were contacted, including several LA Fitness facilities. They all confirmed the delamination problem. Tuflex flooring, flooring that consists of 30" squares about 3/8" thick and is installed similar to tile as shown in Figure 4-3, was instead suggested by the designer. This suggestion was adopted.

Figure 4-3: Tuflex Flooring Courtesy of Floor Guide.

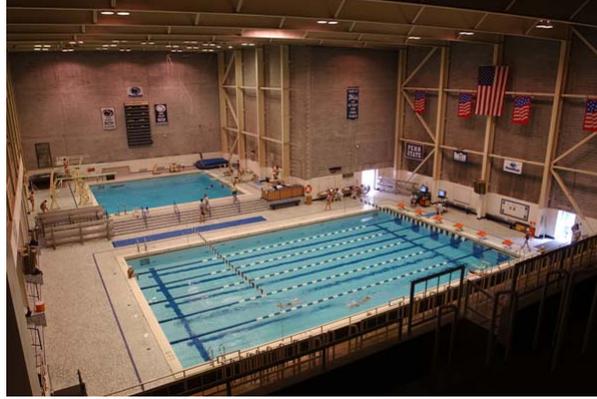
A key aspect of the Pearland Recreation Center and Natatorium that would be interesting for investigation is the structural system in the natatorium. Unlike the steel structural system in the recreation center, the natatorium has been designed using a glulam structural system. As a competitive swimmer that has traveled across the nation competing in natatoriums, I have never seen a natatorium with a glulam structural system. Additionally, glulam is significantly more expensive than structural steel and presents unique challenges during construction. The designer feels that structural steel, even with special coatings, corrodes and deteriorates in the humid environment of natatoriums. It would be interesting to research the performance of structural steel in natatoriums as well as to do a cost-benefit analysis of steel versus glulam structural systems in order to obtain specific cost differences.

Figure 5-1: Natatorium with steel structural system. Courtesy of Penn State

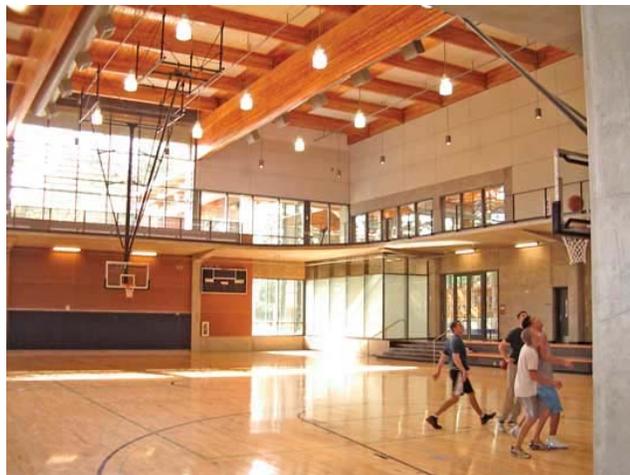
Figure 5-2: Gymnasium with glulam structural system. Courtesy of Structure Mag

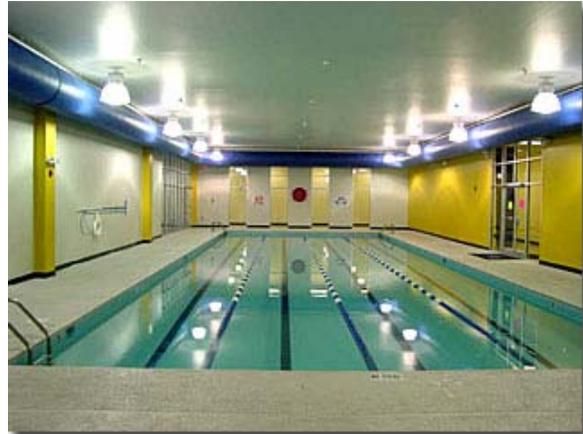
Many natatoriums have acoustically reverberant environments. In many cases the reverberation causes announcements over a public announcement system to be inaudible to people in the building. The designers of the Pearland Recreation Center and Natatorium have taken this fact into account and have included Duct Sox (sound attenuating air duct, see Figure 5-3: Duct Sox applied in a natatorium) and acoustical tiles on the wall of the natatorium. Research into the adequacy of these features in acoustical attenuation could be a potential topic for further investigation.

Figure 5-3: Duct Sox applied in a natatorium. Courtesy of Duct Sox
