Hunter College school of Social Work Thesis Proposal

To analyze how energy efficiency can be implemented using facade and green roof redesign. It ties structural engineering concepts with existing enclosure installation methods to provide a secure barrier against water and the temperature of the outside world.

Vanessa Rodriguez Structural - IP Dr. Memari Hunter College School of Social Work 2180 Third Ave. New York, New York January 19, 2010 Thesis Proposal

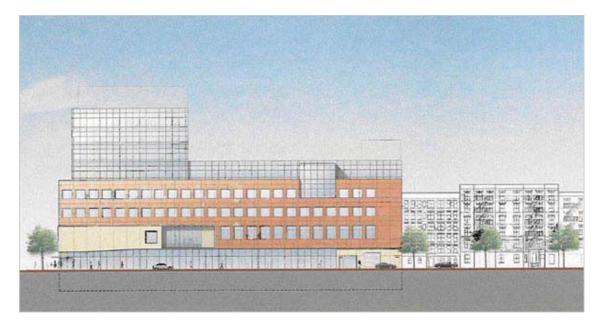
Figure 6.North Elevation of Hunter College School of Social Work

As seen on the North elevation (below) the bottom band is $8'' \times 2 \frac{1}{2}''$ two-aided curtain wall with custom cap with both transparent panels and spandrel shadow boxes. The left side of the middle band is architectural precast concrete while the right side is brick-faced precast panel in stack bond pattern with false jointing. The top band is $6 \frac{3}{4}'' \times 3''$ four-sided structurally glazed curtain wall with both transparent panels and spandrel shadow boxes. Above the main top band there is a vertical protrusion whose façade is 1'' stucco on cmu substrate. Similarly the South elevation has this same pattern of horizontal bands of varying material.
