TECHNICAL ASSIGNMENT THREEE

PENN STATE AE SENIOR THESIS

SUPPORT SERVICES BUILDING

PENN STATE MILTON S. HERSHEY MEDICAL CENTER – HERSHEY PA

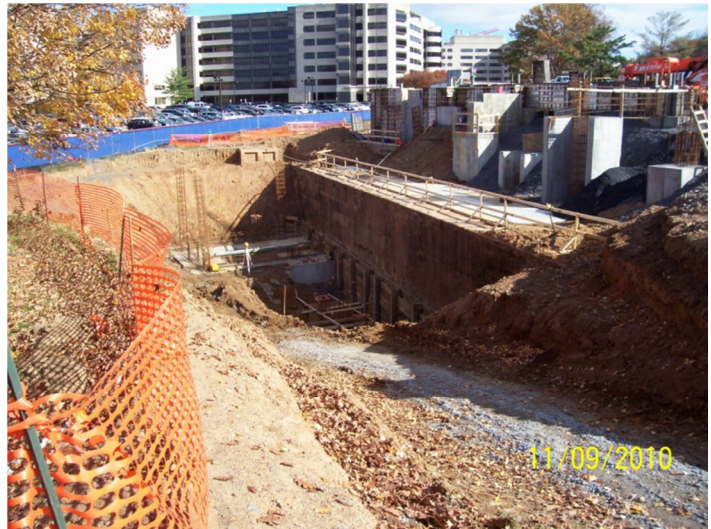
In order to construct the building around the utility tunnel, the tunnel had to be “bridged”. This bridging effect placed pile caps and columns on either side of tunnel. To complete the pile caps on the northern side of the tunnel, a 30' deep excavation was required. However, there was minimal room for this excavation to occur. In order to reduce costs, the construction team chose to let the site subcontractor engineer a sloped excavator rather than install an earth retention system. Figure 2 at right shows what the excavation looked like. Although this was a good idea, the site subcontractor didn't place enough emphasis at the beginning of the project on getting the engineered excavation drawings approved. Thus, it delayed the construction of the pile caps and gradebeams in this area. It was also discovered that to achieve the proper slope of excavation, work inside the excavation had to be sequenced in order to maintain the slope.

Figure 2: Tunnel Excavation

A 30' deep excavation was required in order to complete the foundation work for the Support Services Building on the south side of the tunnel. There was little room to complete the excavation and in order to reduce costs the project team decided to slope the excavation rather than install an earth retention system. Getting approved engineered excavation drawings took longer than expected, and because of the amount of room the sloping required, work in this area had to be phased in order to maintain a safe excavation.

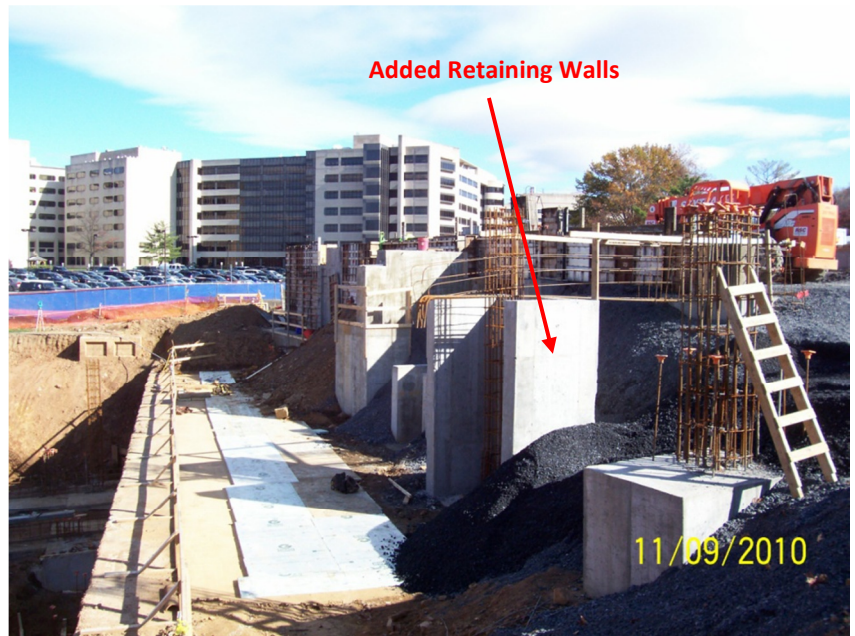
Two additional issues that arose with the excavation above the tunnel was due to the fact that the drawings called for the entire area above the tunnel through column line 12 to be excavated down to the top of the existing tunnel roof. Figure 3 on the next page shows the area that had to be excavated. However to completed the bridge over the tunnel the design called for a series of regular gradebeams and cantilevered grade beams in this same area. One of the issues was that backfill needed to be placed prior to pier and gradebeam completion. To solve this problem the concrete subcontractor suggested pouring retaining walls around the piers in order for backfill to be placed before the piers were poured. Figure 4 on the next page shows the installed retaining walls prior to pier and gradebeam placement.

Figure 4: Added Retaining Walls to Allow for Backfill Prior to Pier Placement

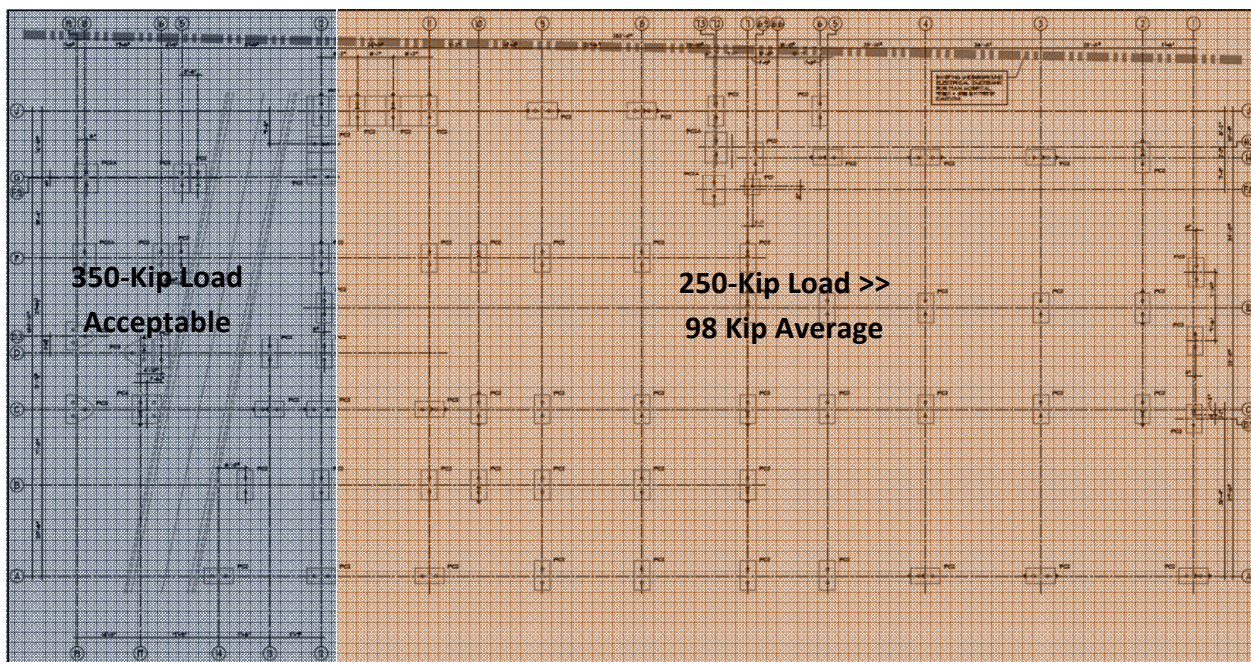
As for the construction teams question about why micropiles were chosen as the foundation system for the Support Services Building. The Geotechnical Report recommended the micropile foundation system based on the design load and differential settlement requirements given to them by the structural engineer. Loads given to the Geotechnical Engineer were a 350-kip column load near the tunnel and 250-kip column load elsewhere. Shown in figure 7 below and based in comparison with actual column loading, the 350-kip column load near the tunnel is acceptable, but the 250-kip column load elsewhere is well above the 98-kip column load average for the remaining portion of the building. In fact there are several columns whose load is less than 50-kips. However as mentioned above, micropiles themselves are not inadvertently a constructability issue, but in the case of the Support Services Building became one. The question still remains; did micropiles need to be utilized on this entire project?

Figure 7: Geotechnical Report Column Loads

Following the recommendations of the Geotechnical Report, the entire Support Services Building is set on micropiles. As mentioned on page 6 of this report, the Geotechnical Report was based on a 350-kip column load near the tunnel and 250-kip column load elsewhere. Shown in figure 7 on page 6, the 350-kip column load near the tunnel is acceptable, but the 250-kip column load elsewhere is well above the 98-kip column load average for the remaining portion of the building. In fact there are several columns whose load is less than 50-kips. Total costs of the micropile contract were \$791,301.00. Looking at this figure and seeing the column loads, the construction team fills that eliminating some of the micropiles and substituting the associated pile caps with spread footings could have saved the project in upwards of \$250,000.00. This number is purely a rough estimate, but yet is something that should be considered. A re-design of the foundation system could be similar to that shown in figure 12 below.

Design of the foundation system, in particular the micropiles was based on the recommendations of the Geotechnical Report. However the loads given to the geotechnical firm at the time of the geotechnical were only accurate in the tunnel portion of the building. The remaining two-thirds of the building is completely over designed. In several instances the actual load on the column is less than 1/5 of the load that the Geotechnical Report was based on. Based on past experience it is the belief of the construction team that the foundation system for the Support Services building is entirely over designed significant cost savings could have been achieved with a re-design of the foundation system.
