The New York City Bus Depot

New York, NY

Executive Summary:

The following technical report gives a summary of the existing structural conditions of the New York City Bus Depot using the 2010 New York State Building Code for analysis. The plans and images for this building are provided by STV Incorporated. Permissions for use are provided by the New York City Transit Authority. Analyses of the features of this building, which utilize the 2010 New York State Building Code, follow the guidelines and standards outlined by the 2006 International Building Code and ASCE7-05 when applicable.

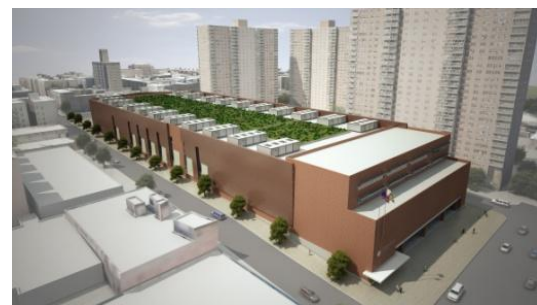
Figure 2: Rendering of the New York City Bus Depot showing its south face and both the corrugated metal and brick veneer facades. (Image courtesy of STV Inc.)

Externally, this new facility has a modern appearance with a corrugated metal and brick veneer anchored onto CMU walls as seen in Figure 2. Large, rectangular expanses of windows with aluminum frames help to provide well lit spaces while using minimal electric lighting. The brise soleil that line the tops of the windows on the East façade to control the sunlight entering the building, helping to achieve the most energy efficient performance possible. To pay homage to the vibrant culture of the neighborhood in which the depot is located, artwork will be placed at street level for any passer-by to see. All of these features will help give life to an area of the borough looking to be renewed and revitalized.

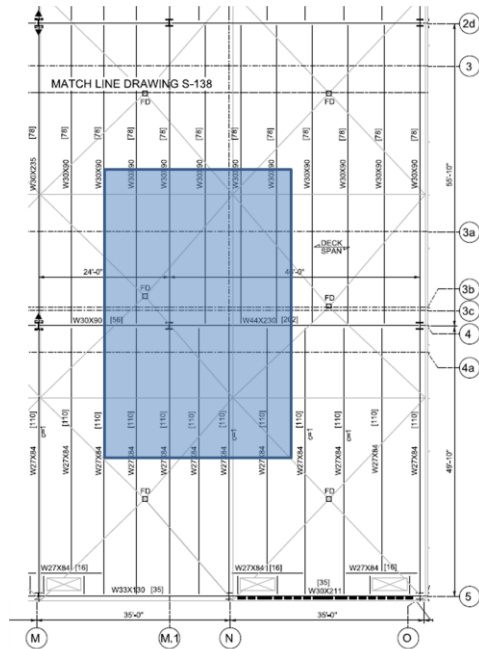
The column checked in this analysis is M.1-4. There are three stacked in this series. The column supporting the roof passes the equivalent axial force, however the lower two columns do not. Had they been sized-up by one more size each, then they would pass. This result is likely due to a miscalculation of loads on the building. The weight that was calculated and shown earlier in the report proved to be approximately 30,000k heavier than the one presented by the structural engineer just before the due date of this report.

Shown to the left is the column and its tributary area highlighted in blue. Further detail on the calculation is available in Appendix A.

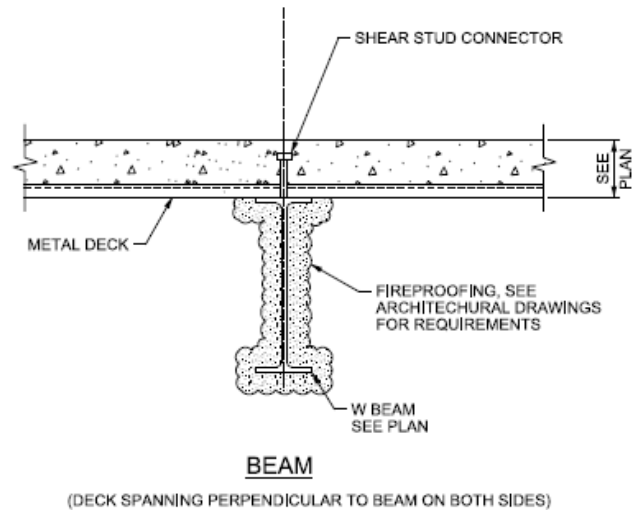
The slab for this analysis passes with ease. In the 65% drawings, the slab is called-out as a composite slab. Upon further design by the engineer, is now corrected to be treated as a 6" concrete reinforced slab. The 2" 18 gage decking is considered sacrificial in the design. Analysis for this piece is done treating the piece as a composite deck where it is found that the system passes easily. Further analysis of 6" slab with no decking would likely yield a result showing that punching shear would control the design due to the high point loads dealt with in the design. For now no reinforcing is designed to analyze the deck from this approach. To the right is a cross section of the metal deck, slab, beam, and shear stud.

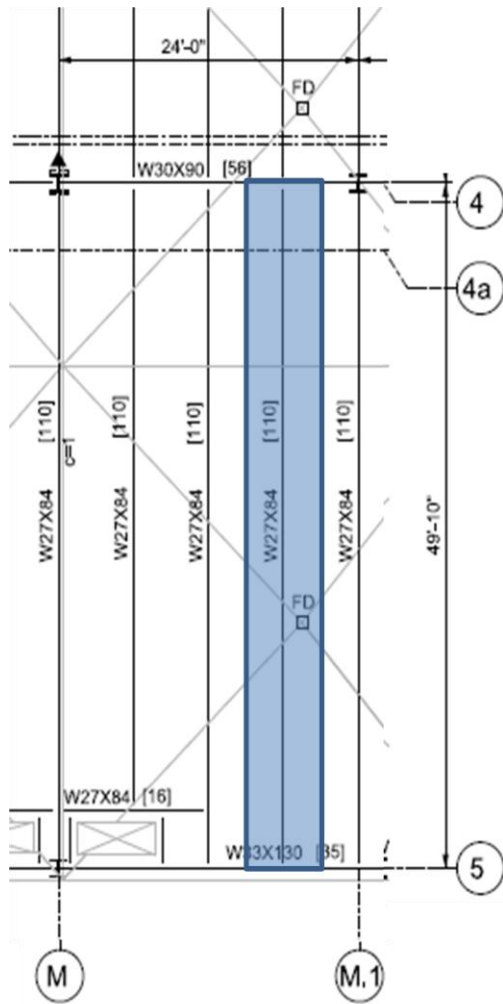
The beam analyzed in this report is a W24x84 with a length of 49'10" and 110 shear studs located on the third floor of the New York City Bus Depot. This beam passes deflection tests and assumes the proper number of shear studs with use of the 6" concrete slab for analysis as opposed to the 8" composite deck system. Calculations for this member can be found in Appendix A. Shown to the left is the tributary area of loading highlighted over the beam in the analysis.

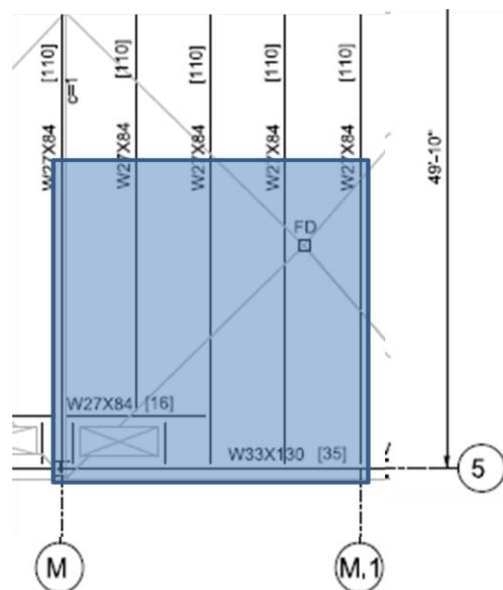
The girder in this analysis is a W33x130 girder with a length of 24'. The analysis shows this girder to fail under the assumed conditions. This is again likely due to the misassumption of weight carried by the girder. Weights calculated from the distributed loads shown in Appendix F output a much higher weight than shown in new calculations from the structural engineer that are unable to be shown in this report.

The girder and the tributary loads used for the calculations in Appendix A are shown on the left.
