Reinsurance Group of America (RGA) Global Headquarters

General Building Info

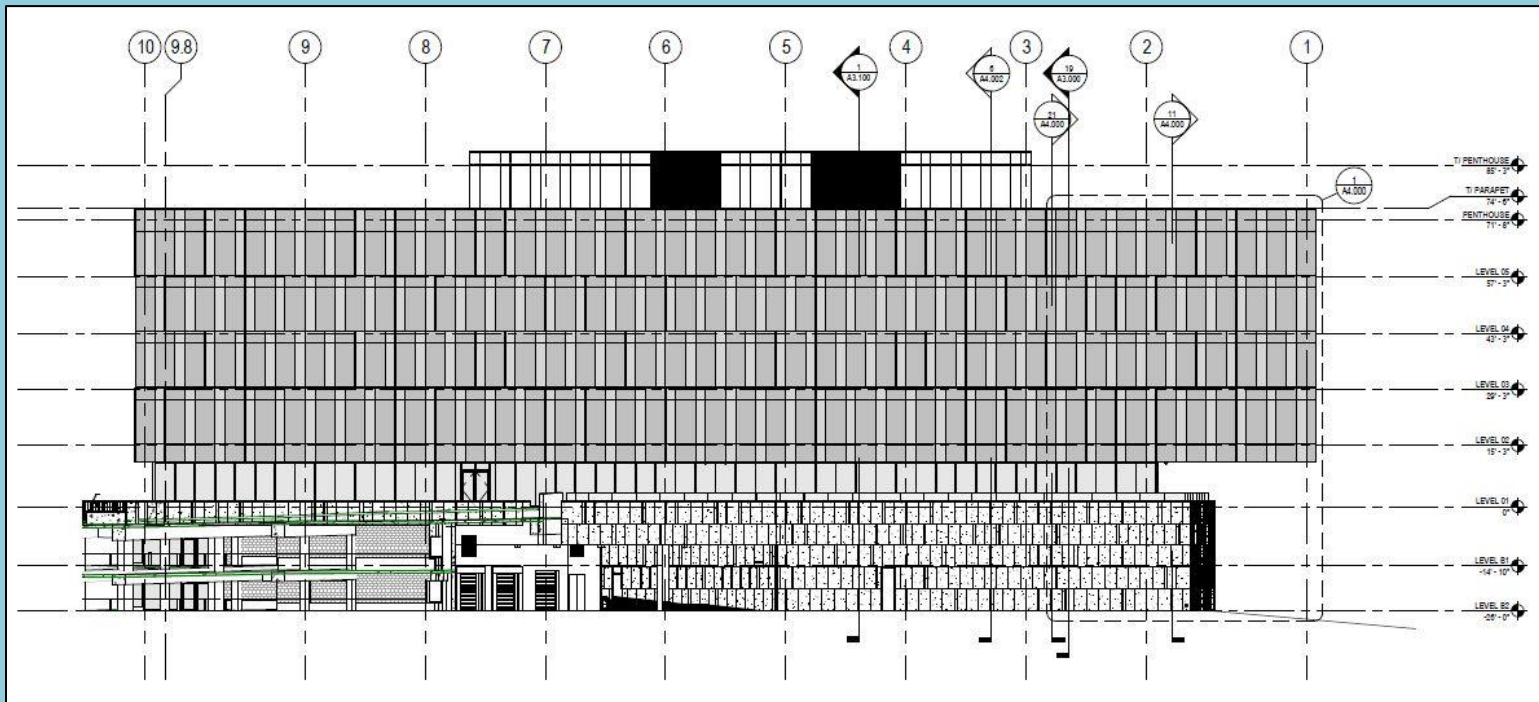
- Steel superstructure with braced frames
- Concrete parking garage with shear walls
- Braced frames and shear walls act together
- Cantilever Truss System

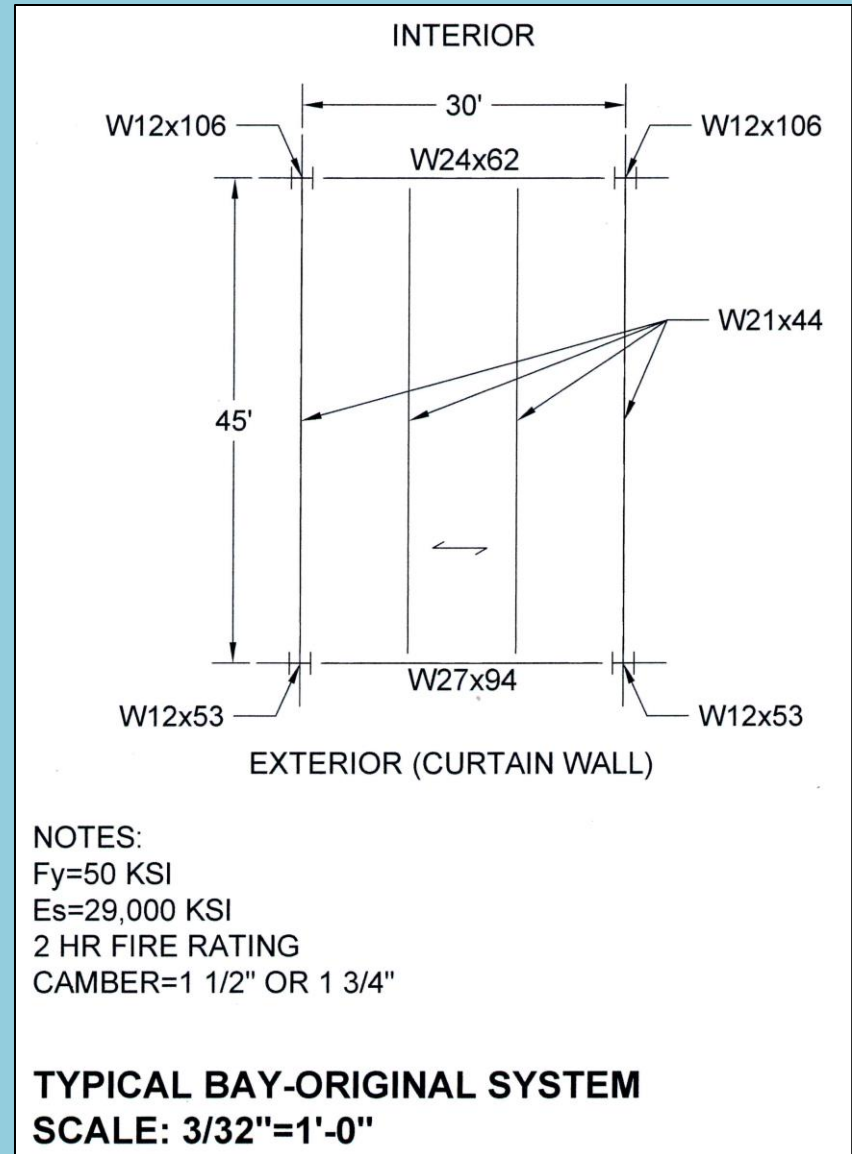
Existing System-Composite Steel

- Typical bay
- 2 hour fire rating
- 49.0 psf
- \$39.73/SF
- 30" Depth
- Deck unshored
- Oversized for strength
- Deflections pass comfortably

Existing	Floor Joists	Hollow Core	One-Way Slab
Weight	49.0 psf	48.5 psf	107.8 psf	101.2 psf
Cost	\$39.73/SF	\$37.18/SF	\$56.70/SF	\$31.23/SF
System Depth	30"	34.5"	42"	32"
Fire Protection	2 Hour	2 Hour*	2 Hour	2 Hour
Deflections (LL)	0.375"	0.58"	0.804"	0.586"
Viable?	Benchmark	Yes	No	Yes

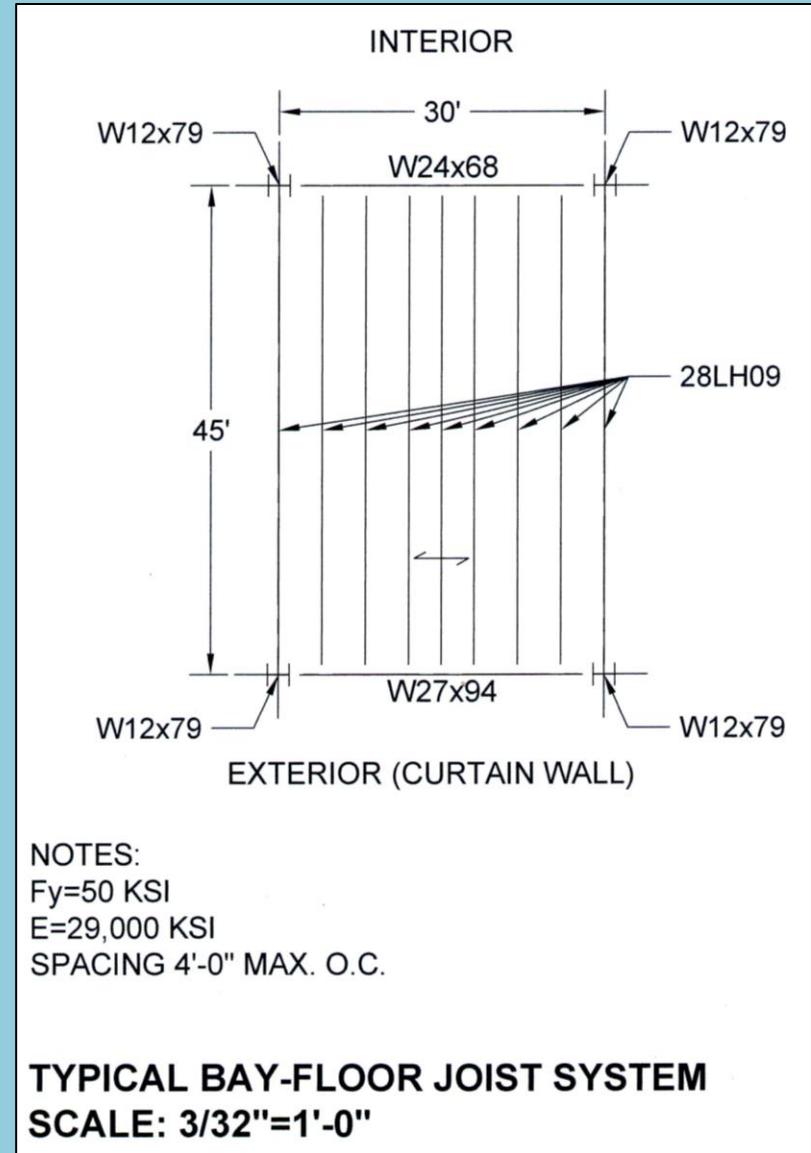
Alternate 1-Floor Joists on Beams

- 2 hour fire rated deck, but **joists difficult to fireproof** effectively
- 48.5 psf ~ Existing
- \$39.73/SF < Existing
- 34.5" depth > Existing
- Lateral load path unchanged

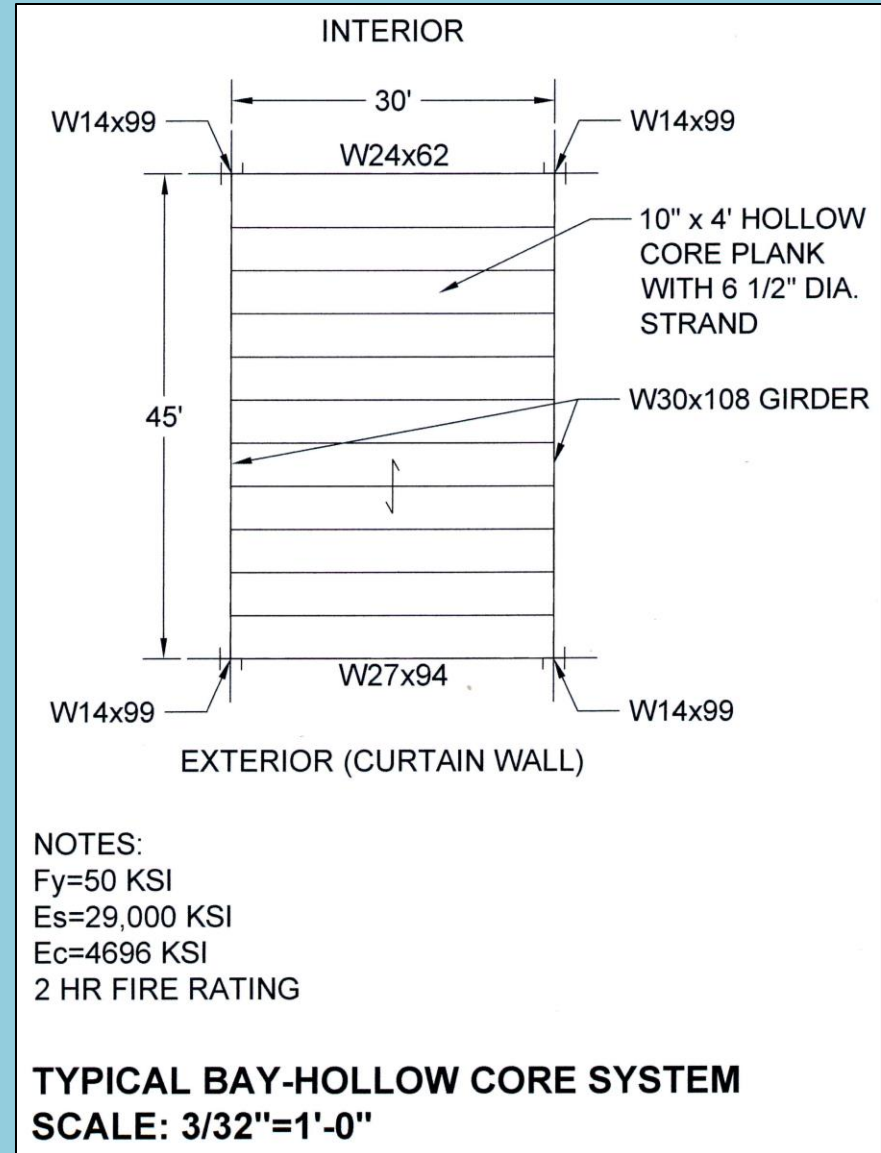
Alternate 2-Hollow Core on Beams

- 2 hour fire rating
- 107.8 psf >> Existing
- \$56.70/SF >> Existing
- 42" >> Existing
- Not a viable option
- Lateral load path unchanged

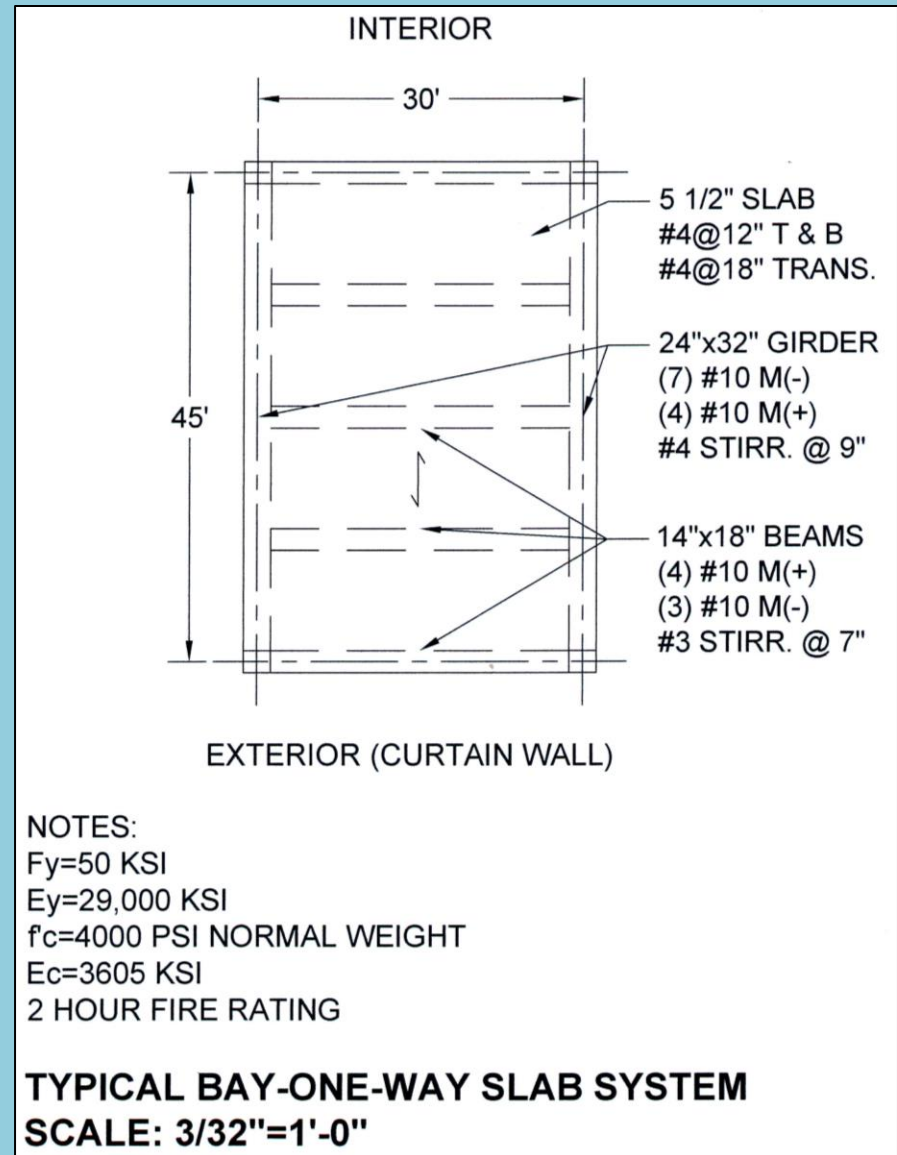
Alternate 3- One-Way Slab with Beams

- 2 hour fire rating
- **101.2 psf >> Existing**
- \$31.23/SF < Existing
- 32" > Existing
- Viable, but weight will impact garage
- Shear walls in parking garage and through the superstructure's core
