# La Jolla Commons Phase II Office Tower

San Diego, California

Alyssa Stangl | Structural Option  
Faculty Advisor | Dr. Hanagan

# La Jolla Commons Office Tower

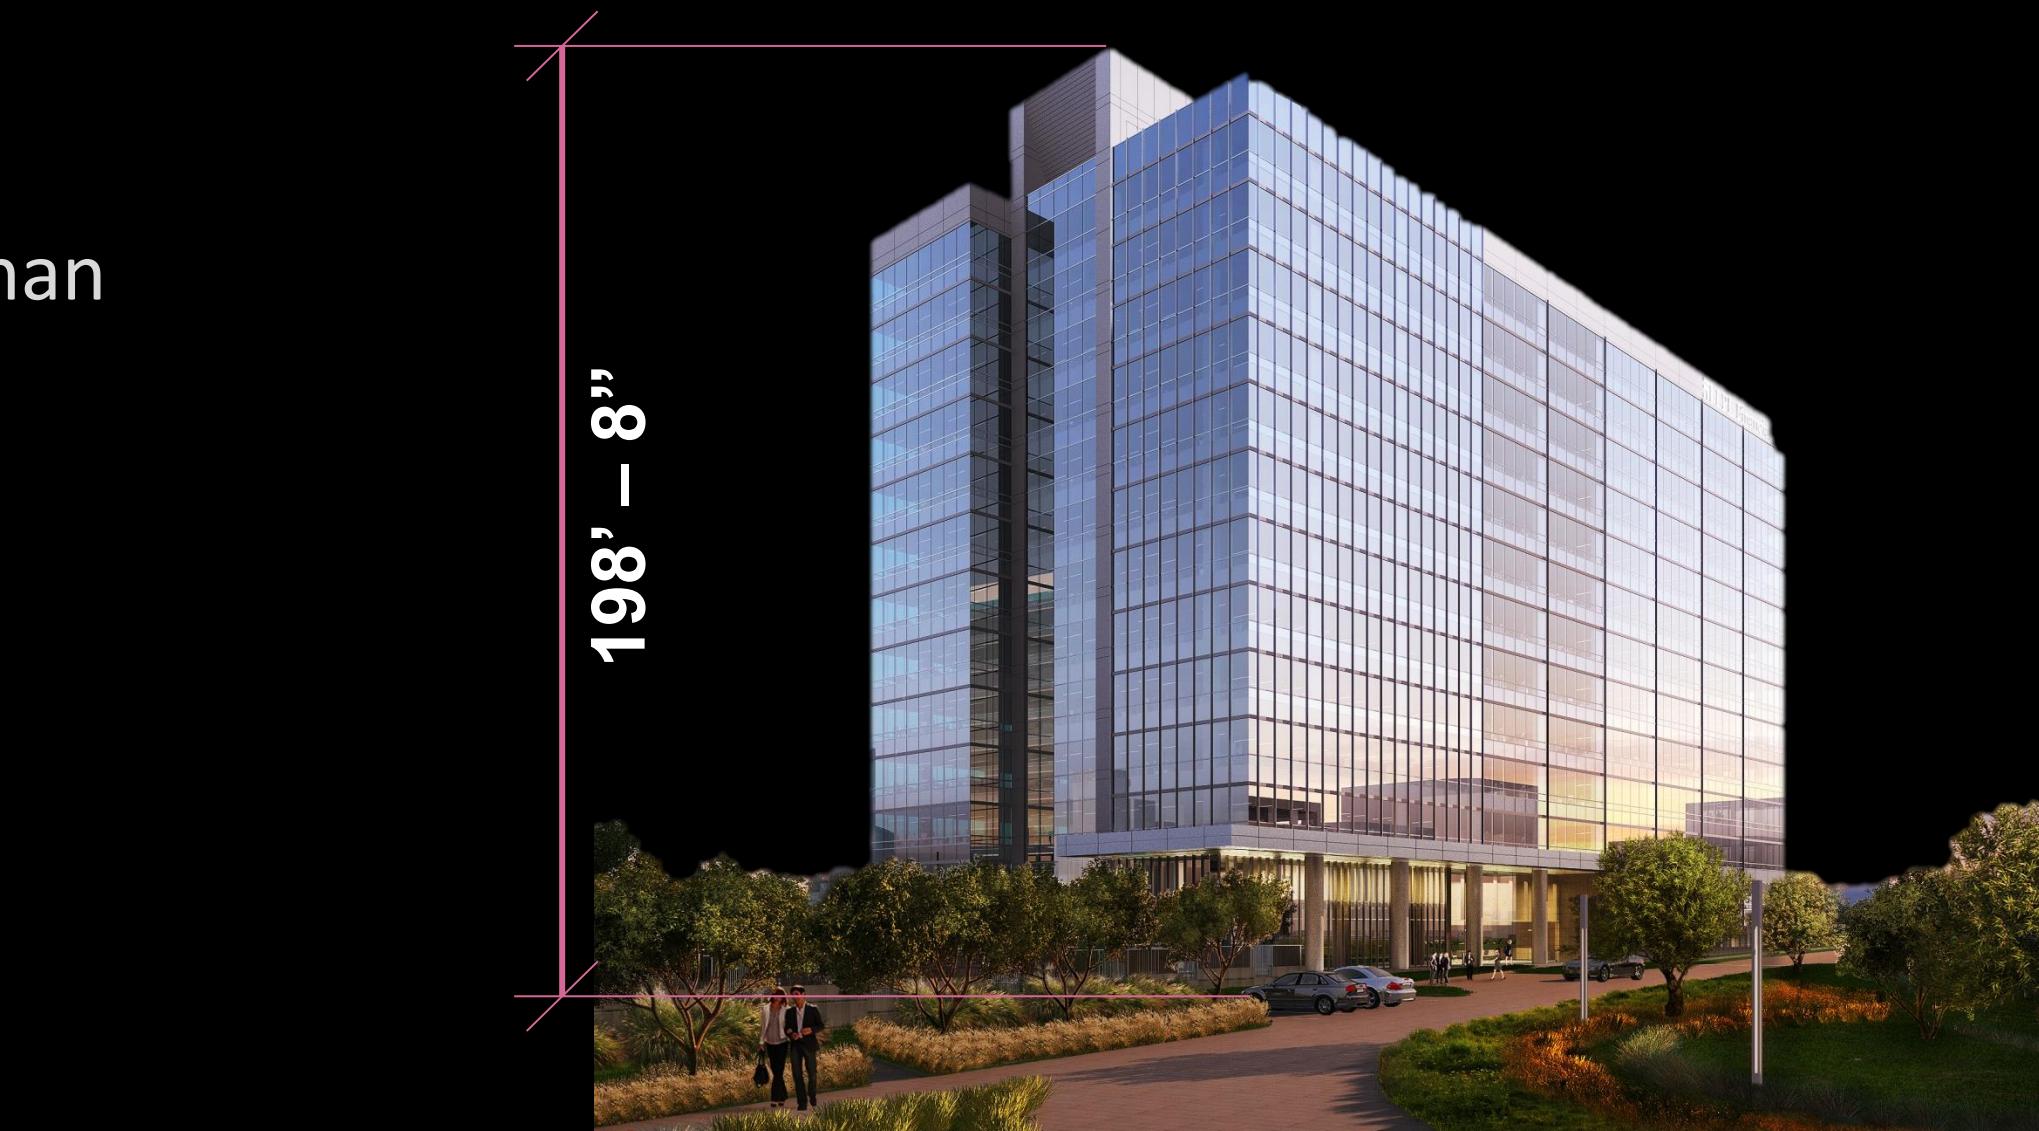
## Floor-to-Ceiling Height

- Building height limited to 198'-8" by FAA
- Steel creates a deeper structural system than concrete
- Loss of floor-to-ceiling space
