La Jolla Commons Office Tower

Appendix Slides

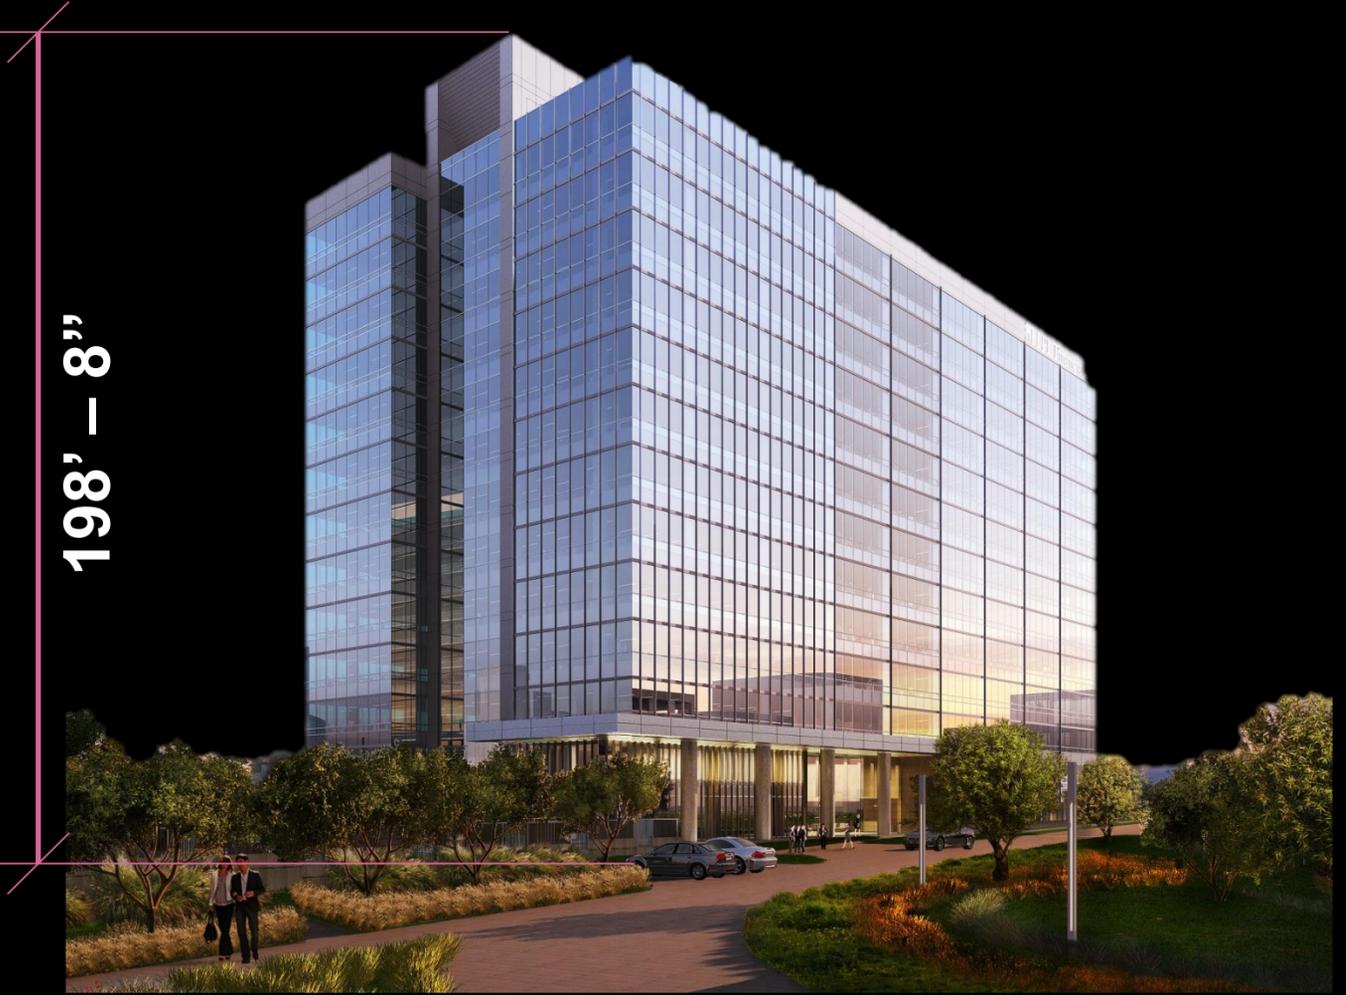
Floor-to-Ceiling Height

- Building height limited to 198'-8" by FAA
- Steel creates a deeper structural system than concrete
- Loss of floor-to-ceiling space
