Thesis Presentation Hall Corporate Headquarters

Tuesday April 13th, 2004 Lighting/Electrical Emphasis

Hall Corporate Headquarters

Lighting / Electrical Emphasis

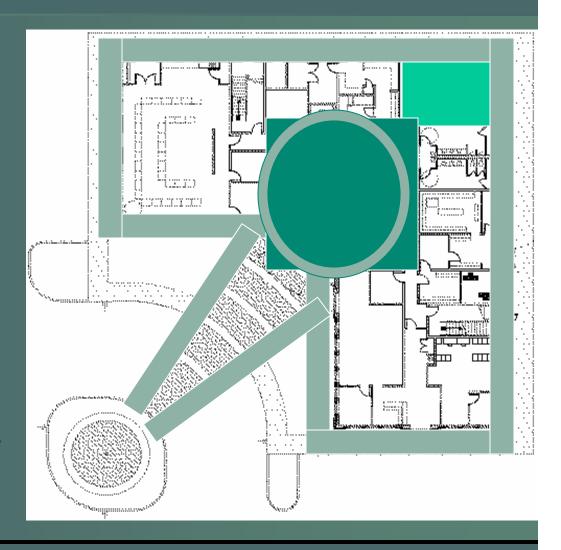
Exterior Facade

Walkway, front of building and circular roof structure

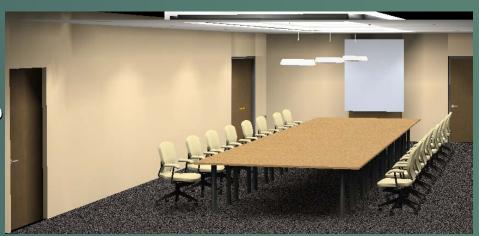
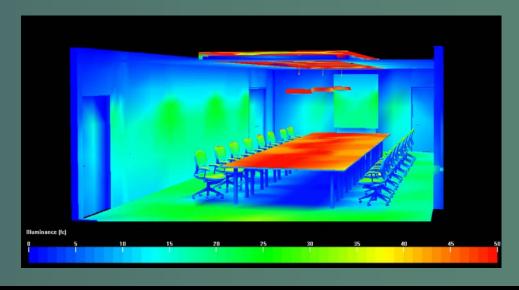
Boardroom Lighting Analysis

Light Analysis

- 50 Fc on the work plane
- Uniform distribution due to indirect lighting in space

ASHREA 90.1 allows for 1.5 W/Sq.Ft Lighting Design uses 1.83 W/Sq.Ft

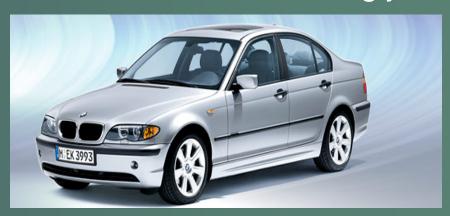
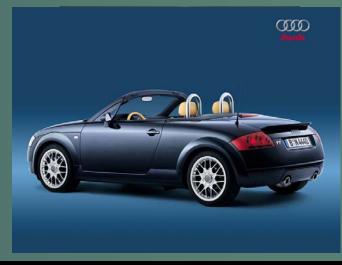
Car Lighting

- Indirect system
- Floor uplight to wash side of car with light
- Smooth gradient emphasizes body shape

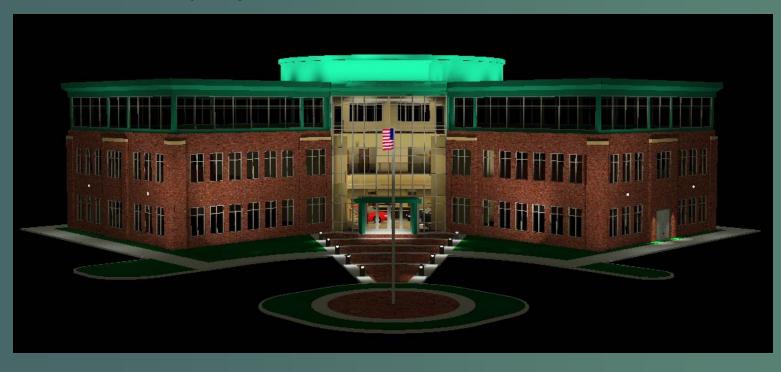
Exterior Lighting analysis

- Exterior façade allowed by ASHREA 90.1 to have 0.25 W/Sq.Ft
- Lighting design
 - 0.24 W/Sq.Ft just under the allowed amount

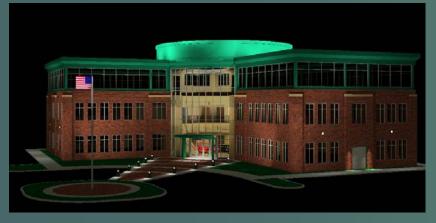
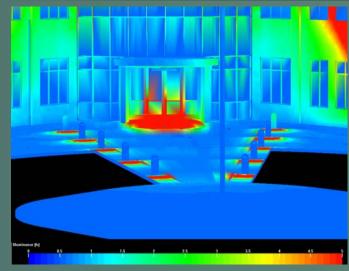
Lobby lights dimmed at night

Entrance canopy and walkway

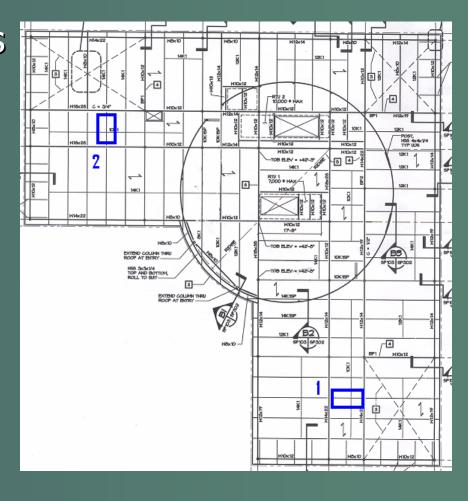
Structural Change

- Design location has a joist in the way
- Alter structural system, replace joist with beams due to increased load
- Frame in skylight for complete support and attachment purposes

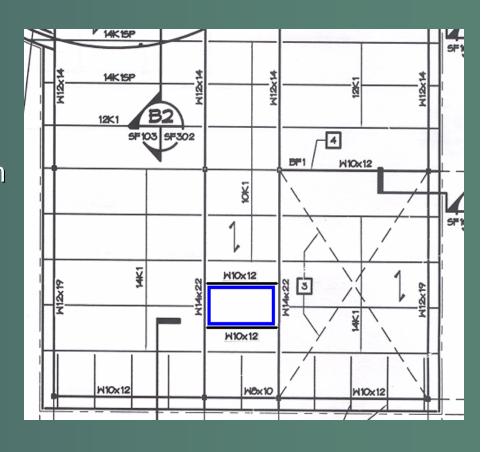
Beam sizing

- Moment calculated at new beam locations
- Sized a W 10 x 12 beam on either side of the skylight due to this moment
- System now supports skylights along all dimensions
