Goizueta Foundation Center For Research And Doctoral Education

Emory University, Atlanta, GA

Analysis I - Additional LEED Points

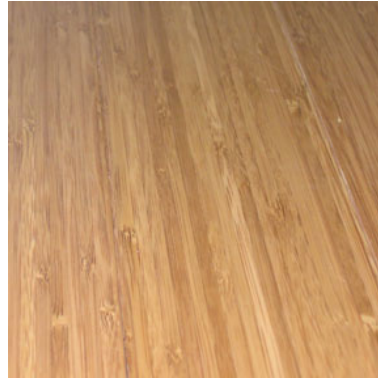
Rapidly Renewable Materials

Bamboo Flooring

- Durable
- Cost Effective
- Life Cycle of 30-50 years

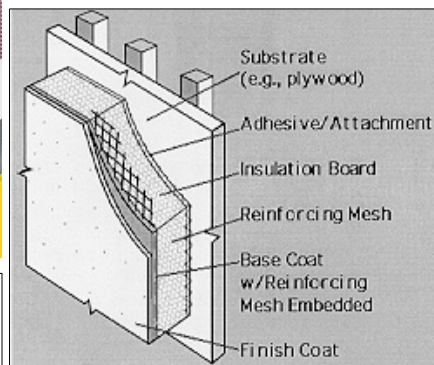
Existing Façade

- A. Substrate/Sheathing
- B. Adhesive
- C. EPS Insulation Board
- D. Reinforcing Mesh
- E. Base Coat
- F. Finish Coat

- Moisture penetration and mold problems
- Labor intensive – requires scaffolding, all work done from exterior
- Only 35 years old
- 5 year warranty
- Higher maintenance – also expensive upkeep

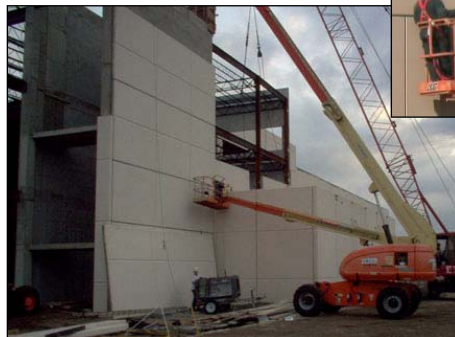
Proposed Façade

Architectural Precast Panels

- 5” thick solid panels
- 62.5 lb/sf
- \$40/sf

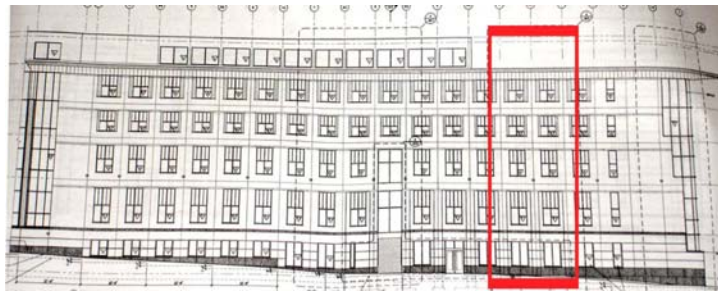
Structural Analysis

- Determined smallest column in rear façade that carries a typical load
- Calculated loads from members, floor slabs, roof, and façade that are carried by the column
- Analyzed in RAM Advanse

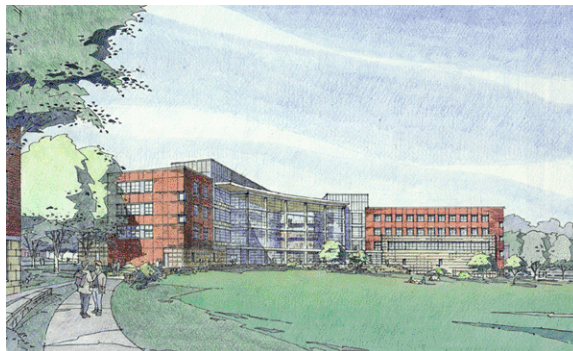
Moisture Detection

Jobsite Experiment:

- Smeal College of Business Building
 - Recently Enclosed
 - Temperature and Moisture Control
