Emory University Psychology Building

Atlanta, Georgia

Technical Assignment #3

**Chris Renshaw
Construction Management
Faculty Consultant: Dr. Riley
Submitted November 21, 2008**

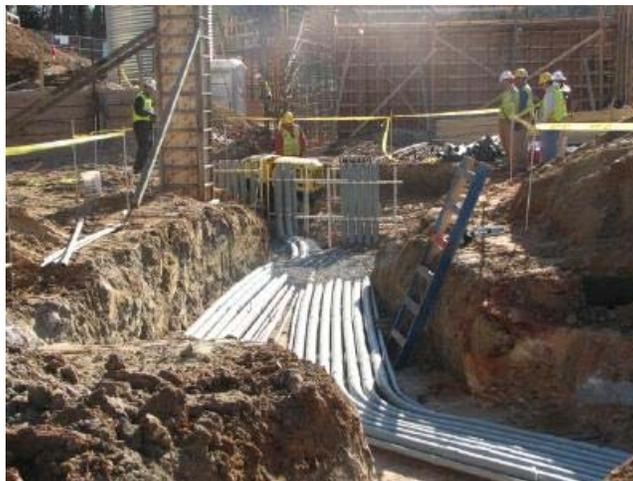
Emory's current campus has been around since 1915. Since that time the campus has been growing in the amount of buildings and infrastructure that it contains. Unfortunately, not all of that construction has been well documented with as-built drawings and locations of underground piping. For that reason, Holder had to be very careful when coordinating all of the underground work for the Psychology Building. Any collisions would cause the new utilities to have to be re-routed and could potentially cause a delay to the schedule of three to four days. The image below shows the layout of conduit for new underground utility feeds.

Figure 1 Underground utility building feeds.

A building model with clash detection helped to coordinate the foundation system and underground utilities, but since some existing piping locations were unknown, the building model could not detect any of those collisions. The only option for Holder was to use the drawings that they had, and hope that they did not hit anything while laying the new utility piping. That hope causes a lot of stress since the project could be delayed at any point and there is really nothing that the contractor can do about it. Fortunately, they had enough accurate drawings that they only had two collisions.

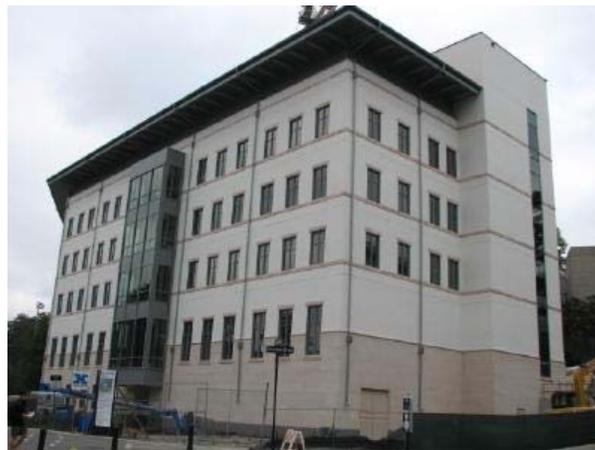
One reason that the windows were such a challenge is that the detail drawings provided for the window construction were not as accurate as they could have been. The areas around the window that required caulking were not clearly identified in the drawings. The details of the window were not fully worked out until the windows were actually being installed. Eventually, the consultants and the Holder's field supervision corrected the problems, but since details were changed, the windows were more difficult and time consuming than originally expected.

Figure 2 View of punched out windows from the southwest.

Since there were so many windows of the same type, or very close to the same type, a checklist of what processes needed to be completed and in what order would have been very helpful for the windows. The amount of repetitive windows can be seen in the image above. Although a checklist wasn't developed on this project, it was certainly a lesson learned by Holder.

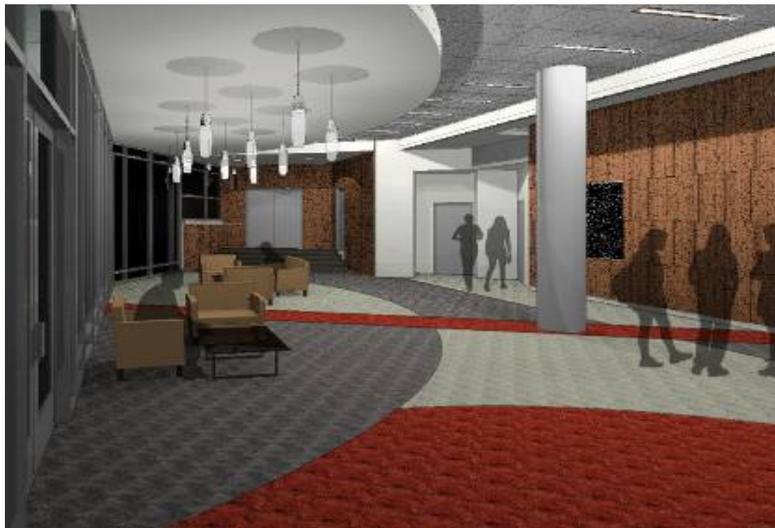
The owner and architect were having a hard time finishing the design of the second floor finishes (shown below), so Holder decided to skip that floor for its interior work sequence. Instead of moving up through the building by floor as a typical project would, the sequence was the first floor, third through fifth floors, and back to the second floor. This solution allowed time for the architect and owner to decide on finishes, as well as prevent any future demolition on the second floor. The change resulted in a minimal change in schedule since the work was almost the same, but in a different order. As an added bonus, the terrazzo flooring design never changed, and the flooring contractors were able to work on the second floor all alone, with no other work going on. This was especially helpful since terrazzo installation is typically a very sloppy process which requires some curing time where people cannot access the areas anyway.

Figure 3 View of second floor lobby before finish upgrades.
