SEEKING STRUCTURAL LESSONS

IN THE WORLD TRADE CENTER AND PENTAGON ATTACKS

W. Gene Corley, S.E.

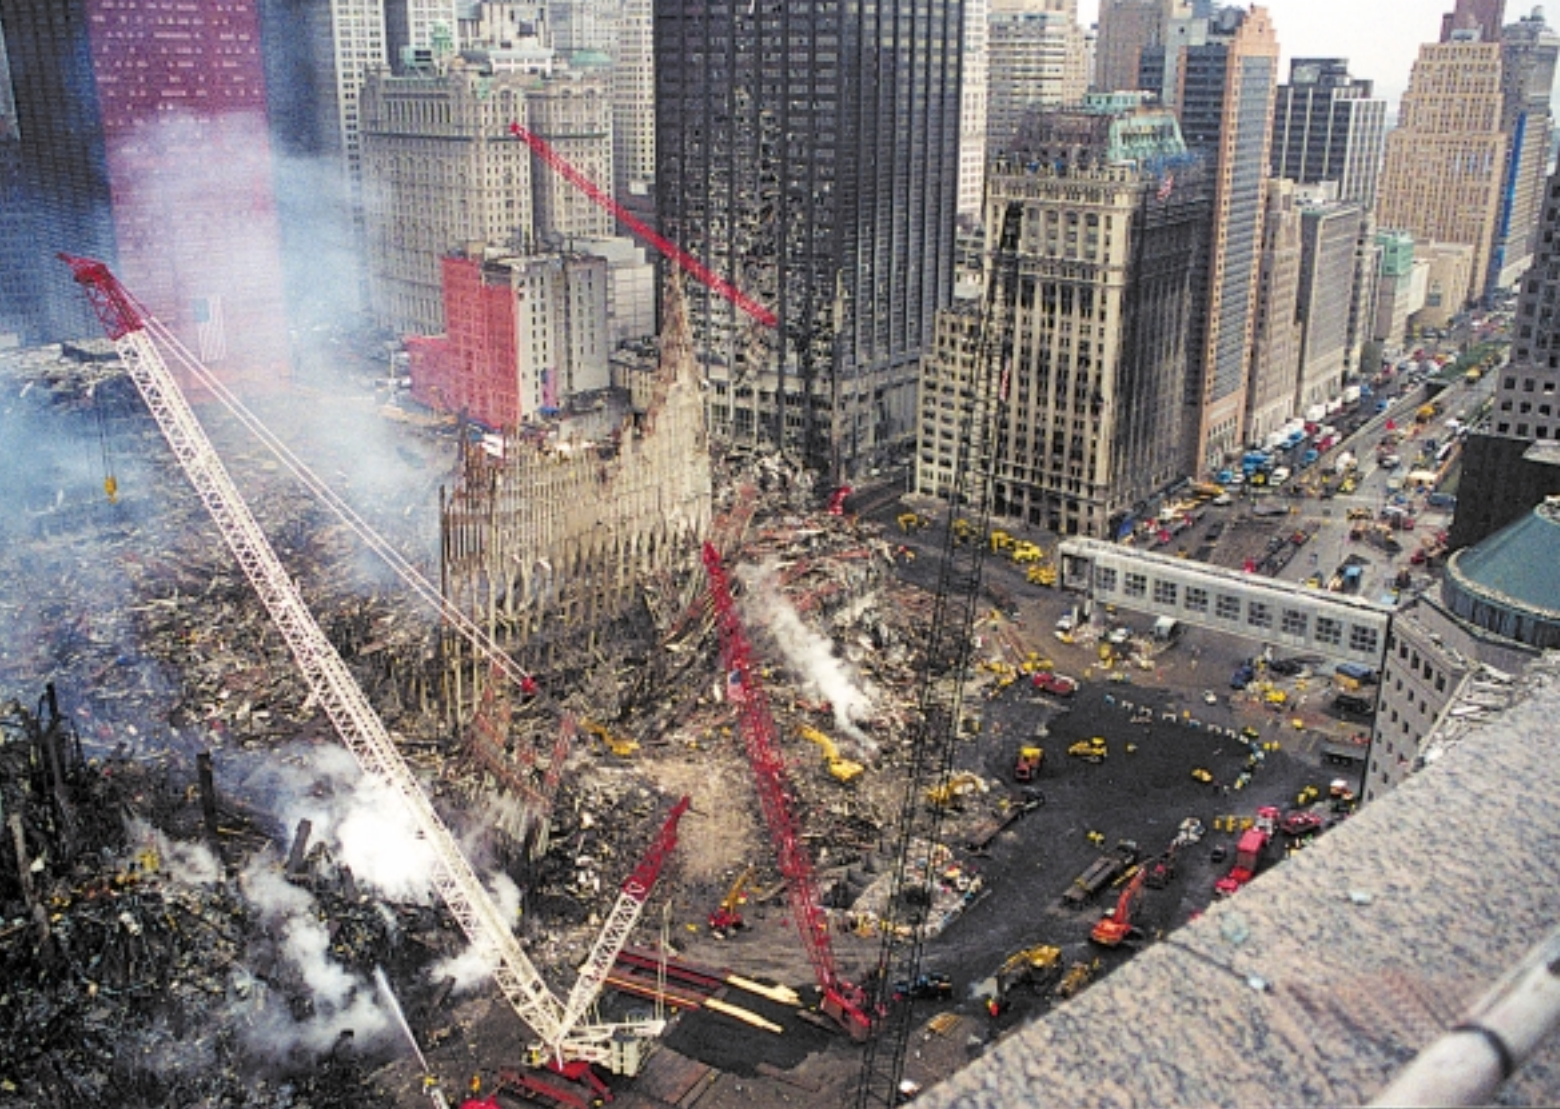
Above and right: Debris removal continues at the World Trade Center site two weeks after the buildings were destroyed.
