SEEKING STRUCTURAL LESSONS

IN THE WORLD TRADE CENTER AND PENTAGON ATTACKS

W. Gene Corley, S.E.

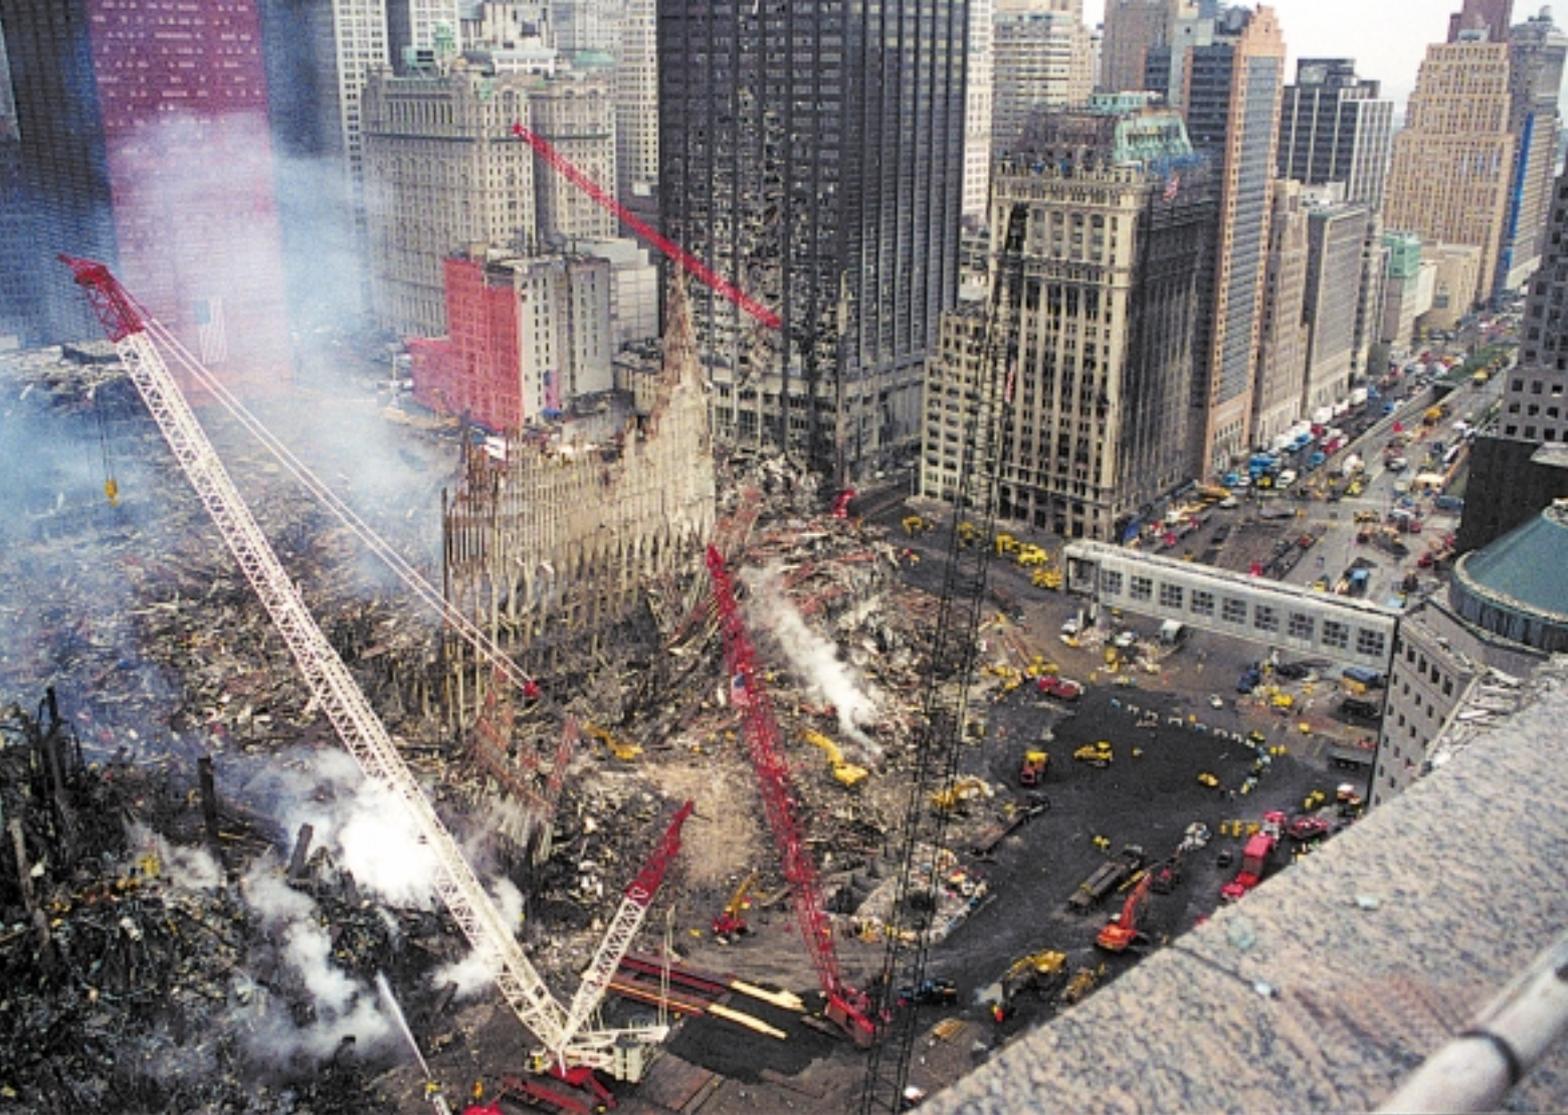
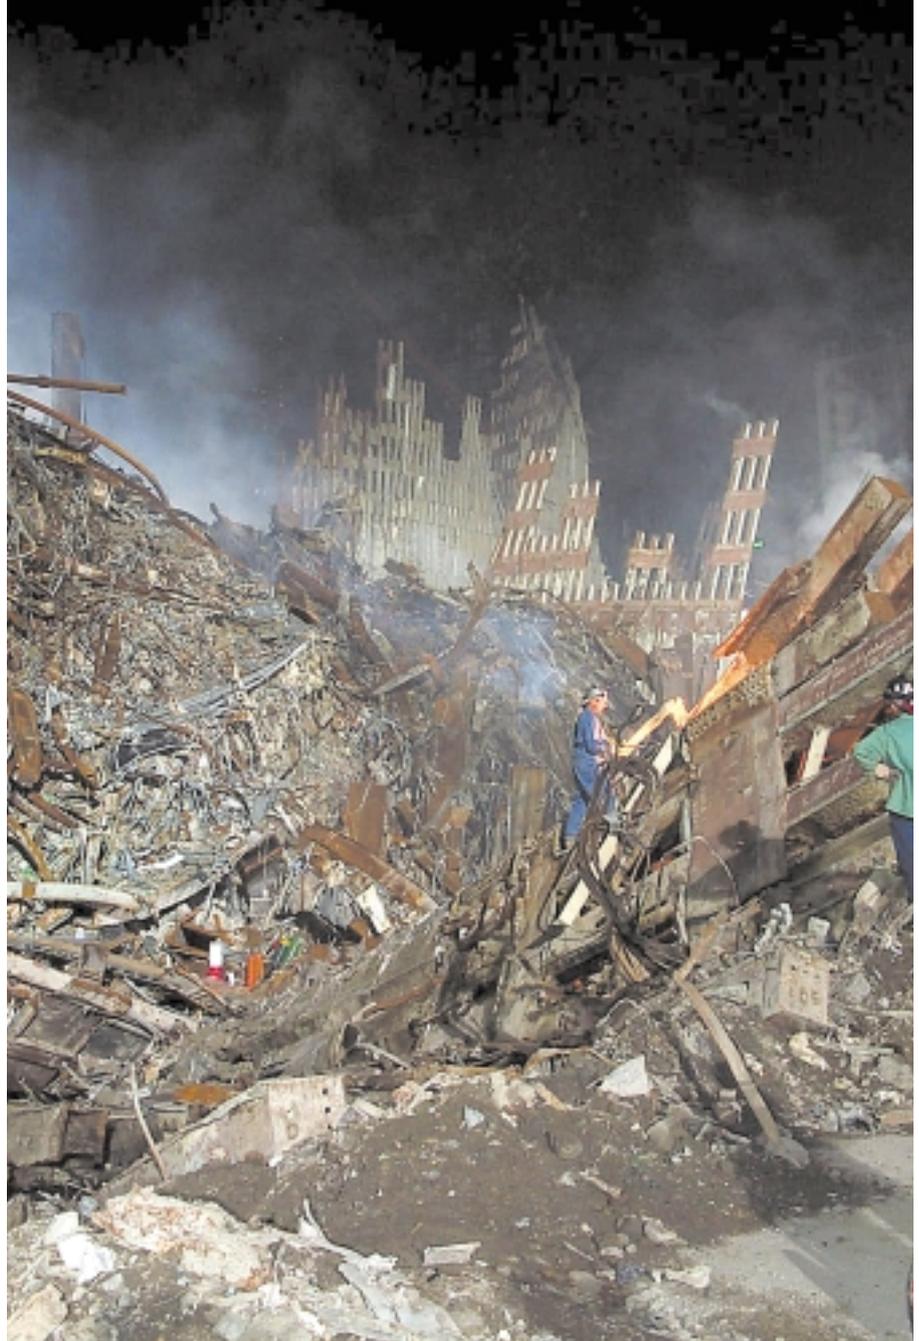
Above and right: Debris removal continues at the World Trade Center site two weeks after the buildings were destroyed.
