## Section 9: Analysis #4 - Bolted Vs. Welded Glulam Arch Connection

In the natatorium of the Pearland Recreation Center and Natatorium a glulam structural system is used, including 14 glulam arches. These glulam arches are connected to the concrete footers using bolts. The bolted connections of these arches were difficult due to the small tolerances of the glulam arches. In hind sight, the contractor suggested that a welded connection would have been more constructible.

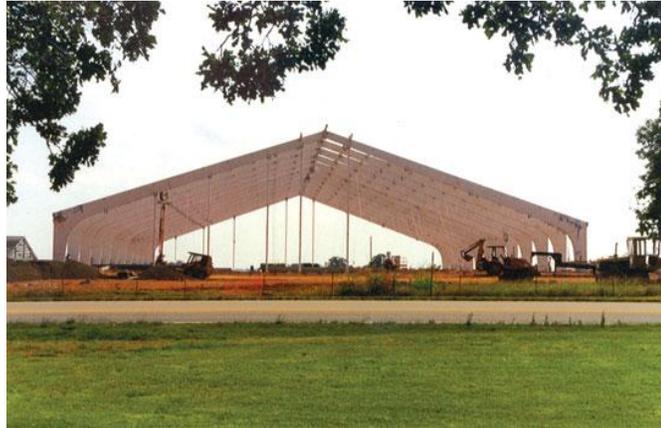
**Figure 9-1.1 - Glulam Arches** (Courtesy of Structural Mag)
