Senior Thesis Proposal

CHEMISTRY BUILDING

Michael Gallagher

Construction Management

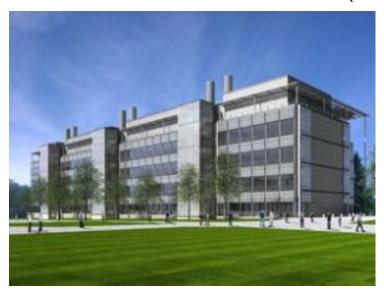
building there are three stair towers enclosed in glass on the exterior of the building. They are a major part of the exterior design of the building and can be seen in the picture on the left. On the inside in the atrium there are also two large staircases which are and architectural feature. They can be seen in the picture above on the left side and help give the building an open feel. Going along with the open feel the end walls of the atrium are comprised of all glass and the entire

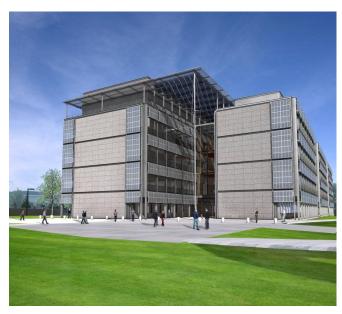
roof on the atrium is a glass skylight. Also the sides of the office building and lab building that face the atrium are all glass. Above the skylight has PV trays which are custom made for this building. They are not a traditional looking panel and are almost all clear glass allowing sunlight to make it through them and still naturally light the atrium. This can be seen in the picture on the right in the top center.
