Northeastern Pennsylvania Office Building

Construction Management

November 16, 2011

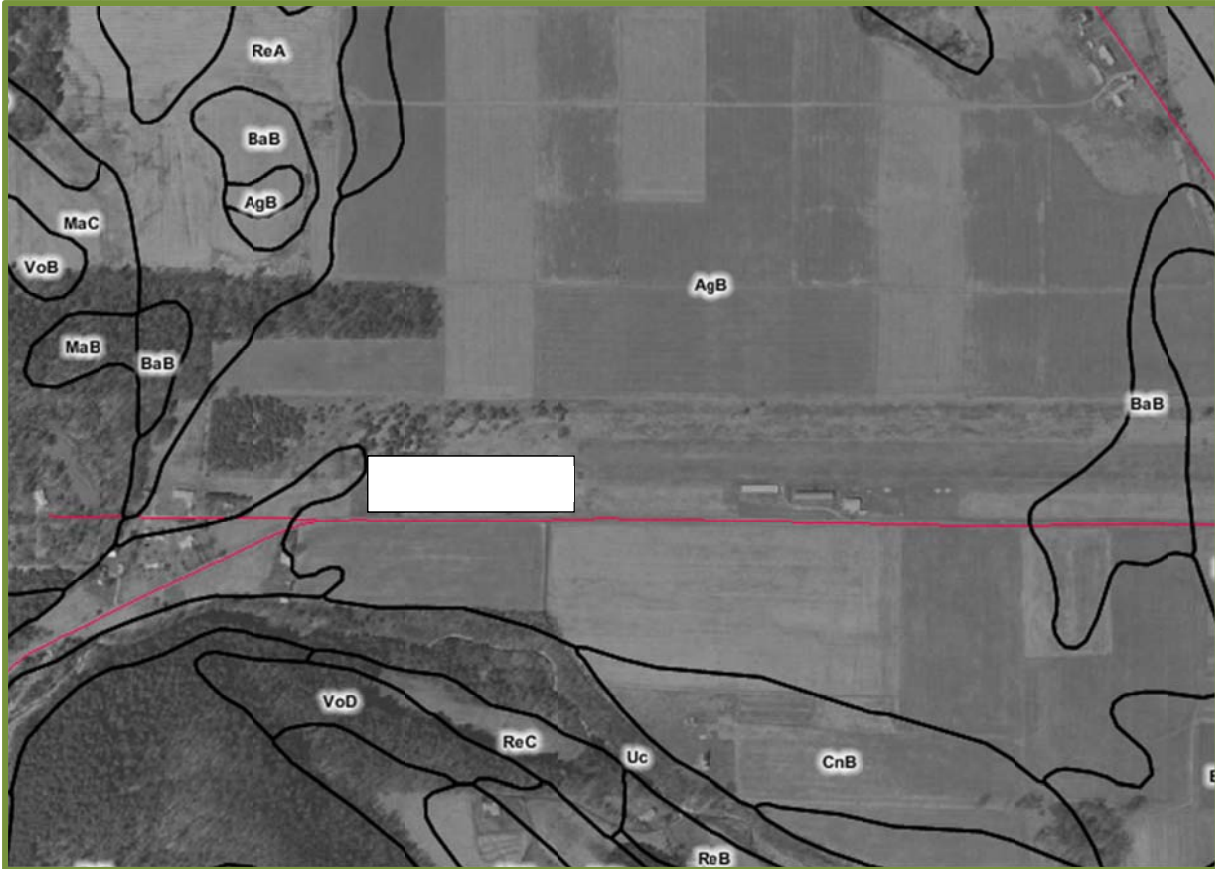
Figure 1. Soil Identification Map for Northeastern Pennsylvania Office Building

During construction of the Northeastern Pennsylvania Office Building, small issues arose that had to be handled by the contractors and subcontractors on site to avoid delays in the project schedule and additional costs to the owner. The first issue that arose involved the sitework and the amount of large rocks found when stripping the site and trenching out the foundations of the buildings. The original geotechnical report had recorded the entire site as Alton Gravelly Sandy Loam (AgB) as seen in Figure 1. This particular soil is generally well-graded and is most commonly found above a deep layer of bedrock. However, many large boulders were discovered when the site was being stripped. When the boulders were removed, large voids were left in the soil and had to be properly filled with excess soil stripped from other areas of the site. This would have given the site contractor a valid excuse to file a change order for this additional work. If the work had to be completed as a change order, the project risked being delayed while the change order was being drafted, processed, and approved.
