# Thesis Final Report

## The Office Building

# The Office Building | Washington, D.C.

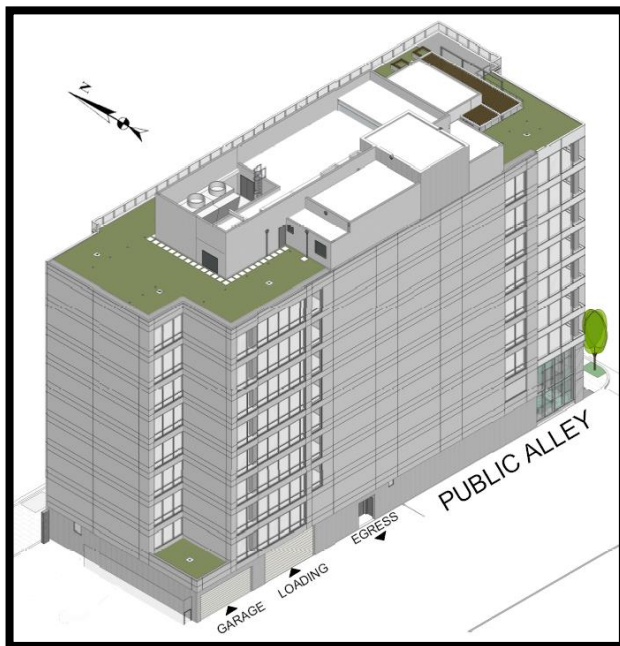
**Figure 1.4 – Axonometric Image  
Southeast Corner** | Courtesy of DAVIS

The building enclosure consists completely of a curtain wall system. Due to the close proximity of the neighboring buildings, the west side of the building, along with portions of the south wall, consists of metal panels, where the rest of the façade is comprised of glass. The mixture of metal panels and glass for the curtain wall can be seen in figure 1.4.

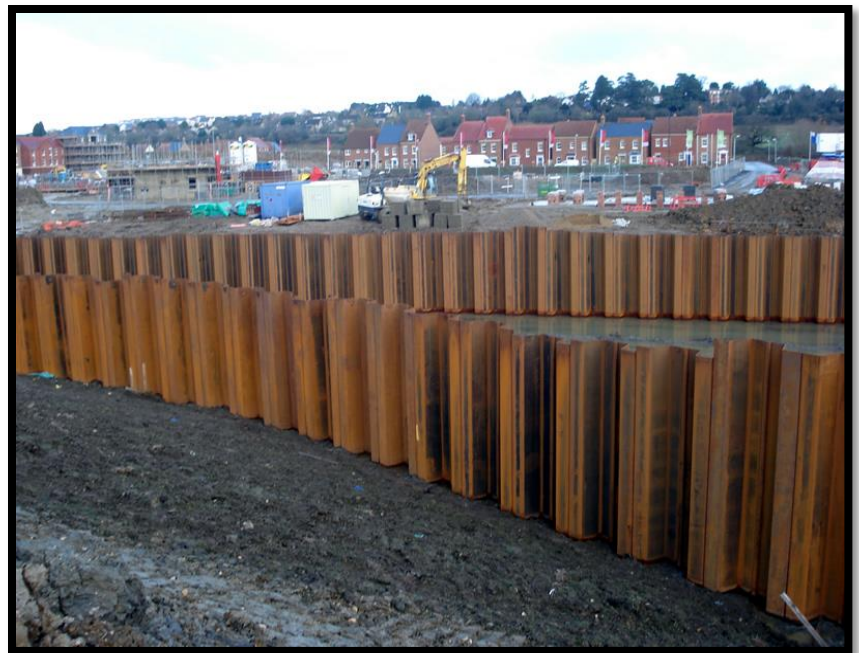
**Figure 2.1 – Sheet Piling** | Courtesy of Maxx Piling

Sheet piling is the process in which thick sheets of metal, (typically steel), are inserted into the soil around an excavation, as seen in figure 2.1. These sheets can be driven with an impact hammer, vibrated with a vibratory hammer, or statically pushed with a hydraulic load system. After the sheets have been placed, crews can go through and excavate the soil out of the hole. Once the foundation is complete, the sheet piles may be required for support, or may be taken out

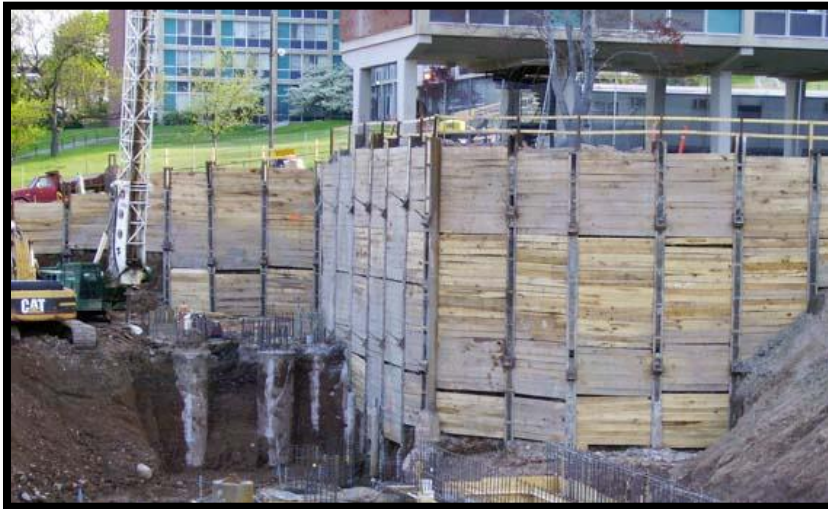
**Figure 2.2 – Soldier Pile and Lagging** | Courtesy of

The process of using soldier piles begins with the installation of the piles, typically steel wide flanges, being placed around the perimeter of the excavation with about six to ten feet uniformly between them. The piles are usually driven with an impact hammer, like the sheet

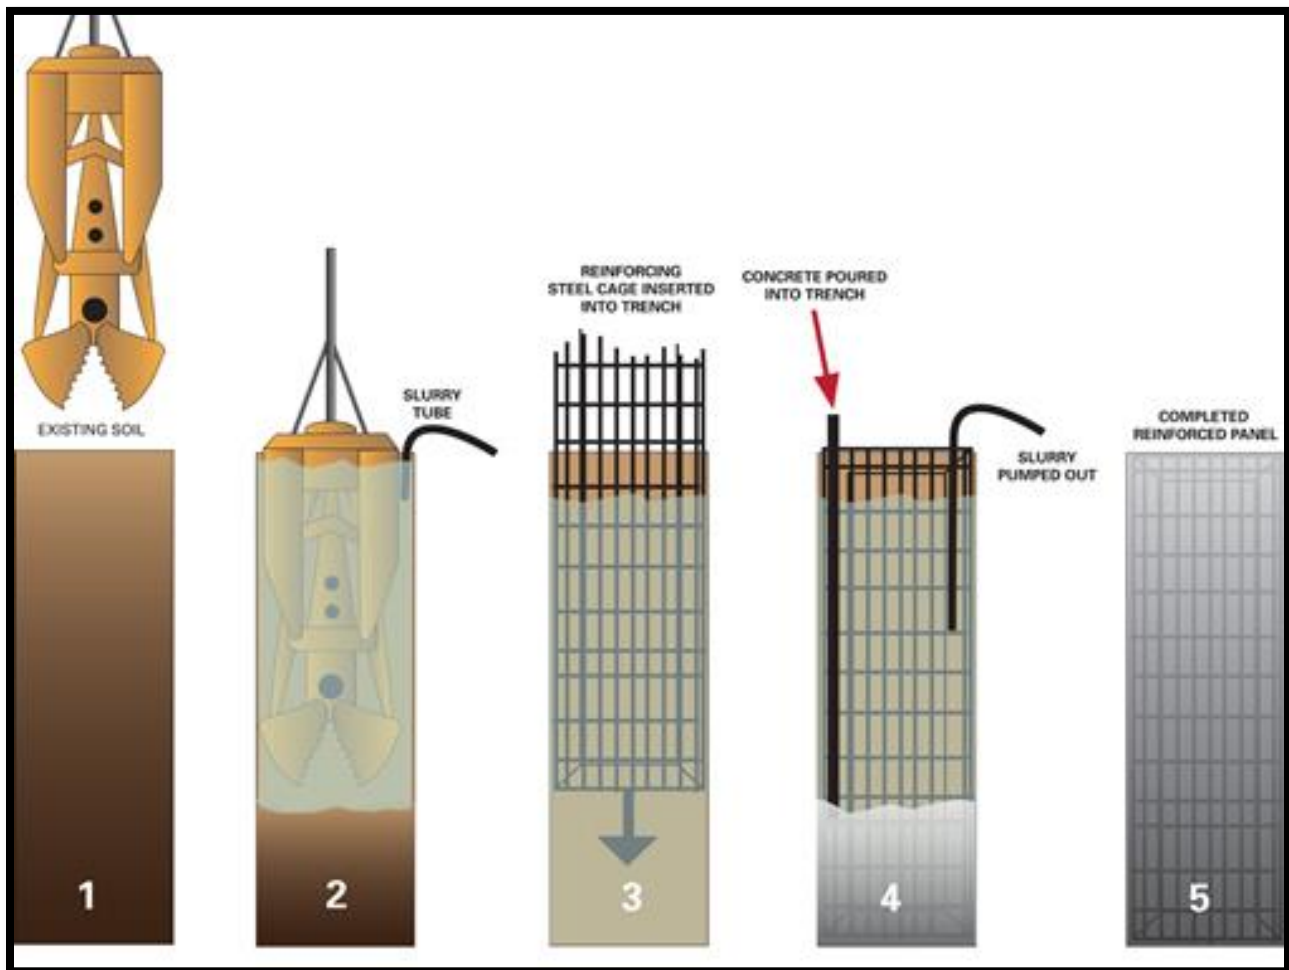
**Figure 2.3 – Stages of a Slurry Wall** | Courtesy of Massachusetts General Hospital

A slurry wall is a cast-in-place concrete wall with a thickness ranging from 18 inches to 5 feet and can have a depth of up to 400 feet. The reinforced concrete wall is broken up into, typically, 25 foot wide panels extending to the fully required depth. Once complete, the wall will not only act as a retaining wall during the excavation and foundation phases, but also as the permanent foundation wall for the building. The wall may be built one of two ways depending on the installation of the panels. These panels may be built consecutively or alternatively. Through the consecutive approach, the first panel is completed, followed by the panels on each side. Under the alternating method, every other panel is completed; these are called primary panels. The primary panels are constructed with space of equal width to the panels in between them for the secondary panels to be placed later. The completion of the secondary panels creates a continuous wall. There are a few steps before the concrete can be placed, which are outlined in figure 2.3. To begin, a trench must be excavated, typically with a bucket in the shape of a clamshell. As the clamshell bucket pulls out soil, the void is immediately filled with bentonite slurry. This slurry creates positive static pressure on the walls of the excavation to eliminate the chance of a cave-in. Once the trench is completely excavated and filled with slurry, the steel reinforcing cage is lowered into the trench. After the reinforcement is installed, concrete is pumped into the trench, displacing the lighter bentonite slurry, which is pumped into tanks for reuse.

New technology has been introduced where the cast-in-place concrete panel has been replaced by a reinforced precast concrete panel, which is simply lowered into place. In this scenario, the slurry contains bentonite, as well as cement. The slurry remains liquid when the panel is placed, and sets up to hardened cement to hold the panel in place. The precast panels are manufactured with tongue-and-groove joints to form the continuous wall.

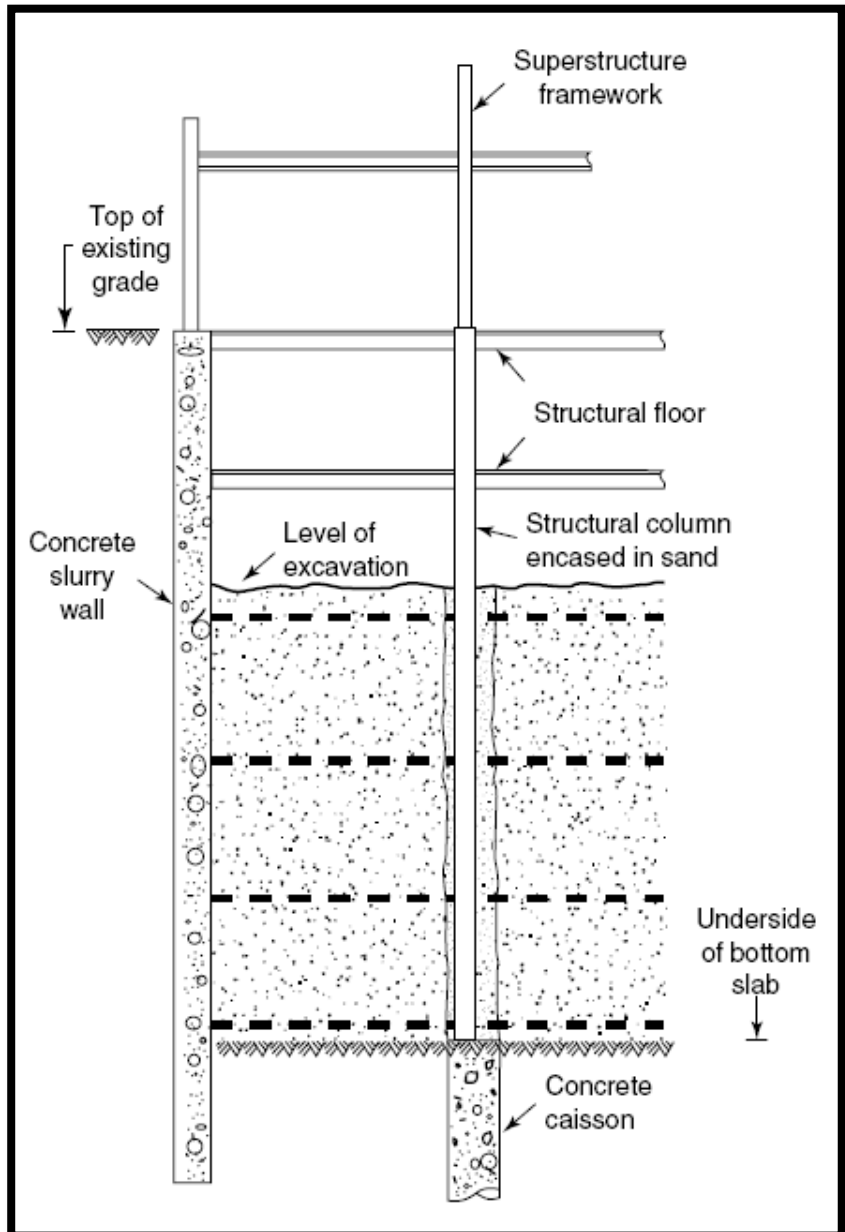
Figure 2.4 – Top Down Construction | Courtesy of Andres

Top down construction is a newly developed technique which combines deep foundations and mining into its process. This method starts with the perimeter of the building being enclosed by slurry walls which will act as the foundation walls once the project is complete. To account for interior columns, caissons with temporary steel liners are drilled to a substantial depth. The caisson is then filled with concrete up to the bottom of the lowest floor of the building. For a steel framed building, columns are inserted into the caissons above the lowest floor and are then backfilled with sand. Once backfilled, the caisson liners are removed. An under-slab is then poured at ground level to provide a base for the structural floor which is then poured afterward. Openings are left in the slabs for equipment to excavate and remove soil below the slabs. As figure 2.4 shows, the soil is excavated until the next floor is reached, at which time the two slabs are poured and the process repeats itself. In lieu of the under-slab and structural slab, a concrete slab atop steel beams and metal decking may be used.

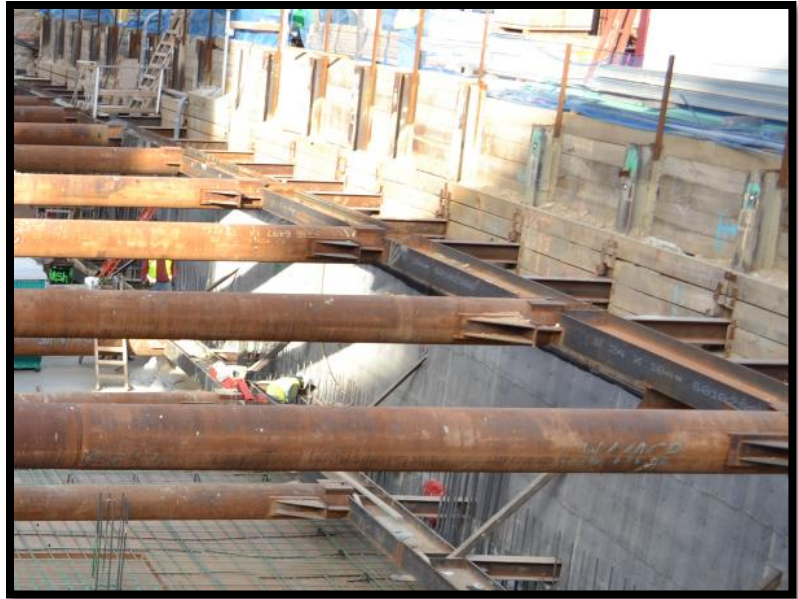
Figure 3.1 - SOE System | Courtesy of DAVIS

As mentioned in Section 2, The Office Building uses soldier piles and lagging for its retaining structure. Because of The Office Building's existing conditions, common support of excavation (SOE) techniques were replaced by a more challenging system. In normal practice, tiebacks are used to provide resistance from lateral earth loads for the wood lagged retaining walls. In the case of The Office Building, a system comprised of wales and bracing keep the wood lagged walls from caving into the site, as shown in figure 3.1. To keep the cross bracing in place, the system is tied into every soldier pile, (located about every 7.5 feet), by a wide flange. These wide flange tie-ins create many obstructions on the site that need to be worked around. When the time comes to pour the concrete foundation walls, every cross bracing connection to a pile will need to be formed around, as seen in figure 3.2. Once the structure is to strength and the cross bracing can be removed, the remaining holes will require grout to fill them in. This process won't occur, however, until crews are pouring concrete on the fourth floor of the building.

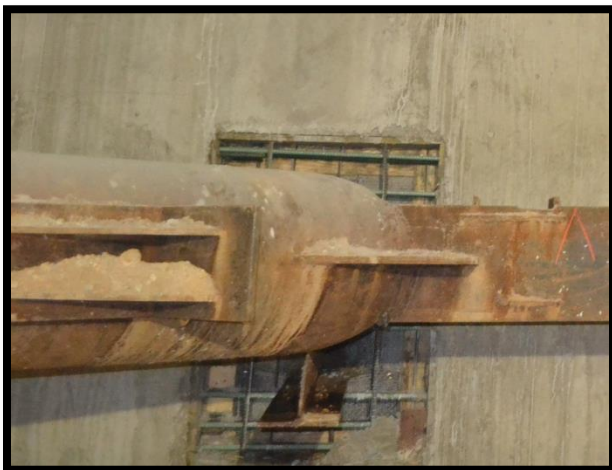
Figure 3.2 – Formed Tie-in | Courtesy of

Forming around every SOE tie-in is a very labor intensive task. Because of this, the foundation walls have long schedule durations and large costs. Both of these factors, time and money, along with quality, are the main concerns of the owner. Research will be conducted to find a more efficient alternative to the cross bracing/CIP concrete combination, in order to appease all of the owner's concerns. Research can also be conducted to find popular foundation wall systems near the location of

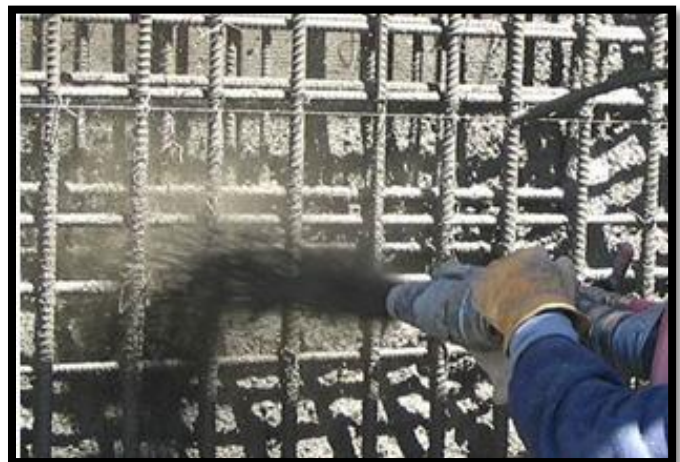
Figure 3.3 – Shotcrete Installation |

Before comparisons came be made, research must be done to fully understand the use of shotcrete. Shotcrete is a spray form of concrete that is distributed through a hose and pneumatically projected at a high velocity onto a surface, as seen in figure 3.3. Shotcrete is most recognized for its use in swimming pools, water features and skate parks, but its versatility makes it a great material for

construction. Due to the high velocity of the projected shotcrete, the material is compacted upon placement. This means the shotcrete forms as it is sprayed, eliminating the use of formwork. It must be remembered that anytime formwork is used, it takes time and manpower to not only erect the forms but also to take them down. For this reason, anytime the amount of formwork can be reduced, the schedule and budget both benefit.

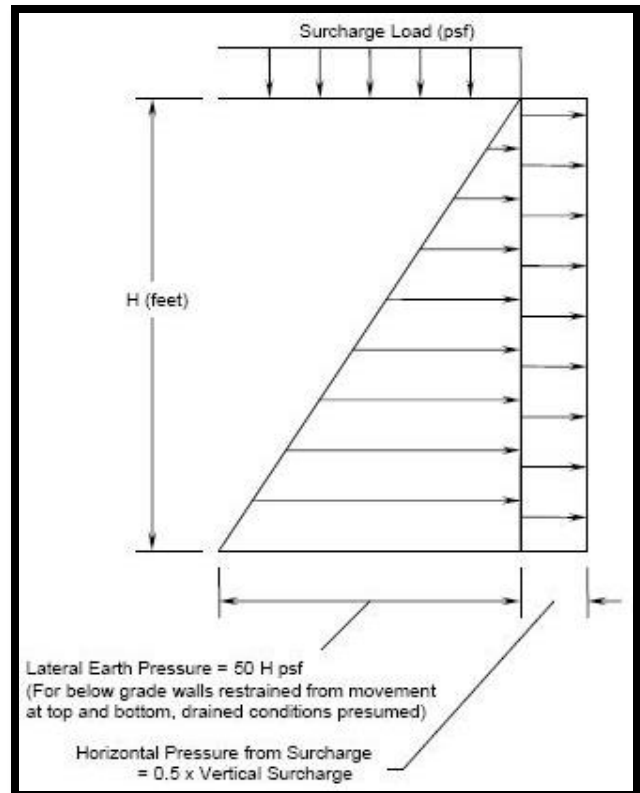
Figure 3.4 – Lateral Pressure Diagram | Courtesy of DAVIS

The geotechnical report was used to find the equations, shown in figure 3.4, for the lateral earth pressure and the horizontal surcharge loads acting on the wall. Knowledge obtained through the Civil Engineering (CE) 397A: Geotechnical Engineering class and from advisors and structural students was used to complete the calculations within this breadth. RISA 2-D was also used to determine the shear forces and moments acting on the walls.

Before the shear forces and moments can be computed, the loads acting on the walls must be calculated. The lateral earth pressure ( $P_1$ ) is a triangular distributed load that grows larger the deeper the wall. In the case of The Office Building, the foundation walls are typically 29’ tall. This height gives us a maximum lateral pressure at the base of the wall of 1,450 plf.

The horizontal surcharge load ( $P_2$ ) is half of the vertical surcharge load ( $P_0$ ), which, in this case, is a resultant of the roadway adjacent to The Office Building. Using AASHTO H-25 Lane Load, it was discovered that  $P_0$  is 800 pounds per “lane foot.” This lane foot is equal to 12’ (the width of a normal lane of traffic). The vertical surcharge load is only calculated out 29’ from the building (the height of the foundation wall). Once the width of  $P_0$  load is determined, it is found that the vertical surcharge load is 67 plf, making the horizontal surcharge load 33.5 plf.

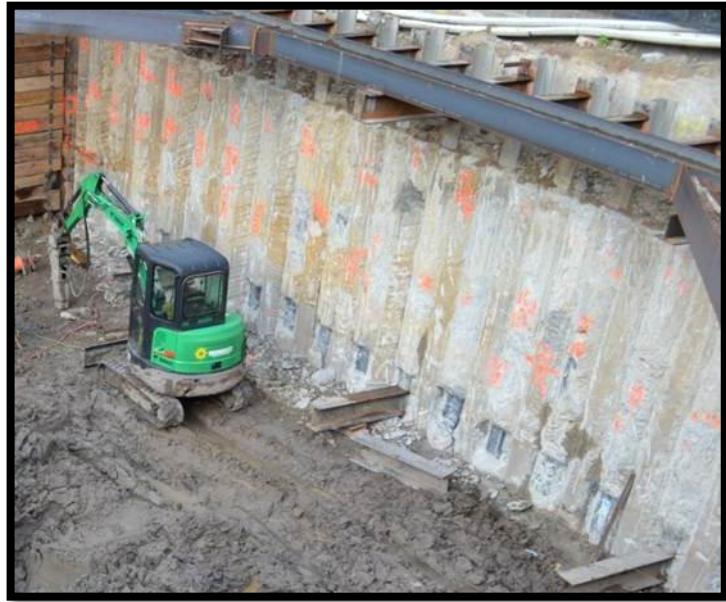
Figure 4.1 – Secant Wall | Courtesy of DAVIS

The building adjacent to the West side of The Office Building lies on the property line, which the foundation is built against. Because of this, the neighboring building's foundation must be taken into account when planning the excavation. If there is not adequate support on the west end of the project site, the ground could give way allowing the neighboring building to tip, or worse, collapse into the excavation. To prevent this, the project team designed a secant pile system, seen in figure 4.1, to be installed before excavation could begin. Unfortunately, this secant pile design pushed back an already delayed schedule.

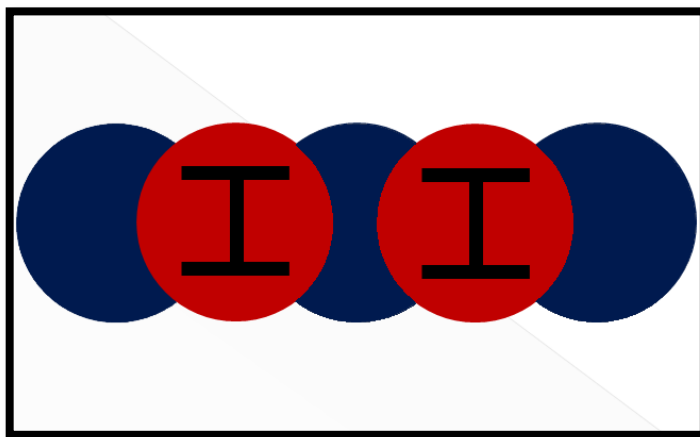
Figure 4.2 – Secant Wall Cross Section

Secant piles are drilled concrete piles that interlock to create a continuous wall. In order to incorporate the interlocking feature, the piles are done in an every-other sequence. To begin, the primary piles are drilled and poured. After a short time of curing, typically three days, the secondary piles are drilled. The strength of the primary piles must be hard enough to keep their shape, but soft enough to allow for the drilling of the secondary piles without trouble. Once

drilled reinforcing, usually a wide flange beam, is lowered into the secondary pile hole and concrete fills in the space. Figure 4.2 shows the cross section of a secant wall with the primary piles in blue and the secondary in red.

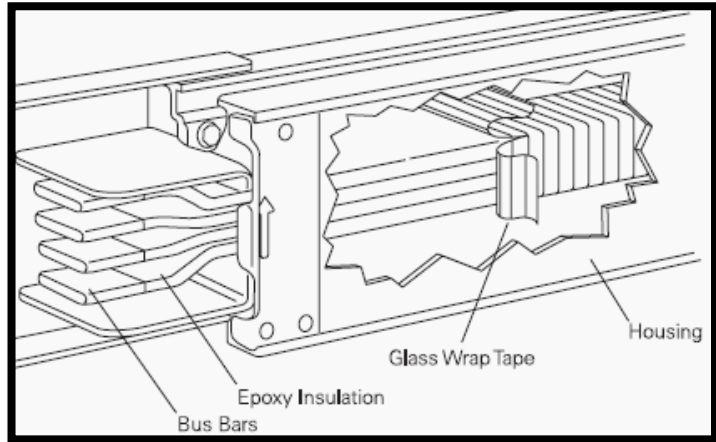
**Figure 5.1 – Busway Breakdown** | Courtesy of Siemens

According to the National Electrical Manufacturers Association (NEMA), a busway is a prefabricated electrical distribution system consisting of bus bars in a protective enclosure, including straight lengths, fittings, devices, and accessories. Busway includes continuous metallic bus bars (usually copper or aluminum), insulation and a housing. Figure 5.1 shows a breakdown of a piece of busway.

Aluminum busway has many of the same characteristics as aluminum wiring. When aluminum is used for the busway, special connectors (like those mentioned above) are required. The epoxy insulation shown in figure 5.1 help reduce the rate at which aluminum corrodes.

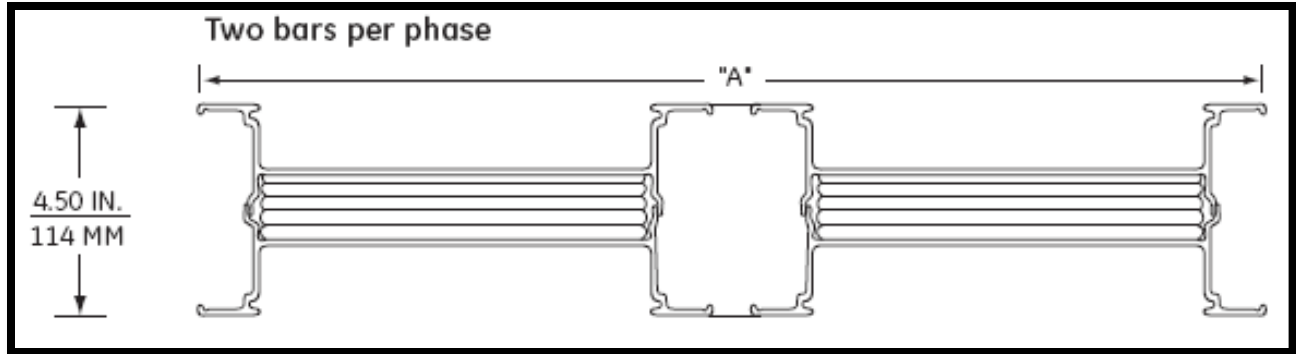
**Figure 5.2 – Busway Cross Section** | Courtesy of GE

In order to size the busway, General Electric’s Spectra Series Busway product data is used. Table 8.1 shows that for aluminum busway, 2,500 A would require two bars with a thickness of 1-1/8” for each phase and neutral. This can be seen in figure 5.2 where “A” is equal to 15.5”. The tables used to size the busway can be found in Appendix 5-B.
